Bridgeton Landfill, LLC

Weekly Data Submittal

Week of March 18, 2018 – March 24, 2018

**Required by Section 52.F of Agreed Order, Case No. 13SL-CC01088
Effective May 13, 2013**

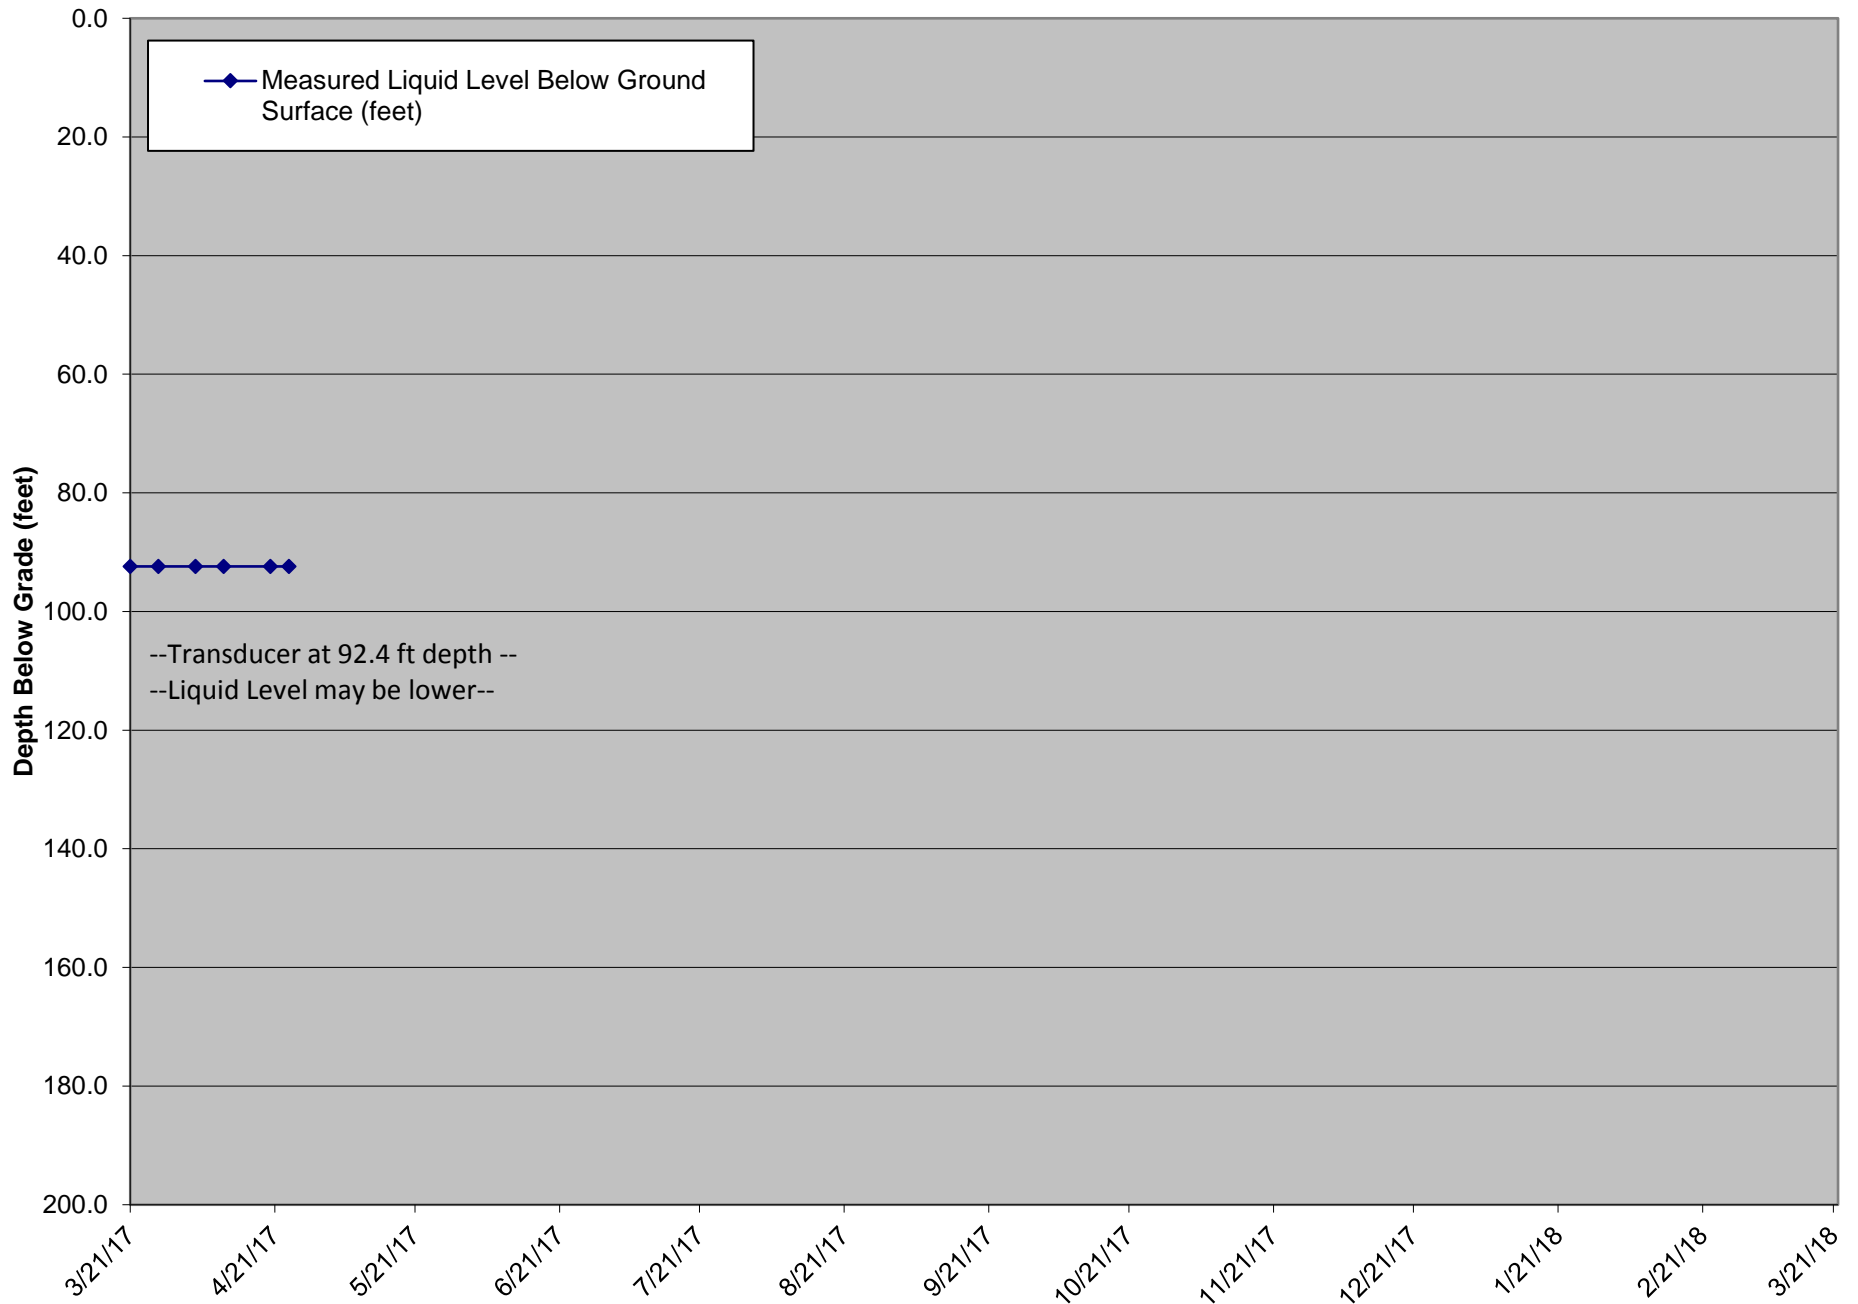
LCS-1D Liquid Level Below Ground Surface

Downhole discharge piping and the pump for LCS-1D was replaced the week of 2/5/18. Pump was non-operational after startup activities. Pump replacement is pending parts arrival.

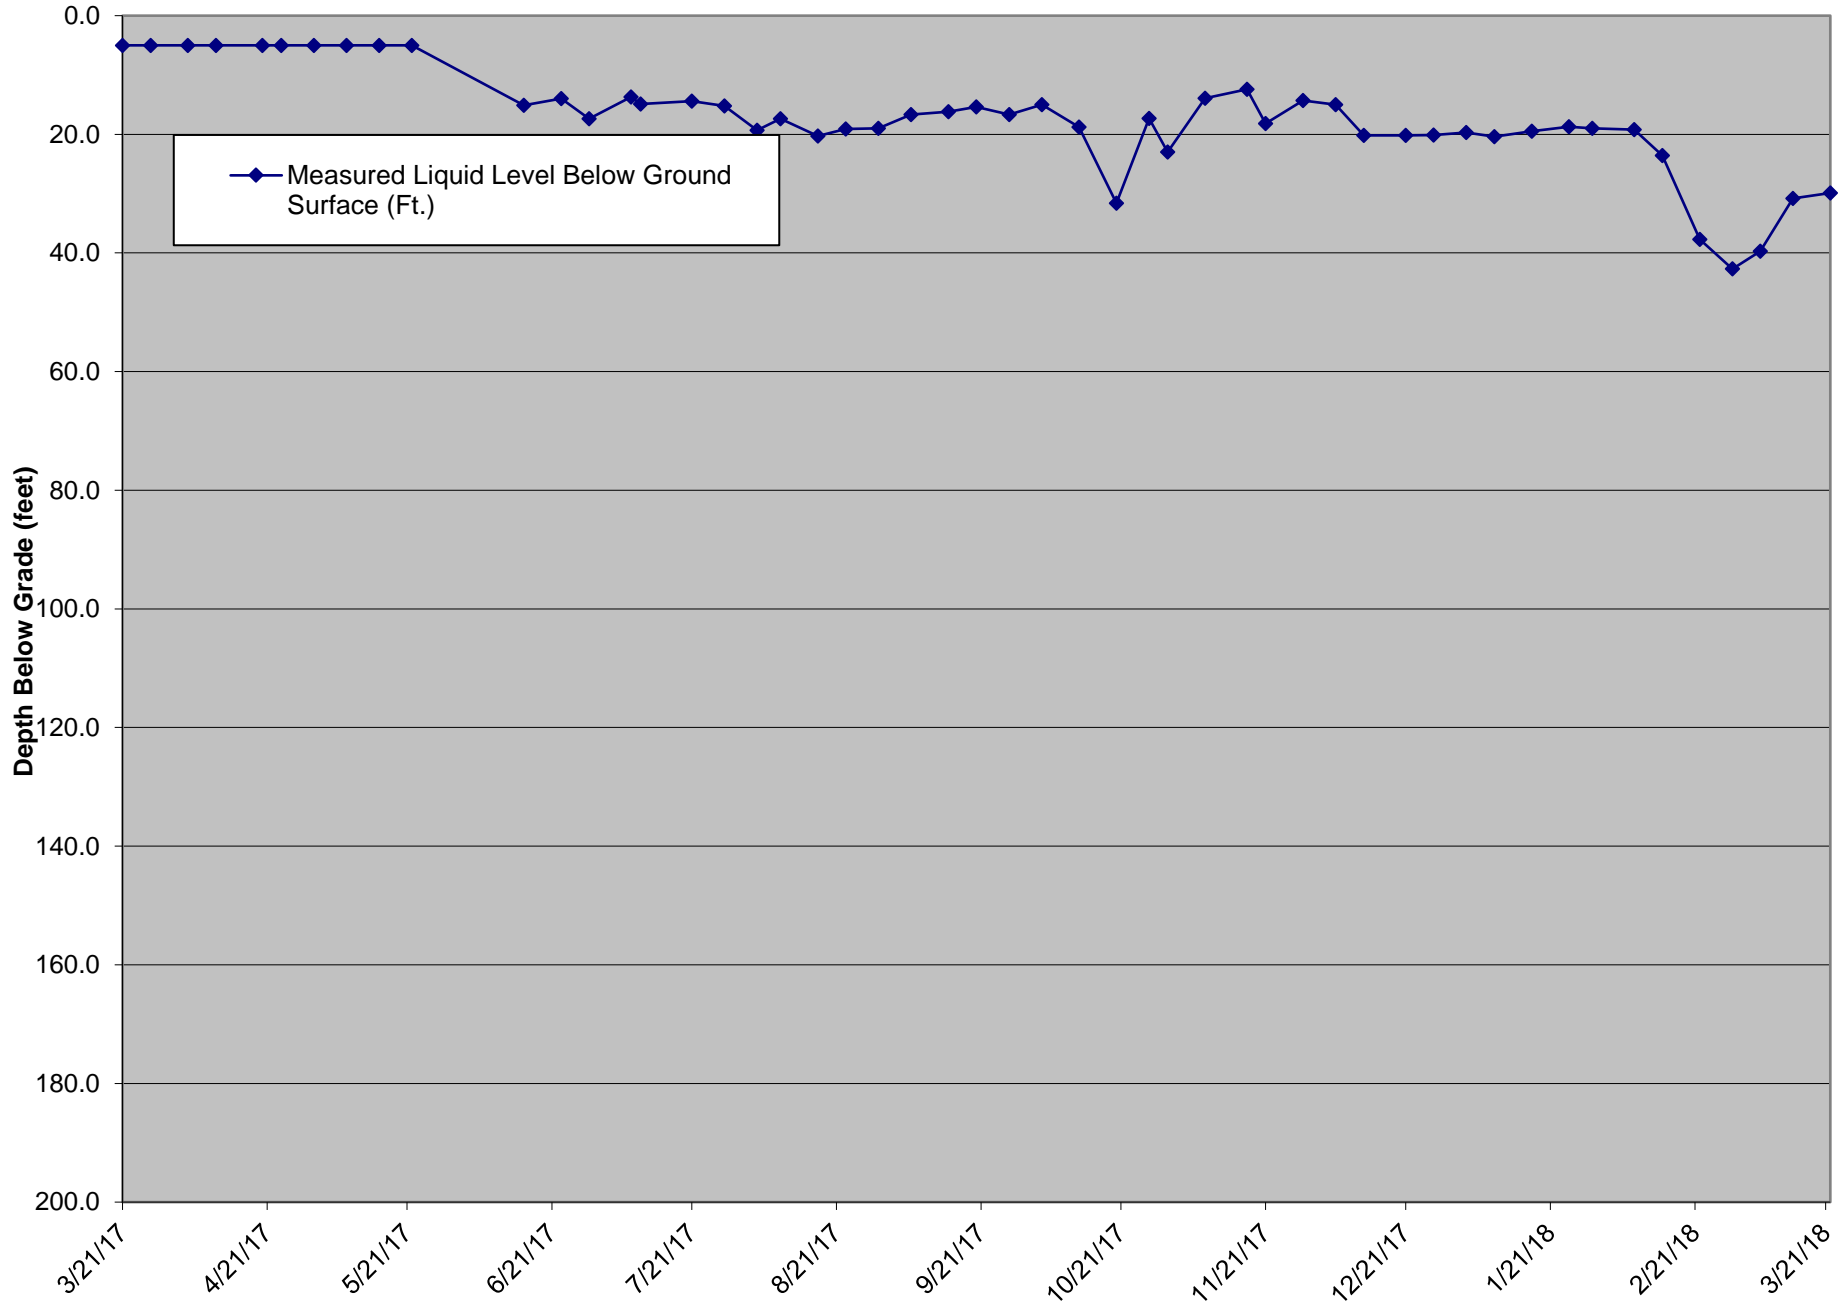
LCS-3D Liquid Level Below Ground Surface

The Blackhawk pneumatic pumps in LCS-3D were replaced with a QED AP-4 pneumatic pump on 2/15/18. Liquid level was measured manually.

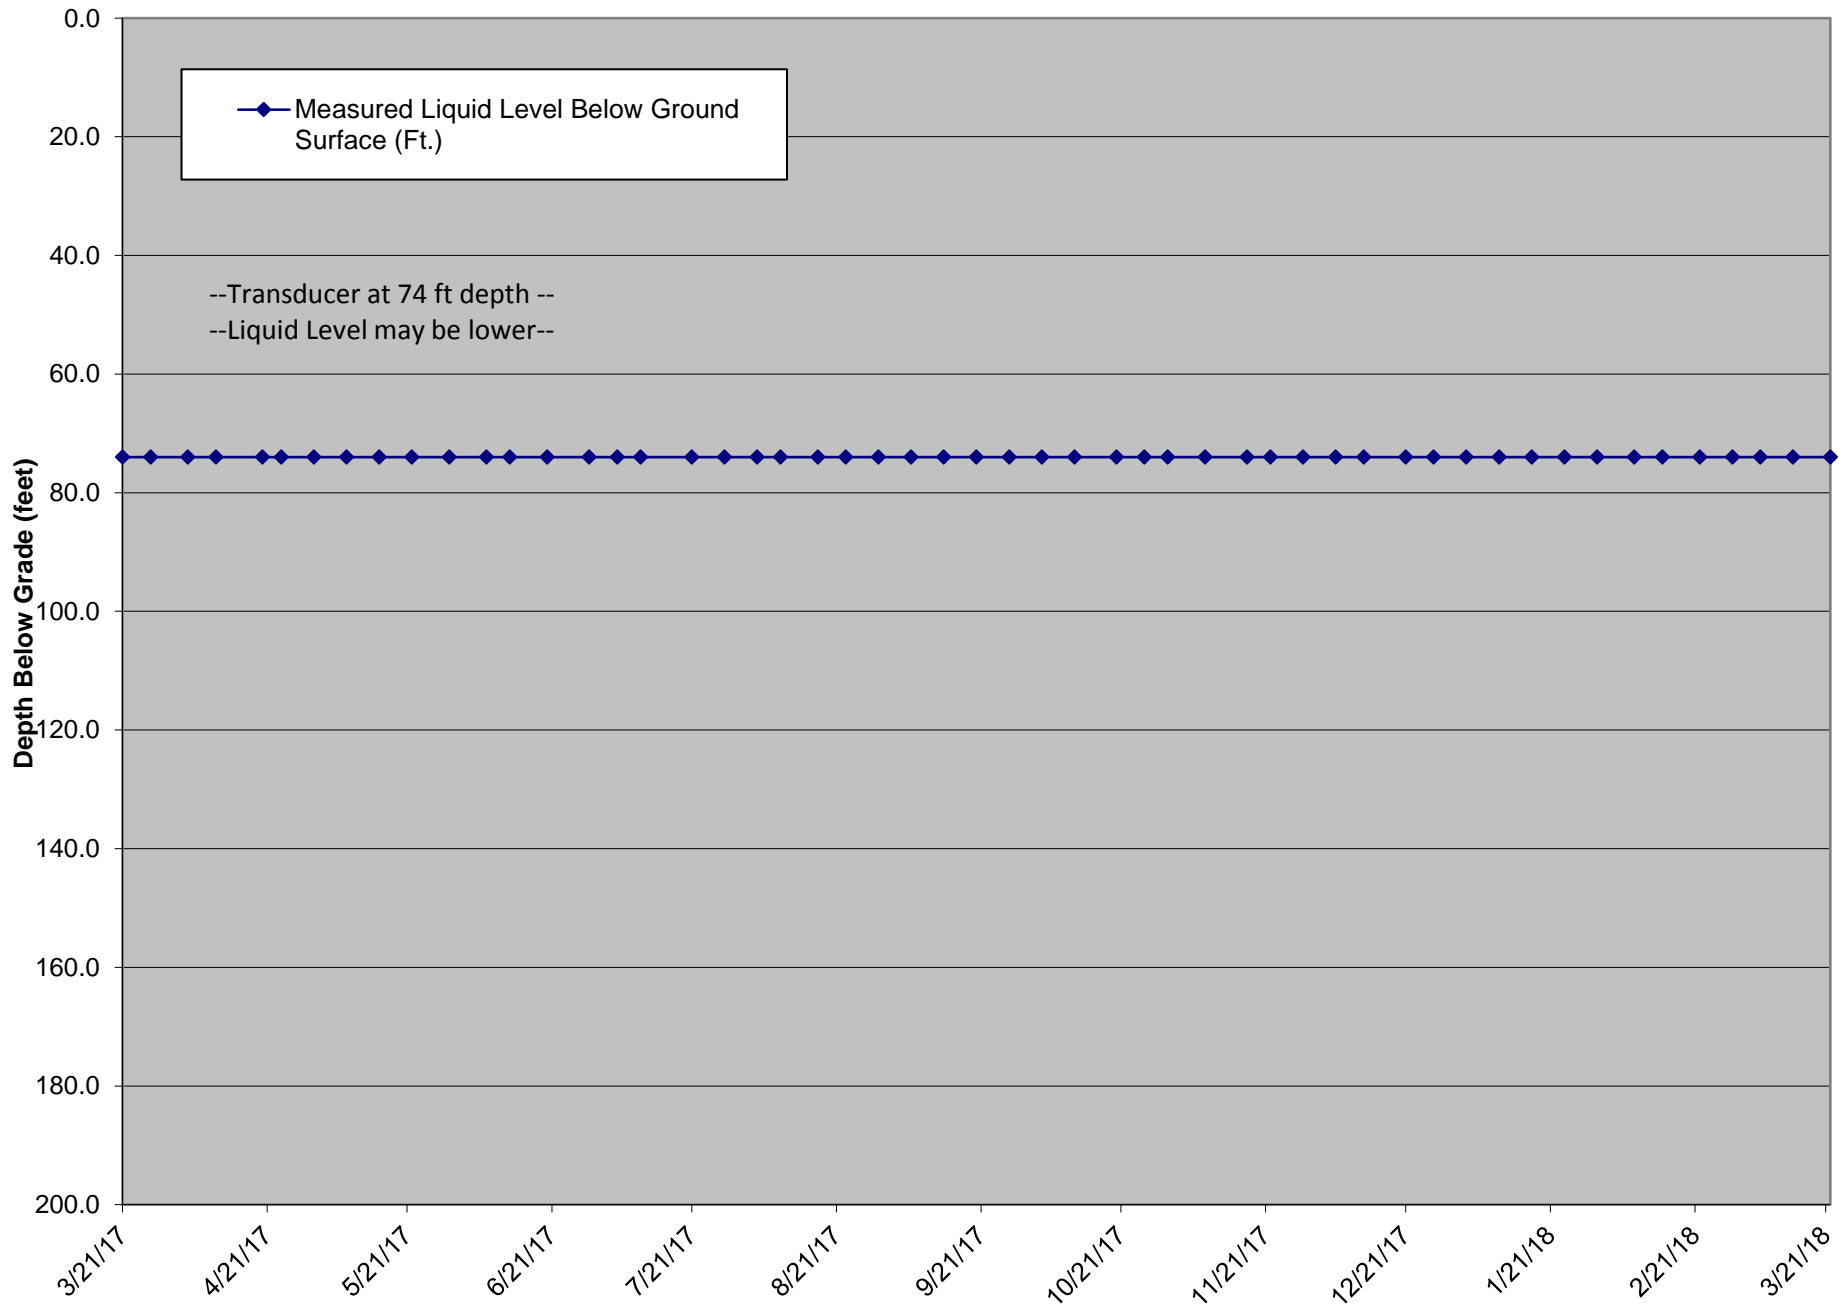
LCS-4B Liquid Level Below Ground Surface

The level sensor in LCS-4B is currently operational and responsive. Liquid level was not recorded by the level sensor during the weekly reporting period. LCS-4B is equipped with a flow meter that displayed no flow during the weekly reporting period. Therefore, it can be concluded that the liquid level was below the bottom of the pump and level sensor in LCS-4B.

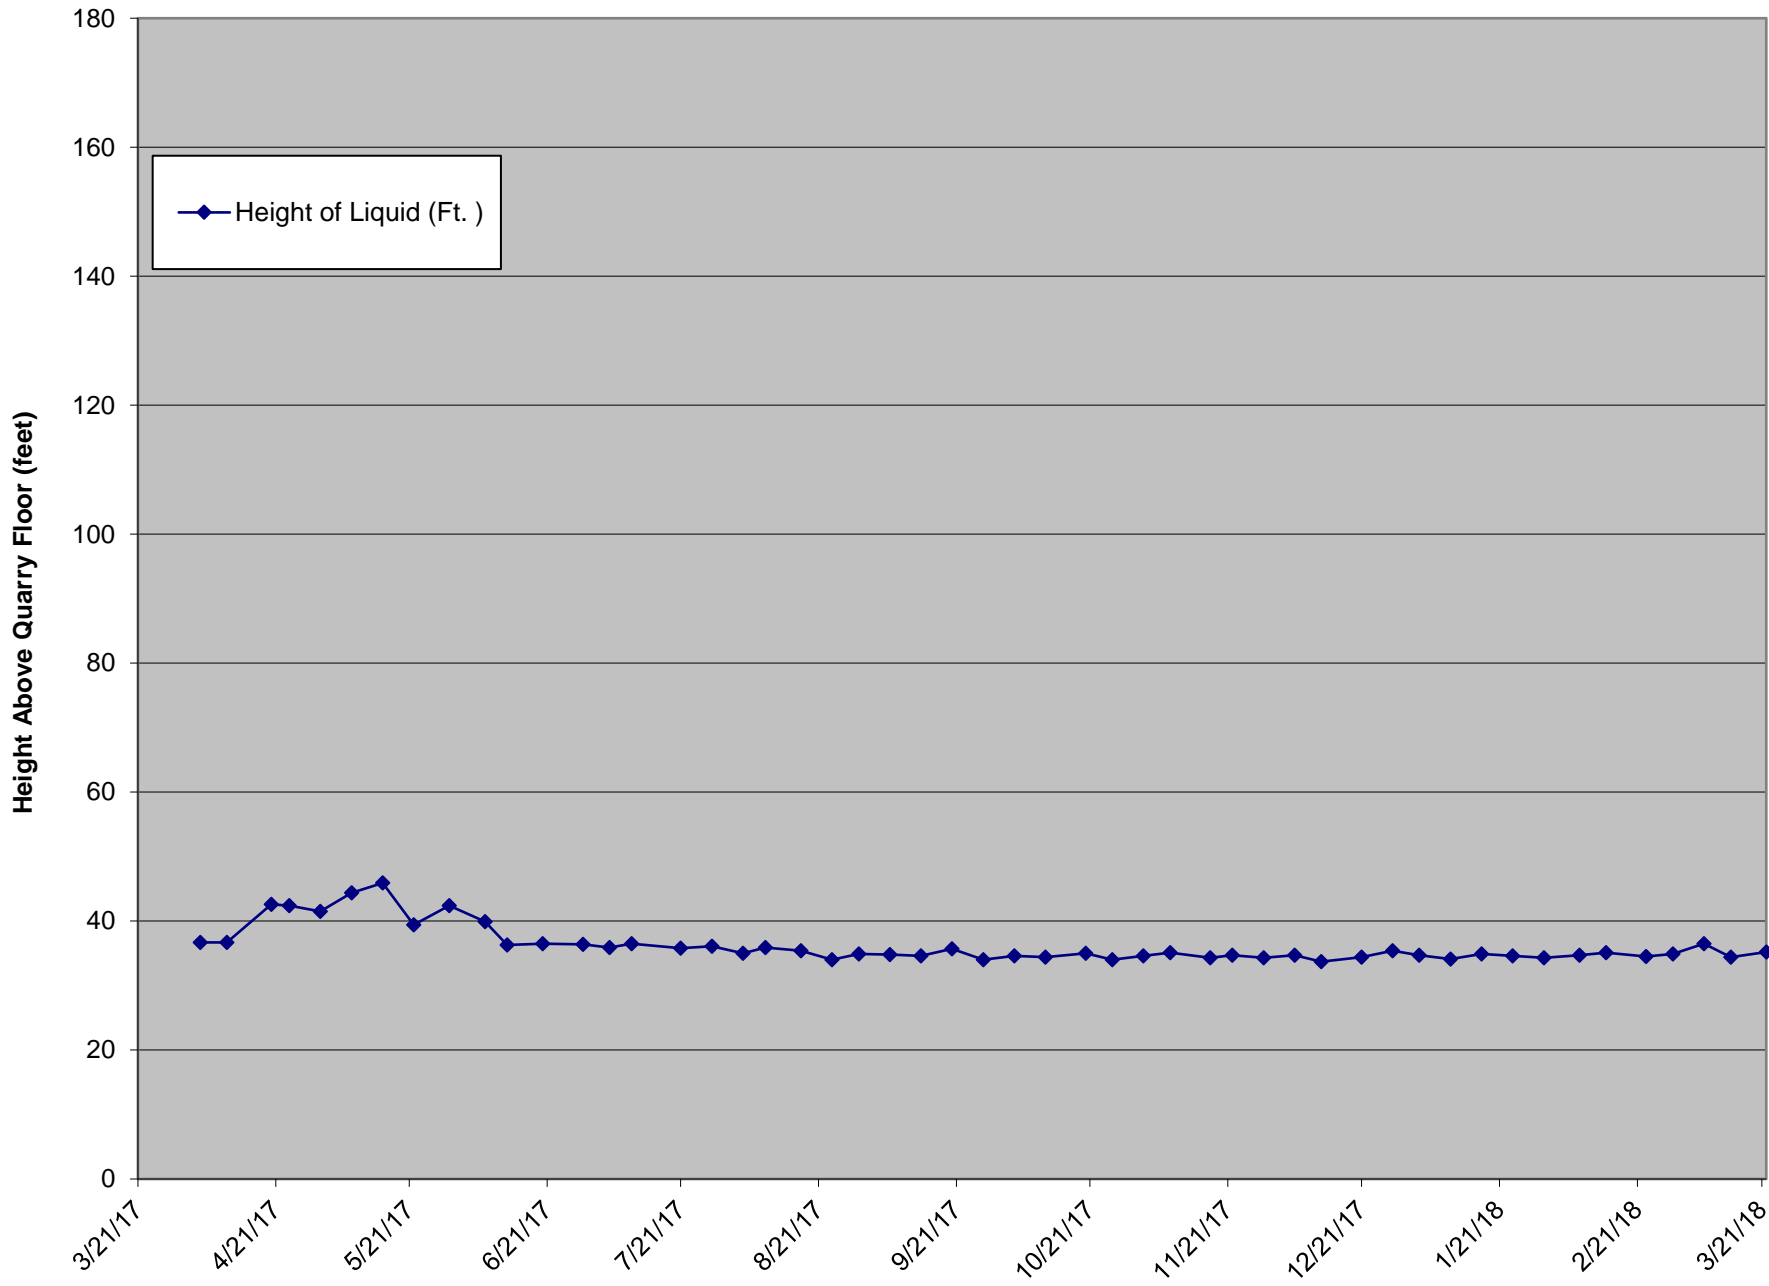
LCS-5B Liquid Level Above Quarry Floor

LCS-5B was fully operational during the weekly reporting period.

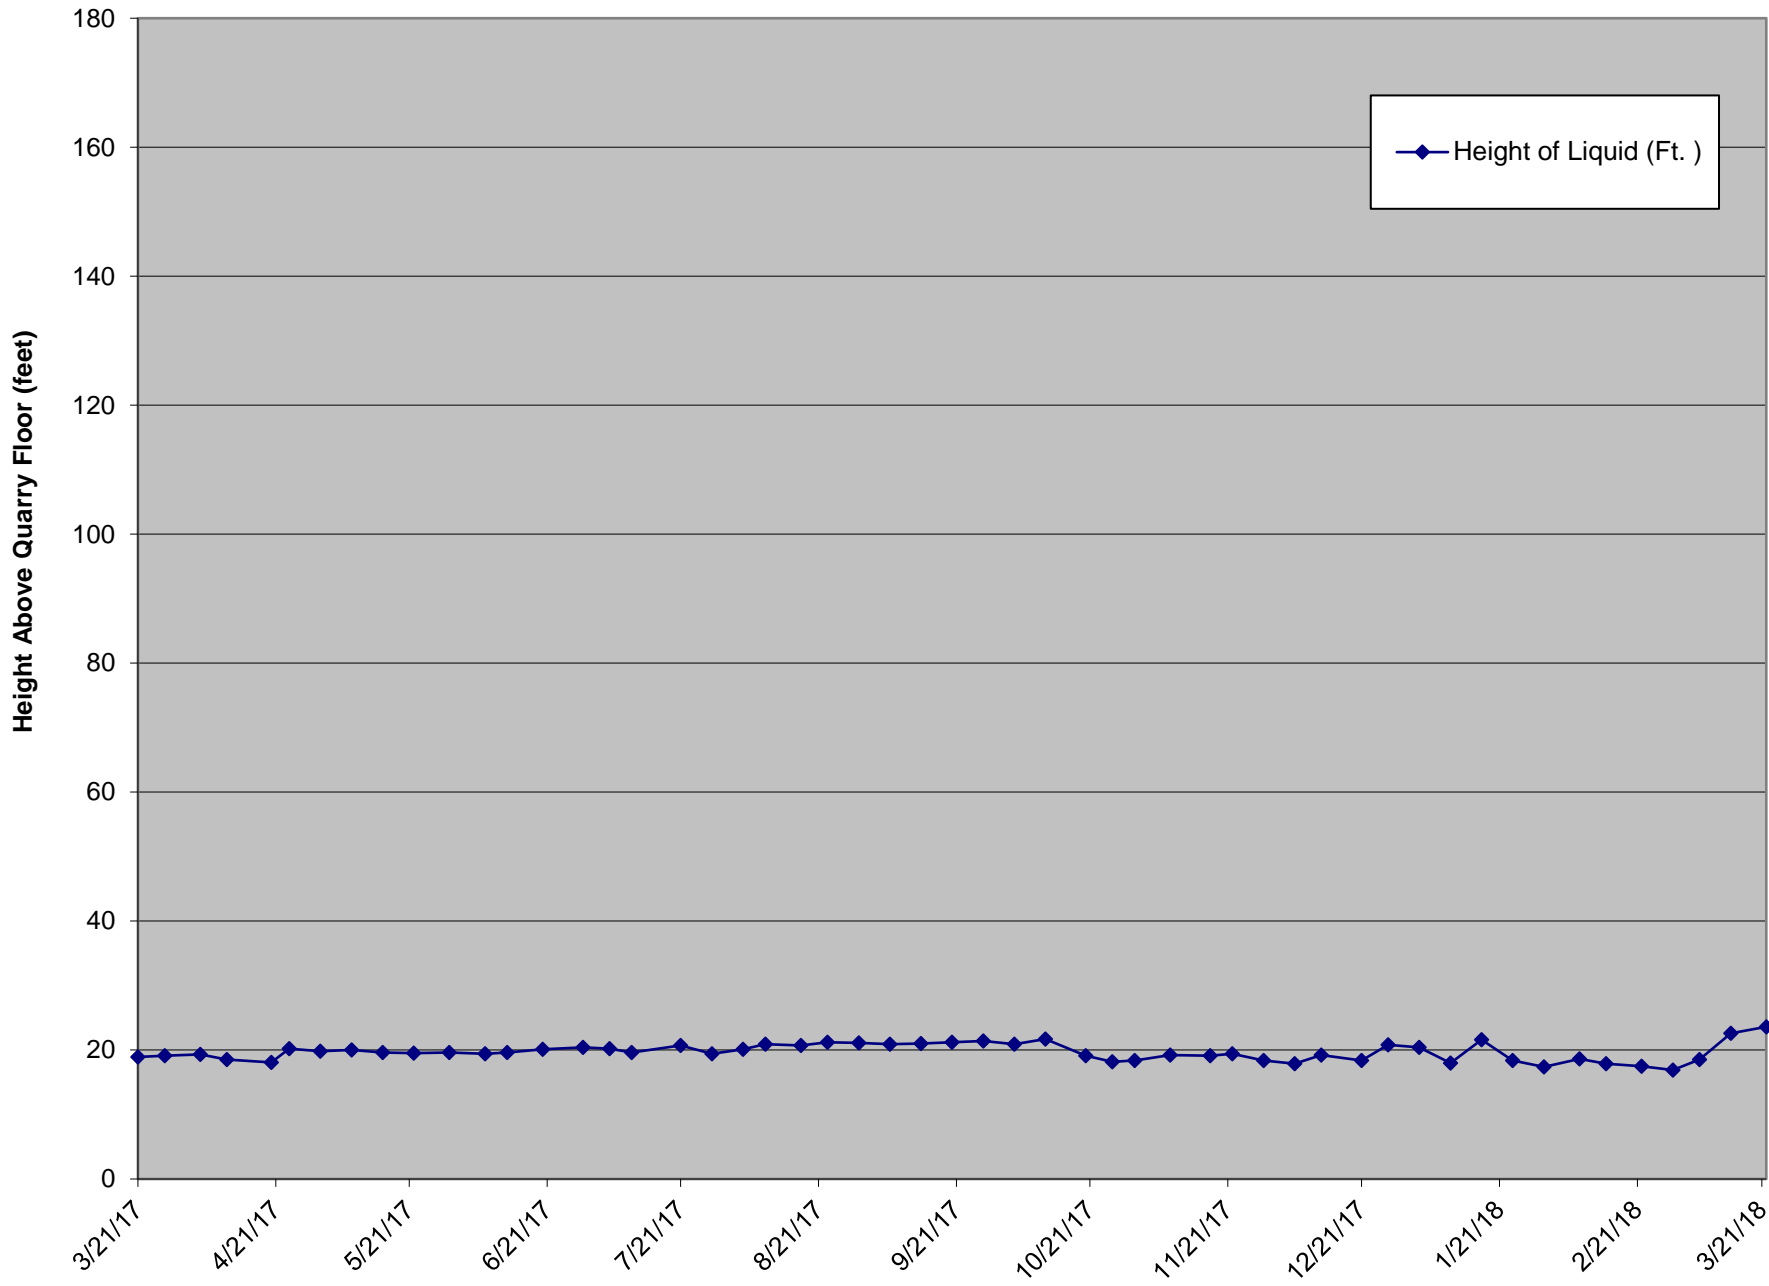
LCS-6B Liquid Level Above Quarry Floor

The pump in LCS-6B was observed to be non-operational on 3/9/18. The liquid level in LCS-6B measured on 3/22/18 is still in compliance with the pump non-operational. Pump replacement is pending parts arrival.

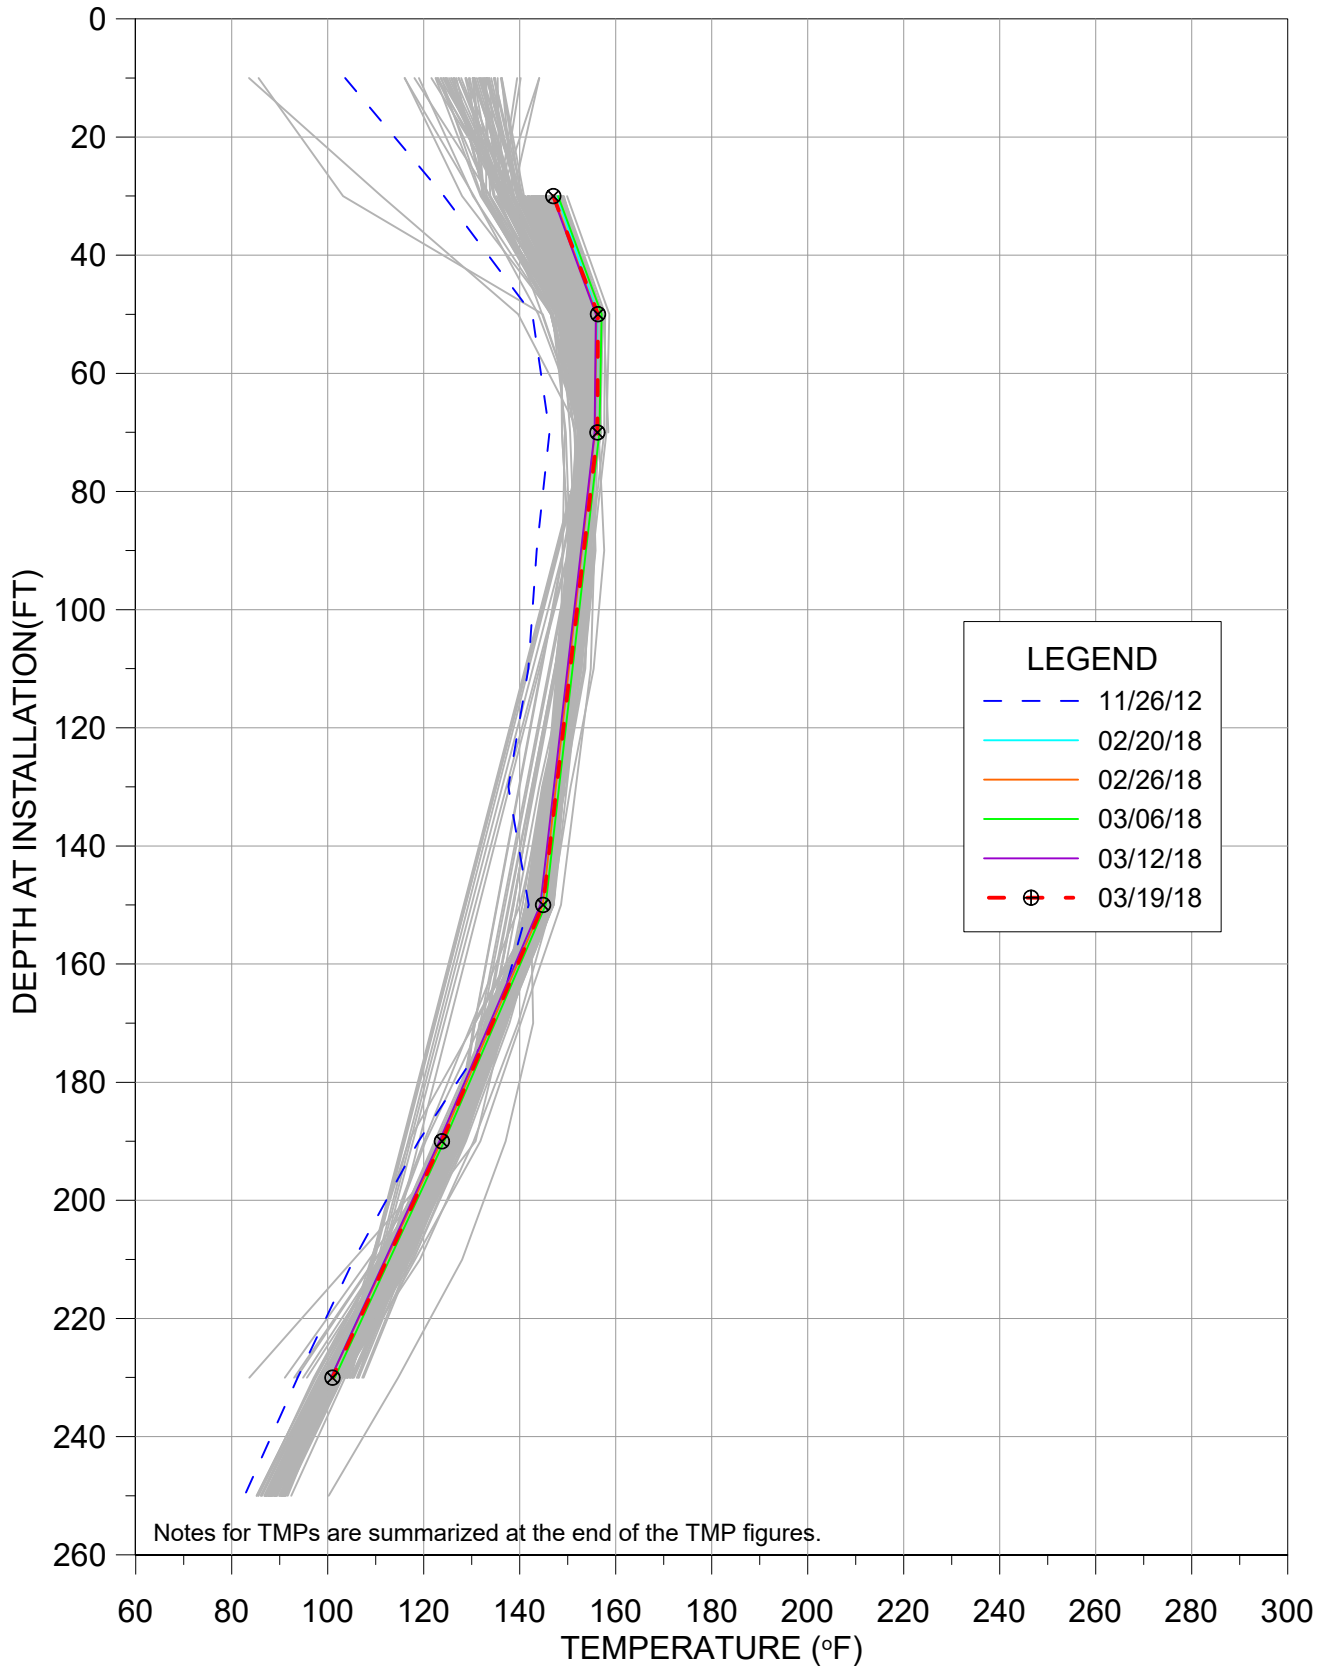
TMP-3

1. No reliable temperature readings have been obtained at 170 ft depth since 1/29/2014, except on 3/13/2014.
2. The connectivity tests on 4/11/2014 conducted by CEC showed that units at 10, 90, 130, 210 and 250 ft depths are no longer reliable.
3. The connectivity tests on 10/28/2014 conducted by Feezor Engineering showed that units at 10, 90, 110, 130, 210 and 250 ft depths are not reliable.

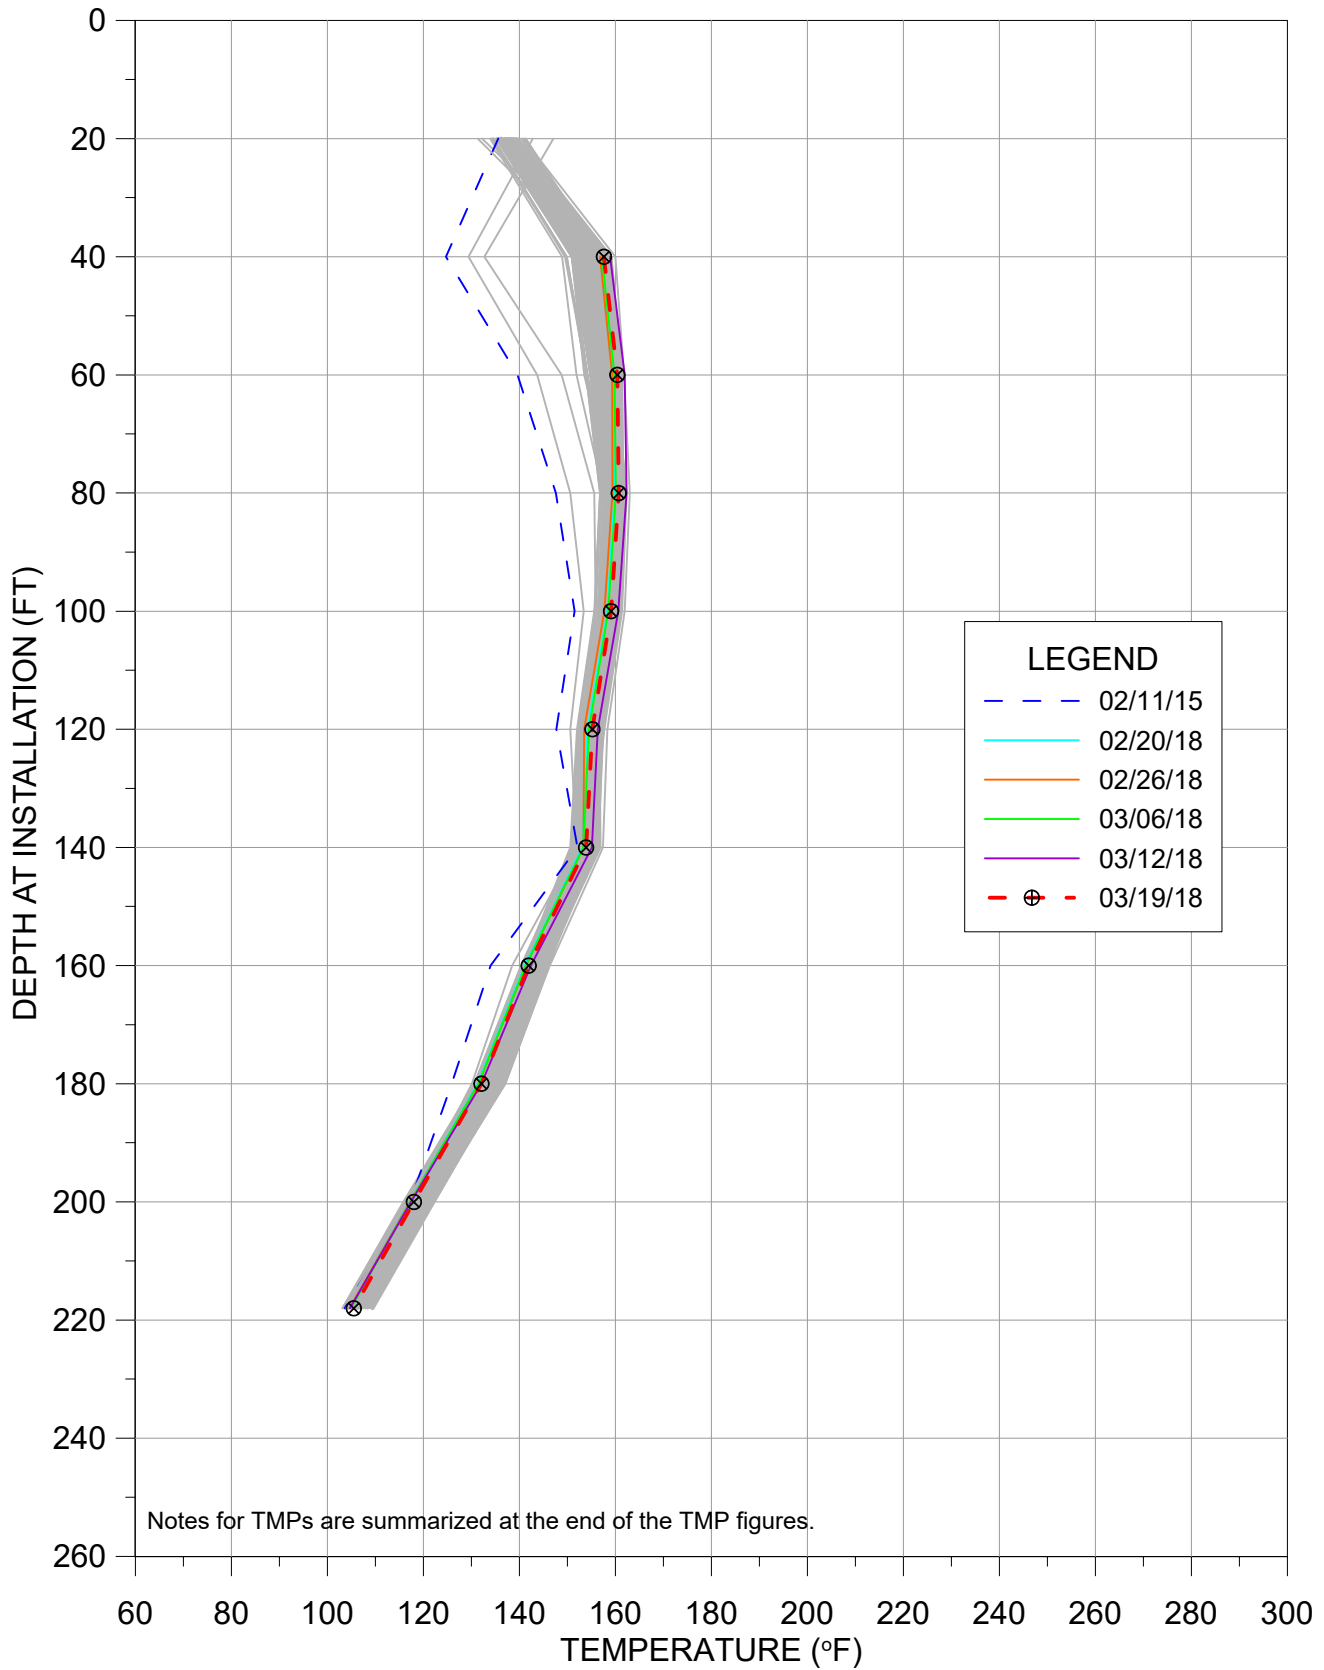
TMP-3R

1. The unit at 20 ft depth had a fluctuating resistance since 9/25/2017. Therefore the temperature is determined to be unreliable.

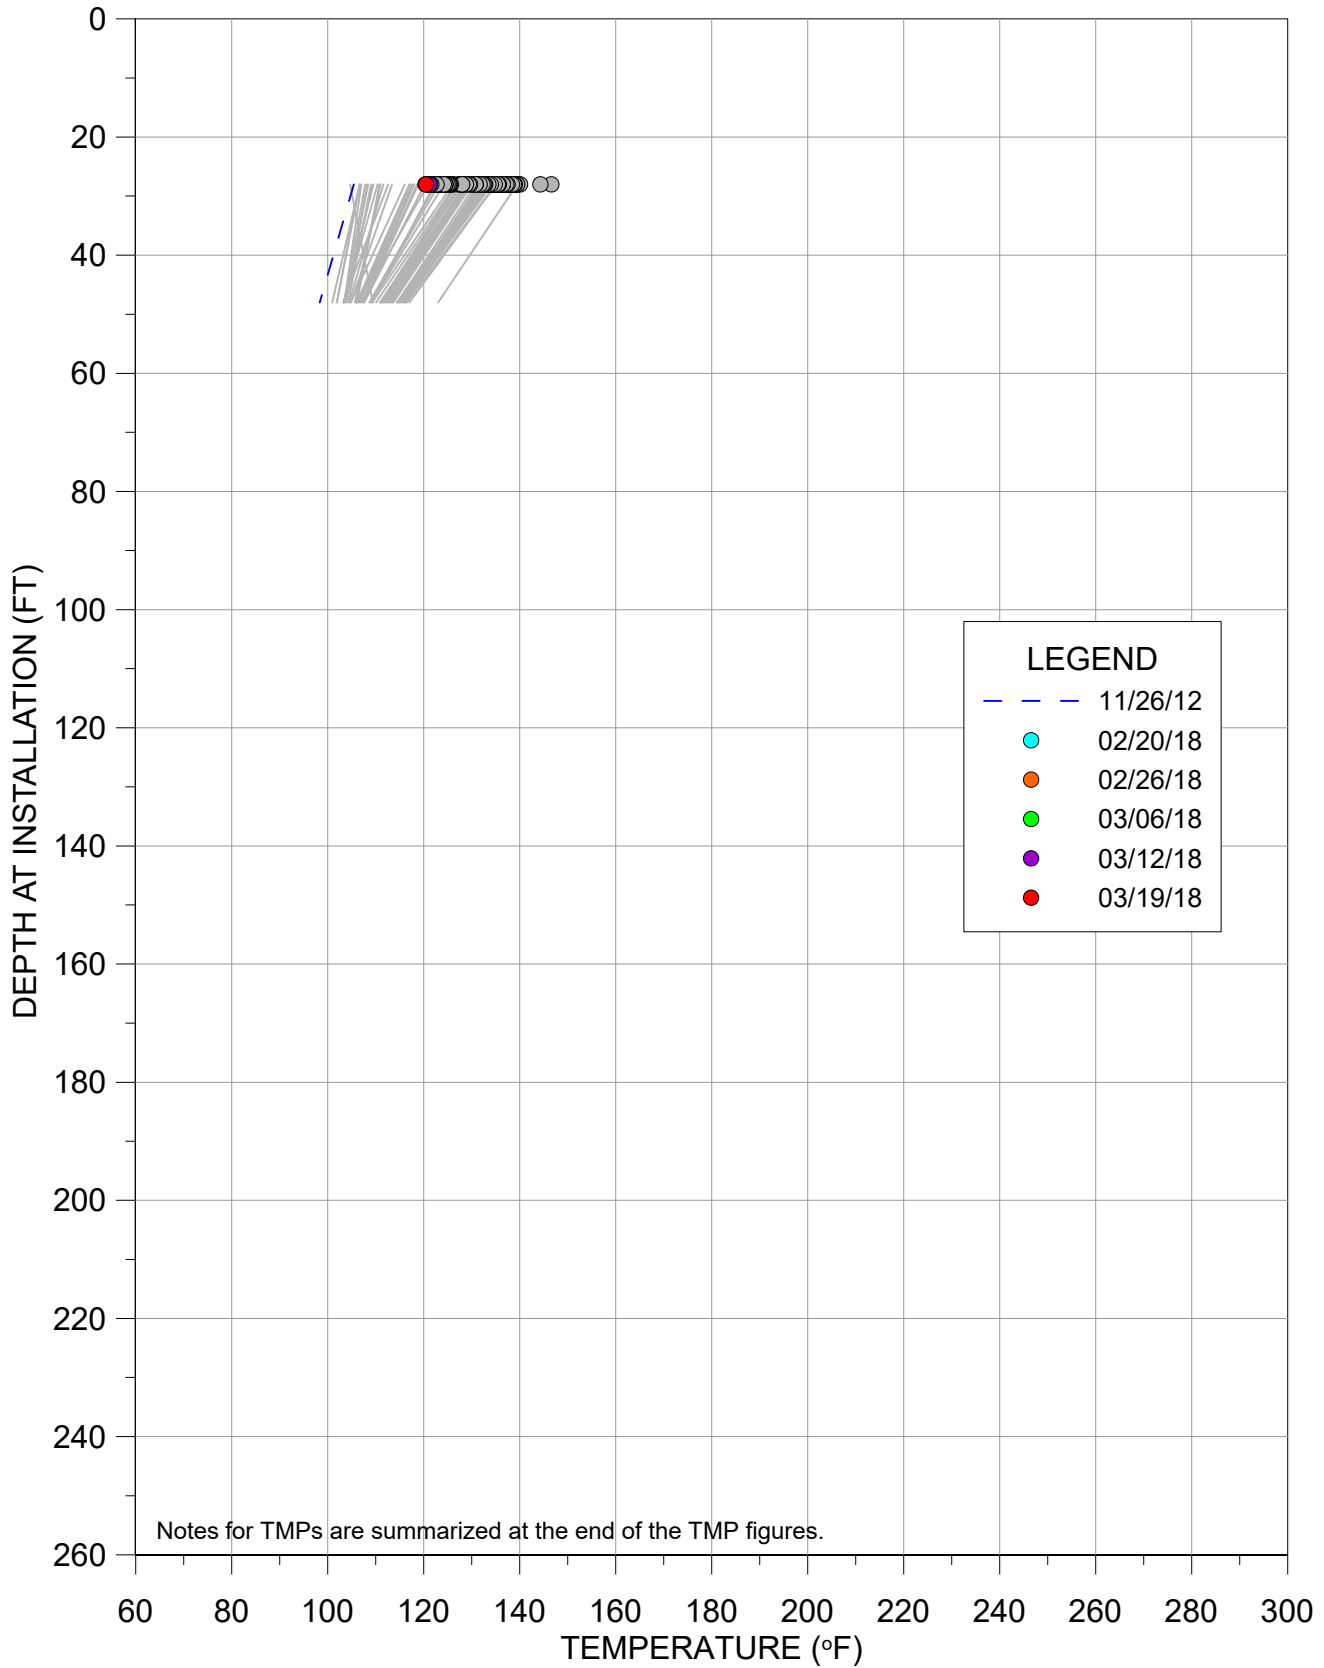
TMP-4

1. The connectivity tests on 4/11/2014 conducted by CEC showed that the unit at 48 ft depth is no longer reliable.

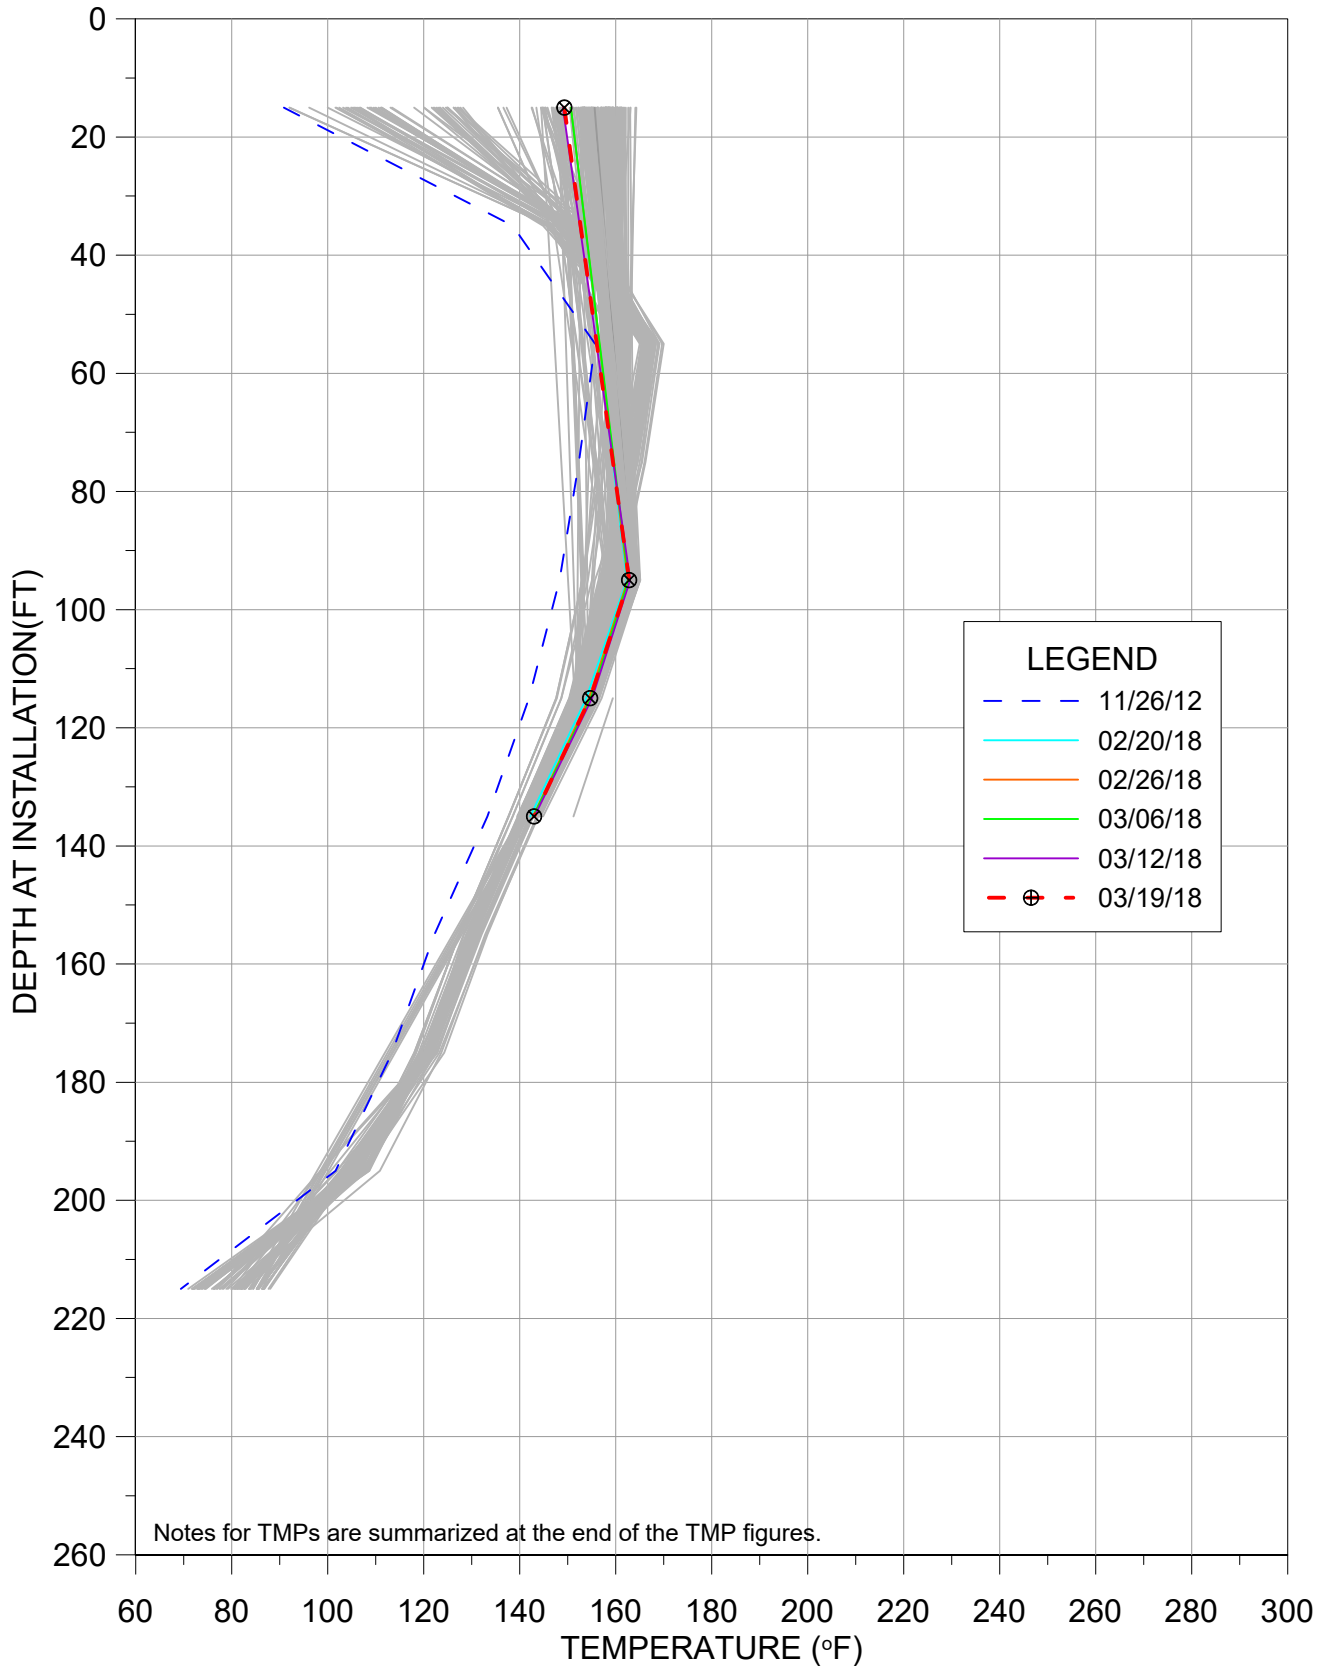
TMP-6

1. The connectivity tests on 4/11/2014 conducted by CEC showed that units at 35, 55, 75, 155, 175, and 195 ft depths are no longer reliable.
2. No reliable temperature readings have been obtained at the unit at 215 ft depth since 6/13/2014.
