Bridgeton Landfill, LLC

Weekly Data Submittal

Week of March 18, 2018 – March 24, 2018

**Required by Section 52.F of Agreed Order, Case No. 13SL-CC01088
Effective May 13, 2013**

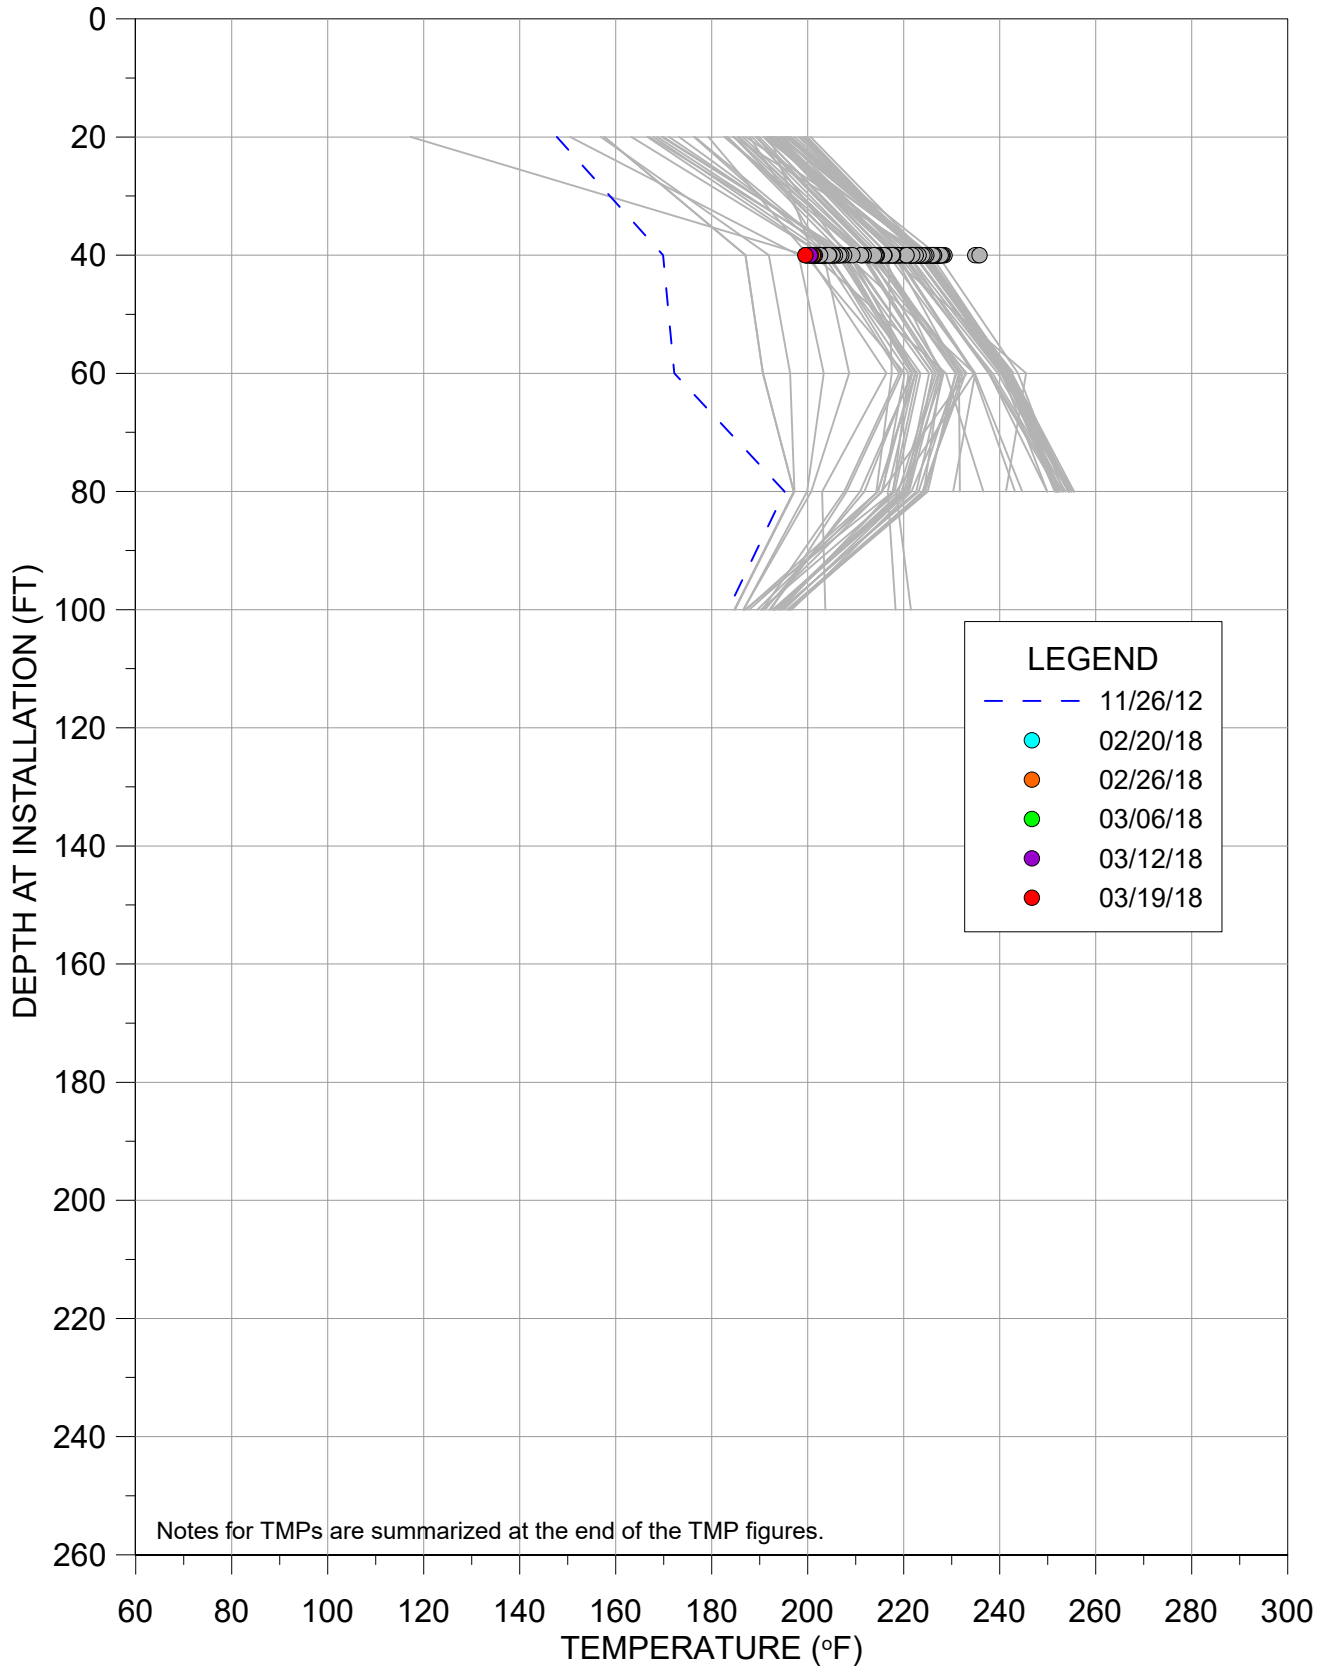
TMP-9

1. Unit at 100 ft depth had an inaccurate temperature reading on 8/1/2013 and no reading since 8/6/2013.
2. The connectivity tests on 4/11/2014 conducted by CEC showed that units at 20, 60, 80, and 100 ft depths are no longer reliable.

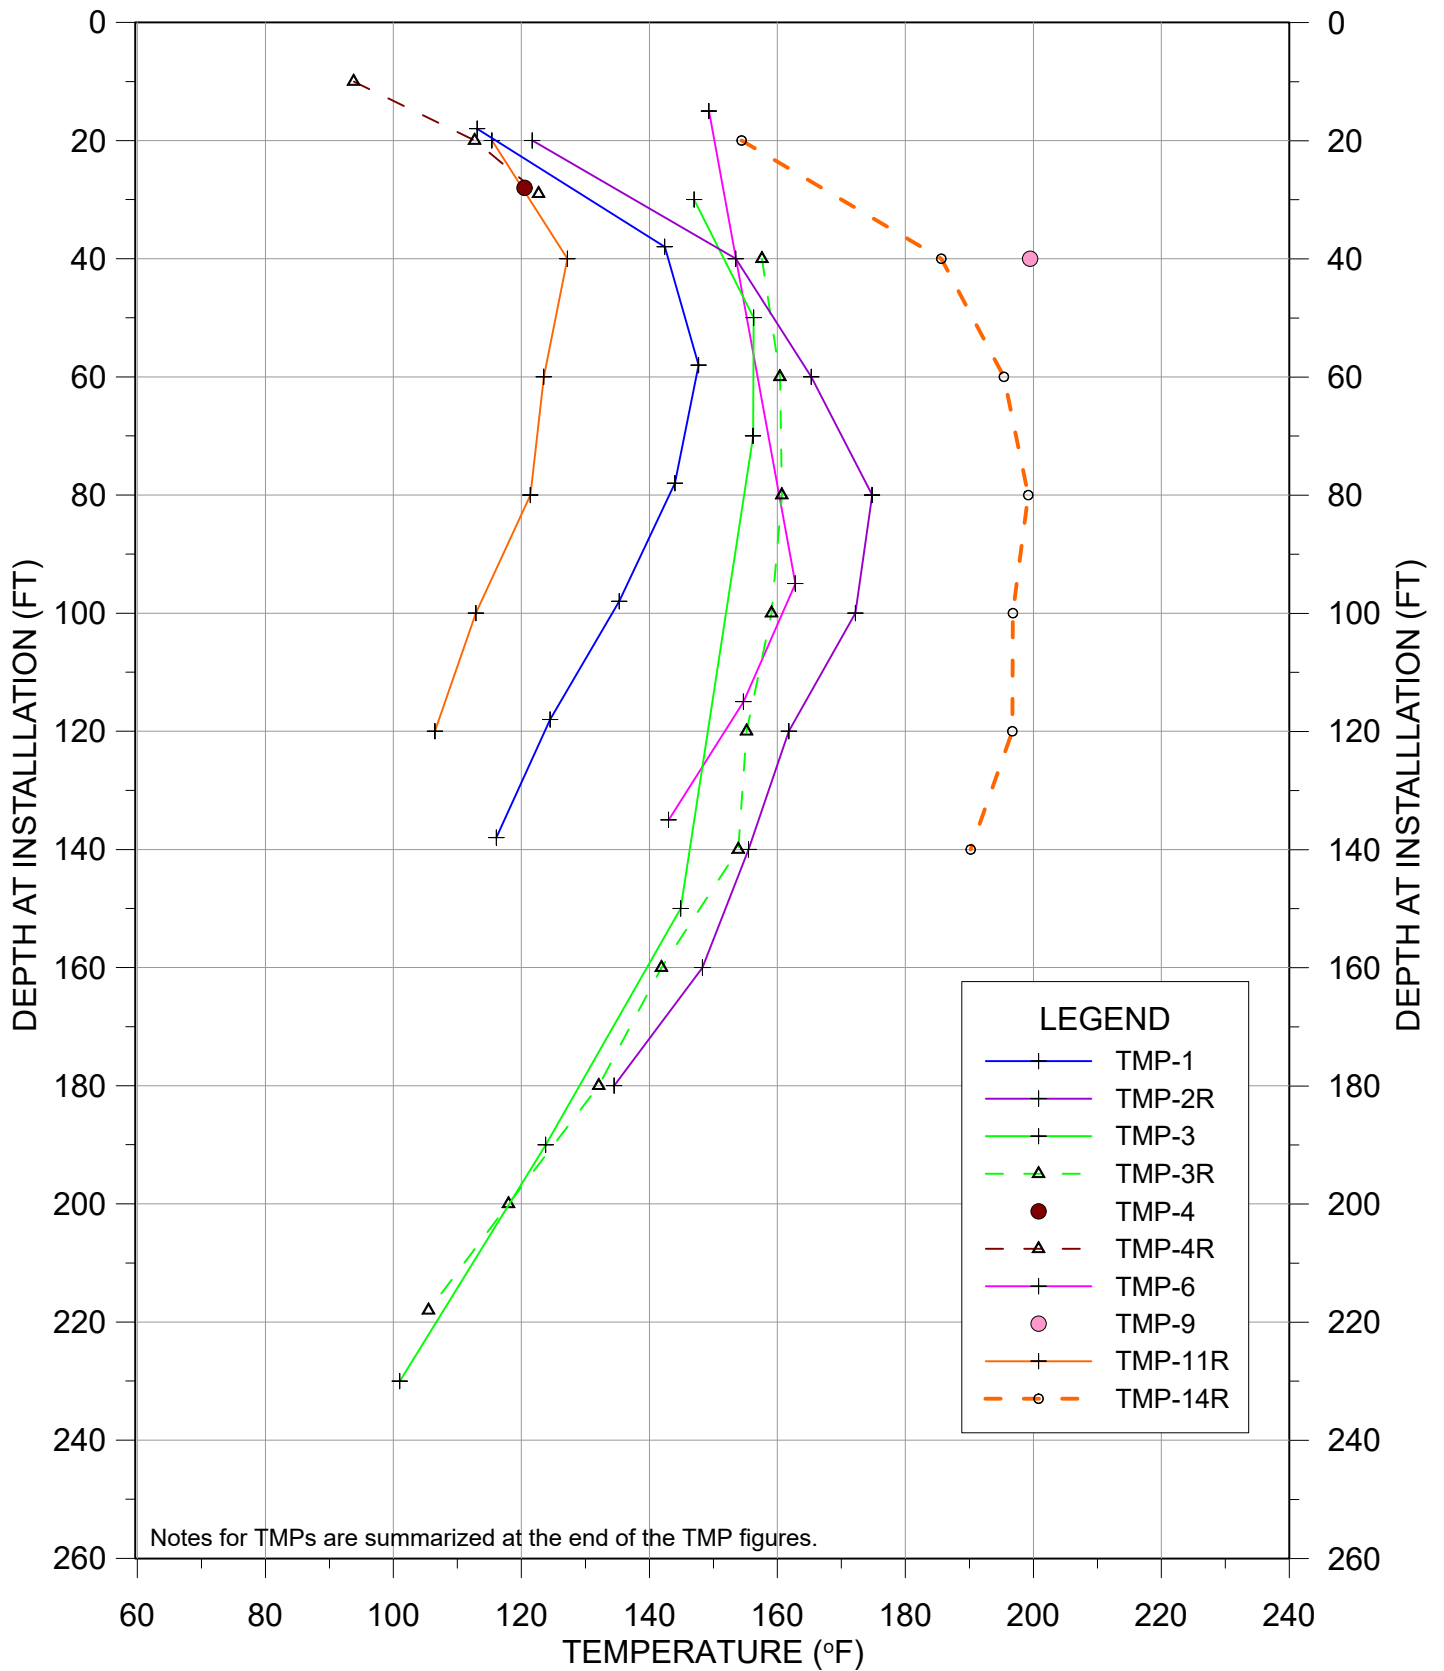
3/19/2018

1. There were no reliable temperature readings for TMP-13 since 3/19/2014.
2. There were no reliable temperature readings for TMP-7R, as determined by the connectivity test on 4/11/2014.

3. There were no reliable temperature readings for TMP-5 since 11/5/2014.
4. There were no reliable temperature readings for TMP-12 since 9/28/2015.
5. There were no reliable temperature readings for TMP-8 since 9/9/2015.

6. There were no reliable temperature readings for TMP-14, confirmed since 3/7/2016.
7. There were no reliable temperature readings for TMP-11 as determined by the connectivity test on 11/23/2016.

8. TMP-2 has been replaced by TMP-2R and will no longer be monitored.
9. TMP-11 is no longer in service and will not be included in the presentation.
10. There were no reliable temperature readings for TMP-10 since 5/30/2017.

11. TMP-16, 25, and 28 have been replaced by TMP-16R, 25R, and 28R and will be no longer reported since 1/15/2018.

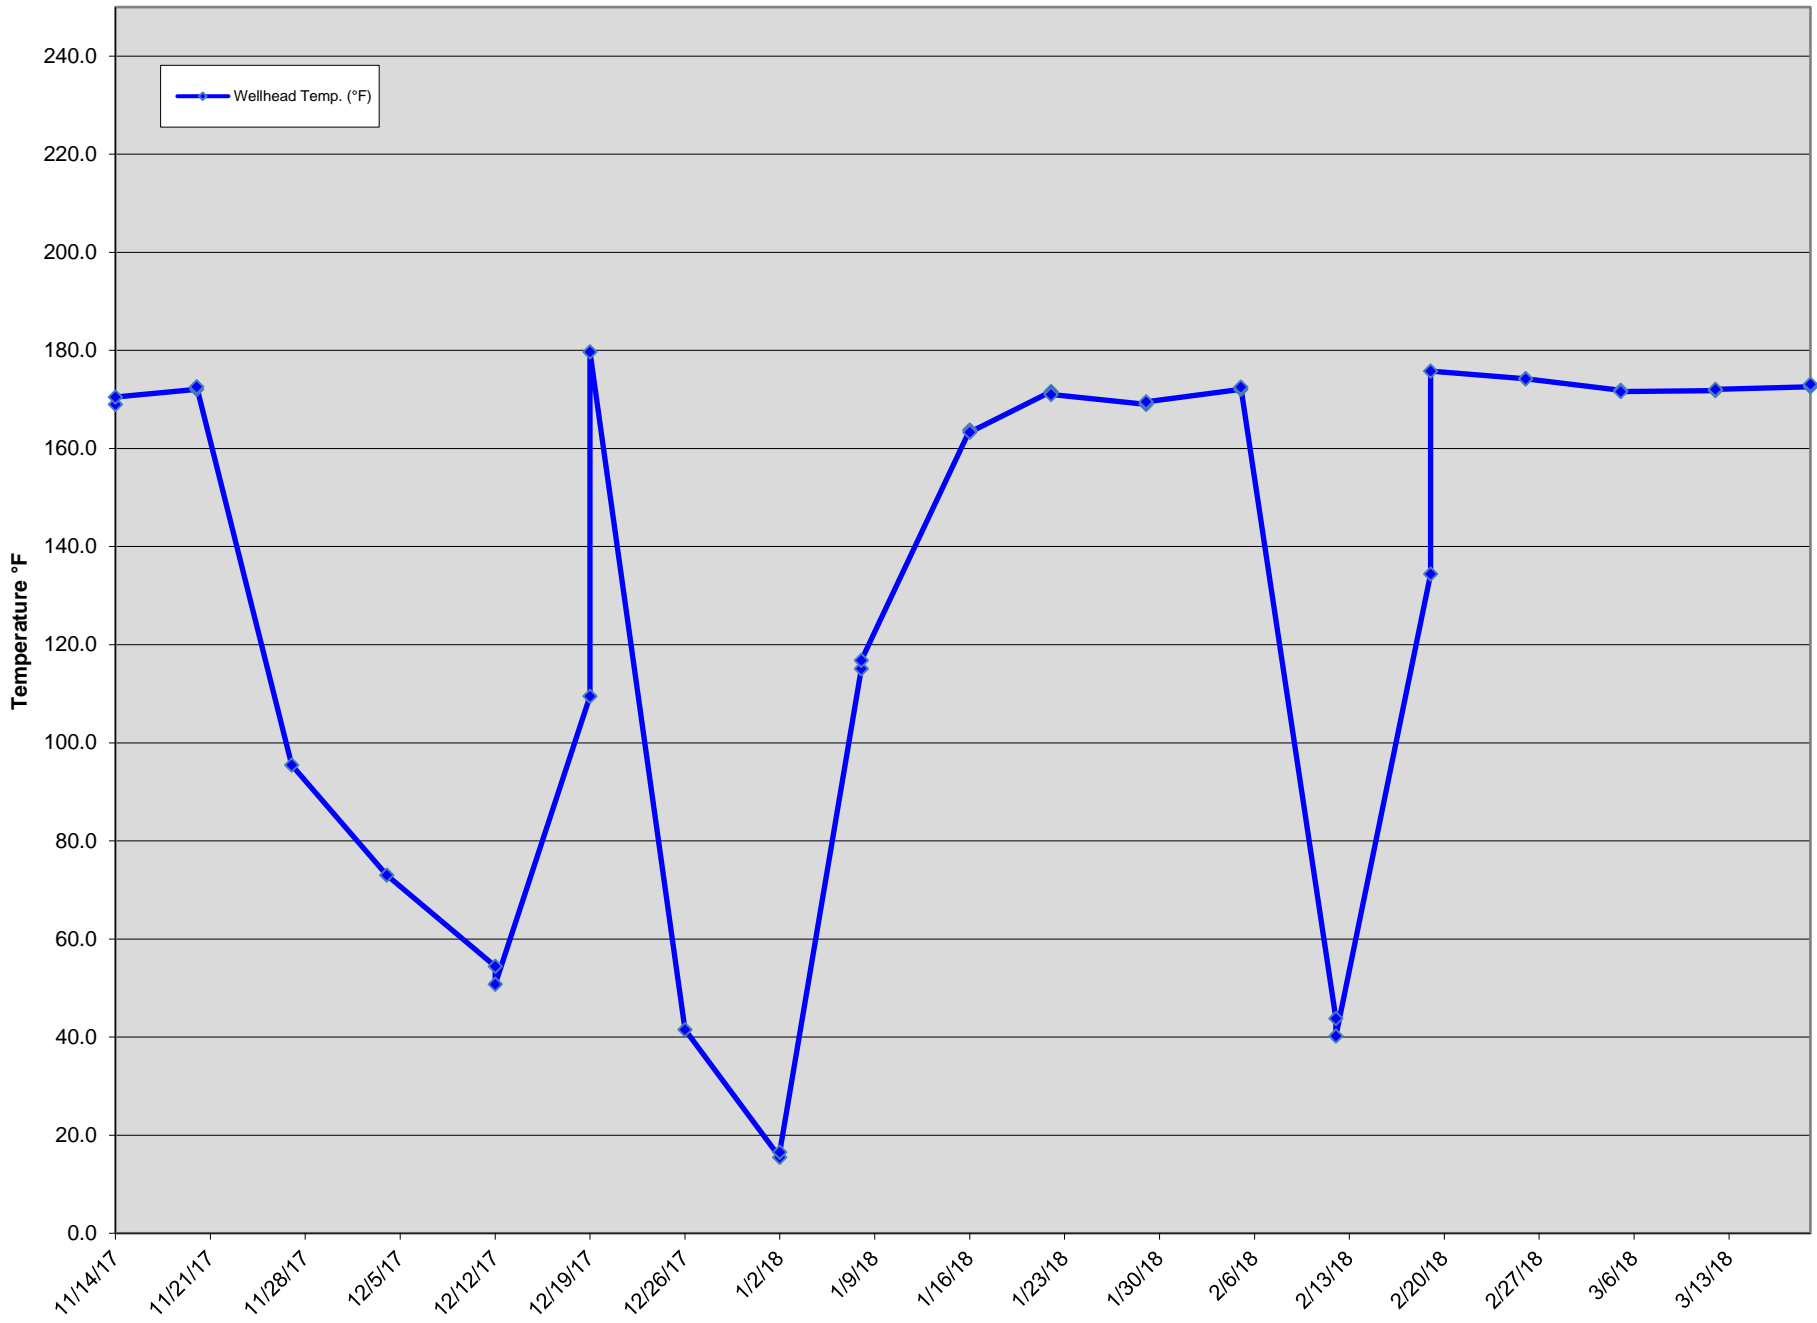
GIW-1 Wellhead Temperatures

As part of the HES, there are currently cooling water circulation loops installed in twelve Gas Interceptor Wells (GIWs) (GIW-02 through GIW-13). The remaining well (GIW-01) had a measured gas temperature within its historical operating limits.
