# Bridgeton Landfill, LLC

# Weekly Data Submittal

Week of April 26, 2020 – May 02, 2020

Required by Section IX.33.g of Final Consent Judgment, Case No. 13SL-CC01088-01 Effective June 29, 2018

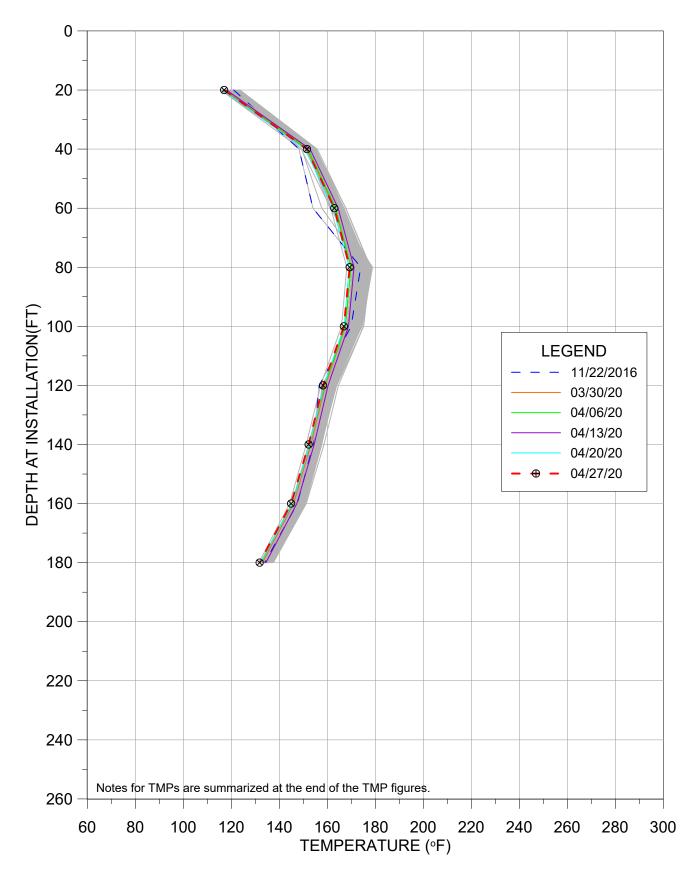
TMP-2R

1. Data reported on 11/29/2016 was inadvertently left as the 11/22/2016 data. This was corrected on 12/5/2016 reading submittal.

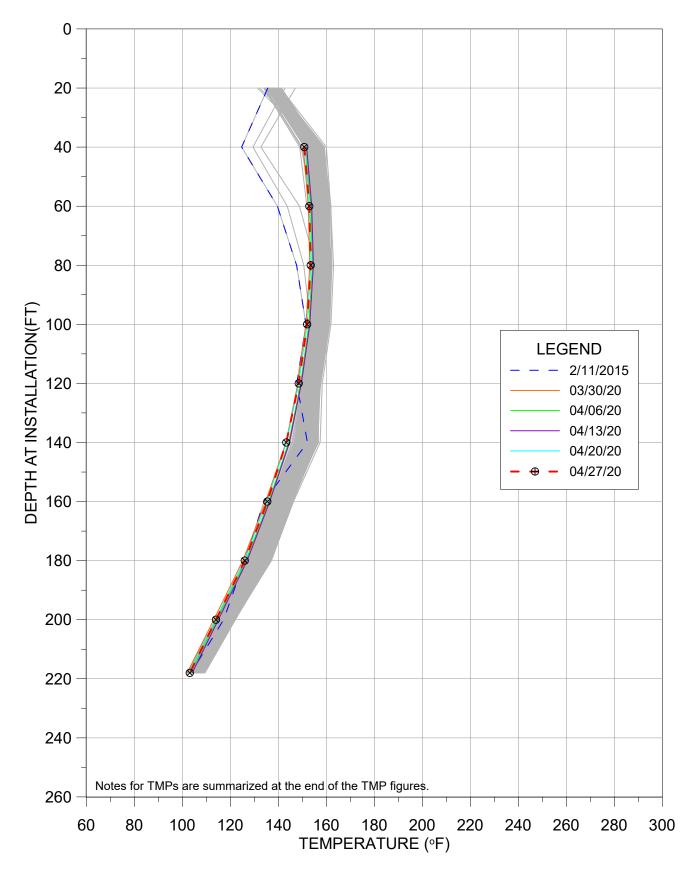
TMP-3R

1. The unit at 20 ft depth had a fluctuating resistance since 9/25/2017. Therefore the temperature is determined to be unreliable.

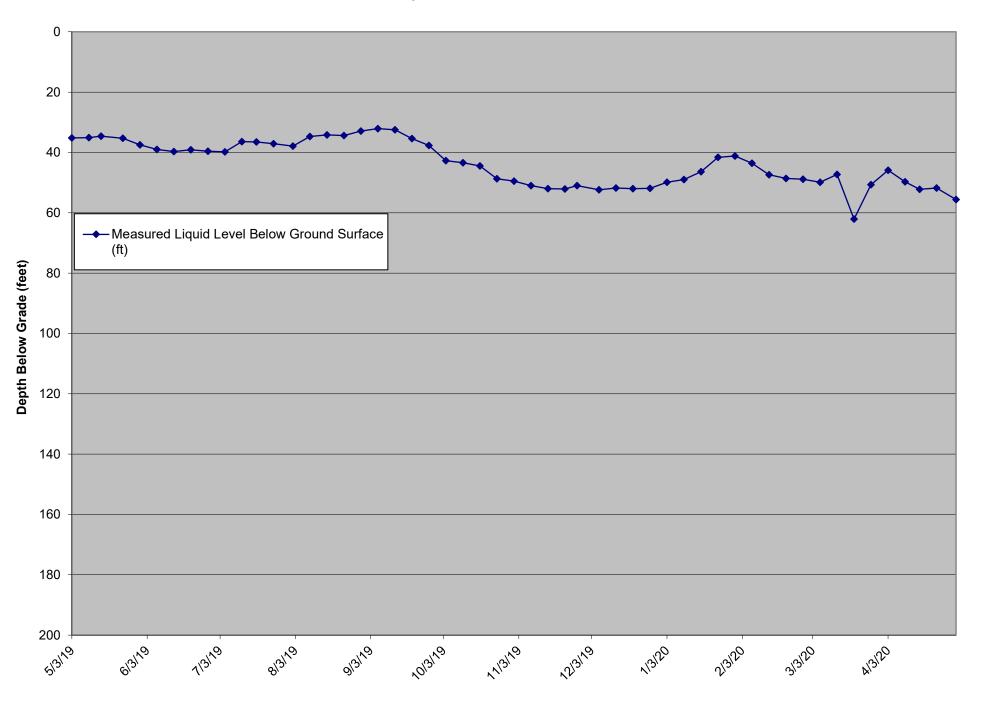
# LCS-4B Liquid Level Below Ground Surface

The level sensor in LCS-4B is currently operational and responsive. Liquid level was not recorded by the level sensor during the weekly reporting period. LCS-4B is equipped with a flow meter that displayed no flow during the weekly reporting period. Therefore, it can be concluded that the liquid level was below the bottom of the pump and level sensor in LCS-4B.

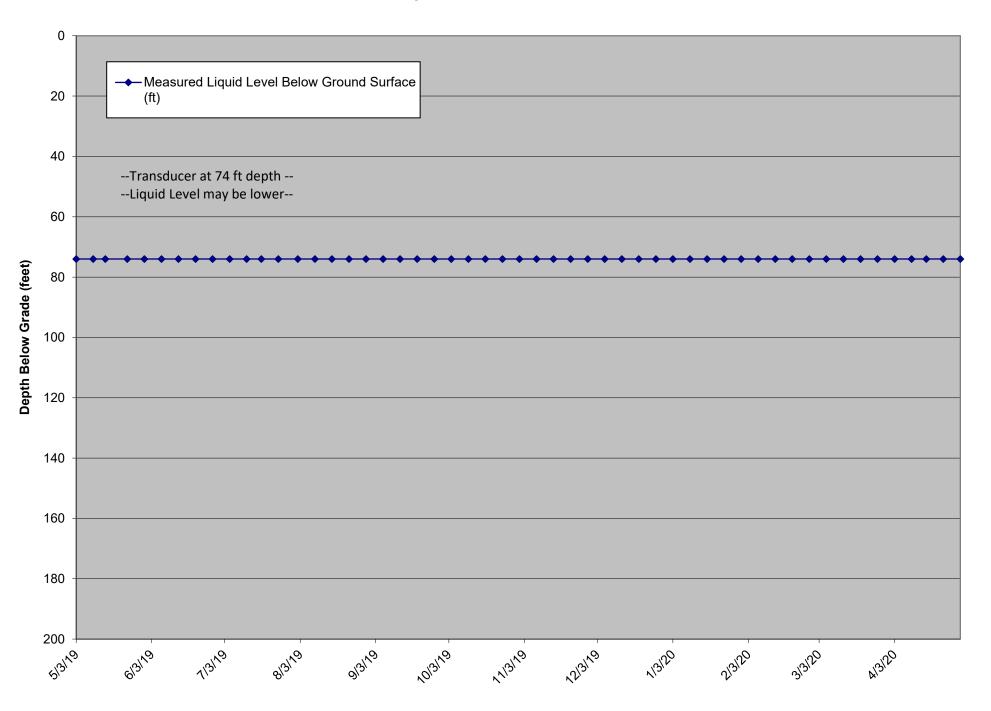
LCS-5B Liquid Level Above Quarry Floor

The pumps in LCS-5B and LCS-6B were fully operational during the weekly reporting period.

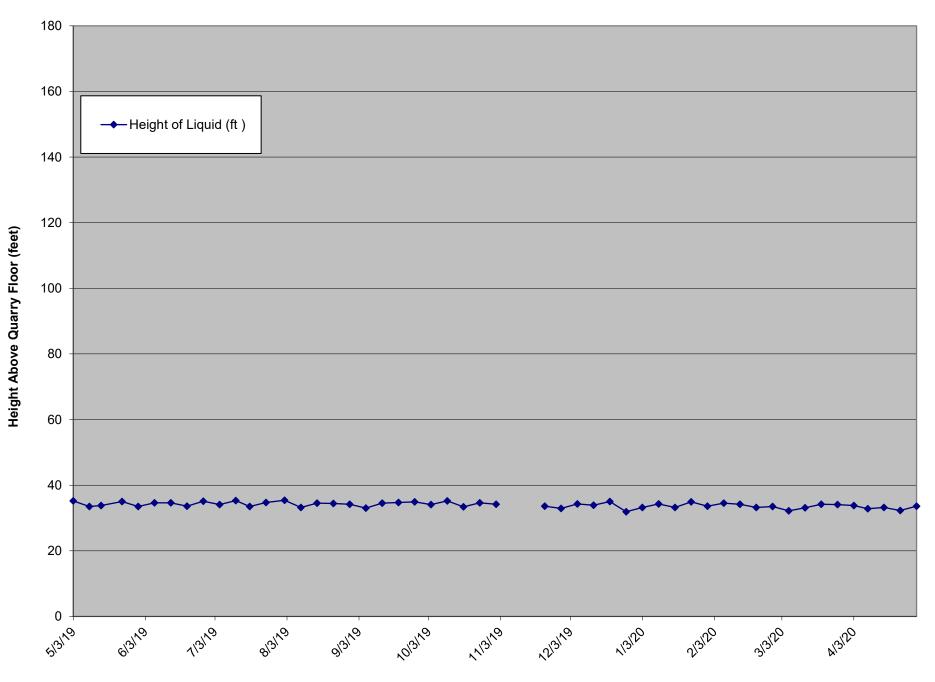
\*The transducer in LCS-5B was down from 11/6/19 to 11/19/19.

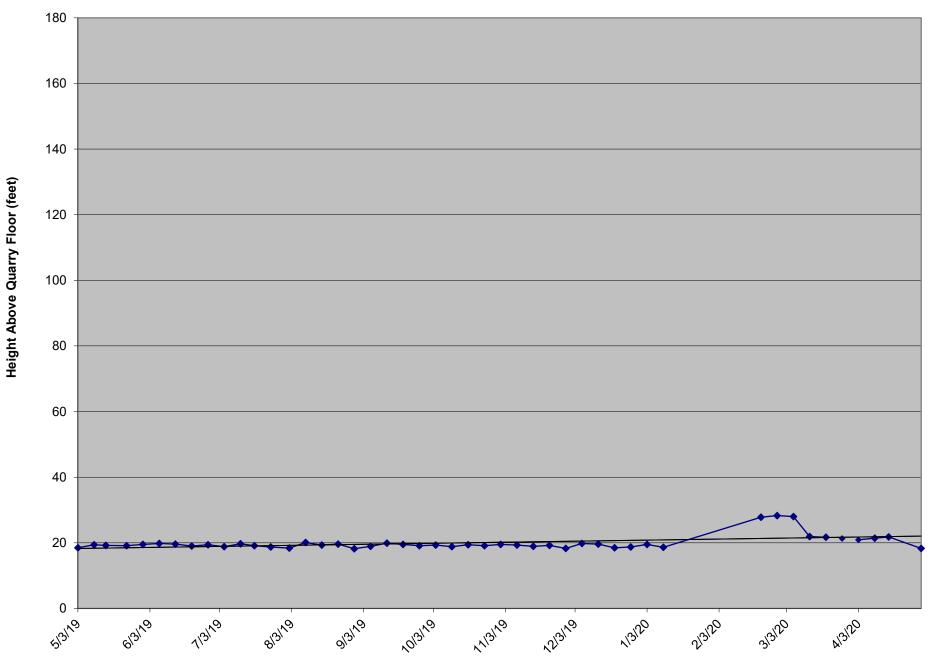
LCS-6B Liquid Level Above Quarry Floor

The transducer became non-operational on 1/13/20. Liquid level was measured manually on 2/21/20, 2/28/20 and 3/6/20. The transducer became operational on 3/13/20. The VFD was observed to be non-operational on 4/23/20, it was replaced on 4/23/20, however the level sensor reading was not taken due to VFD communication loss with SCADA.
