Bridgeton Landfill, LLC

Weekly Data Submittals

Required by Section 52.F of Agreed Order, Case No. 13SL-CC01088 Effective May 13, 2013

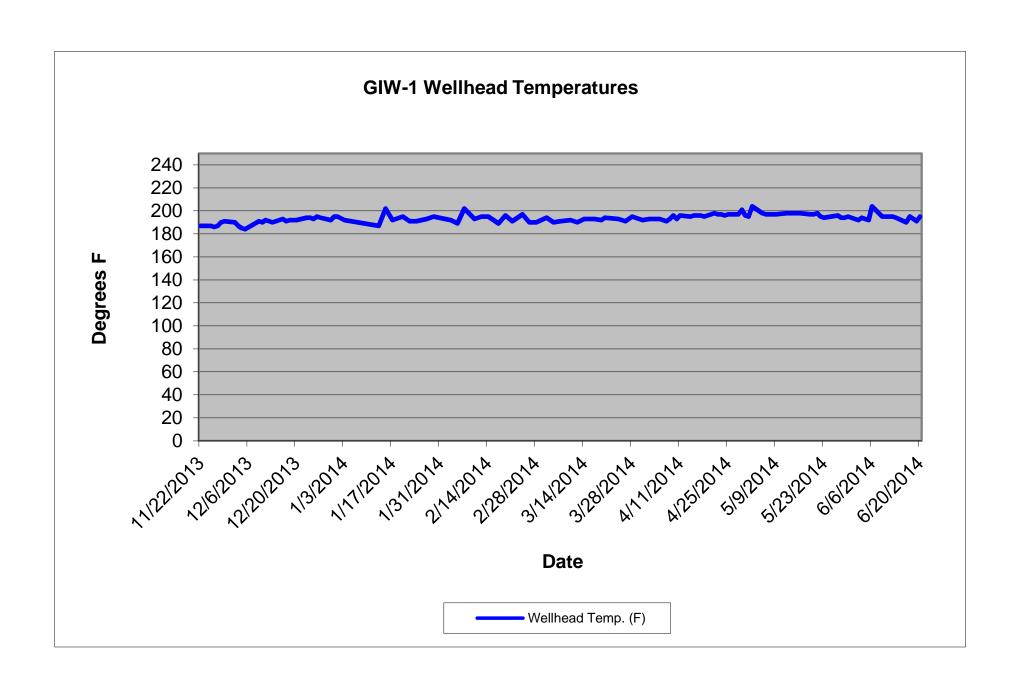
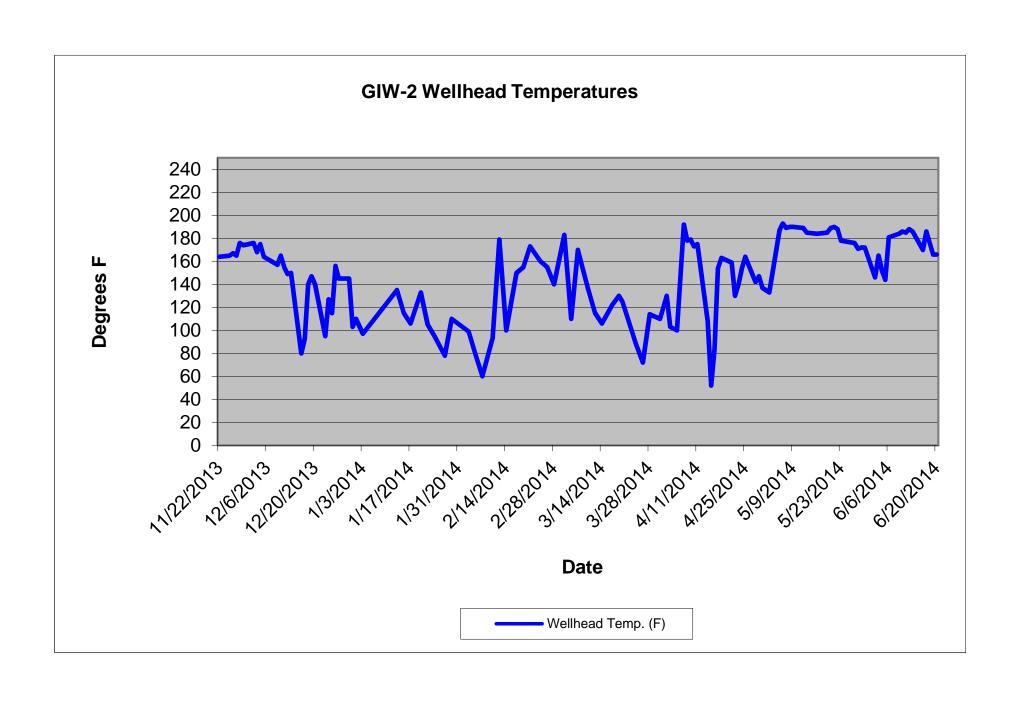
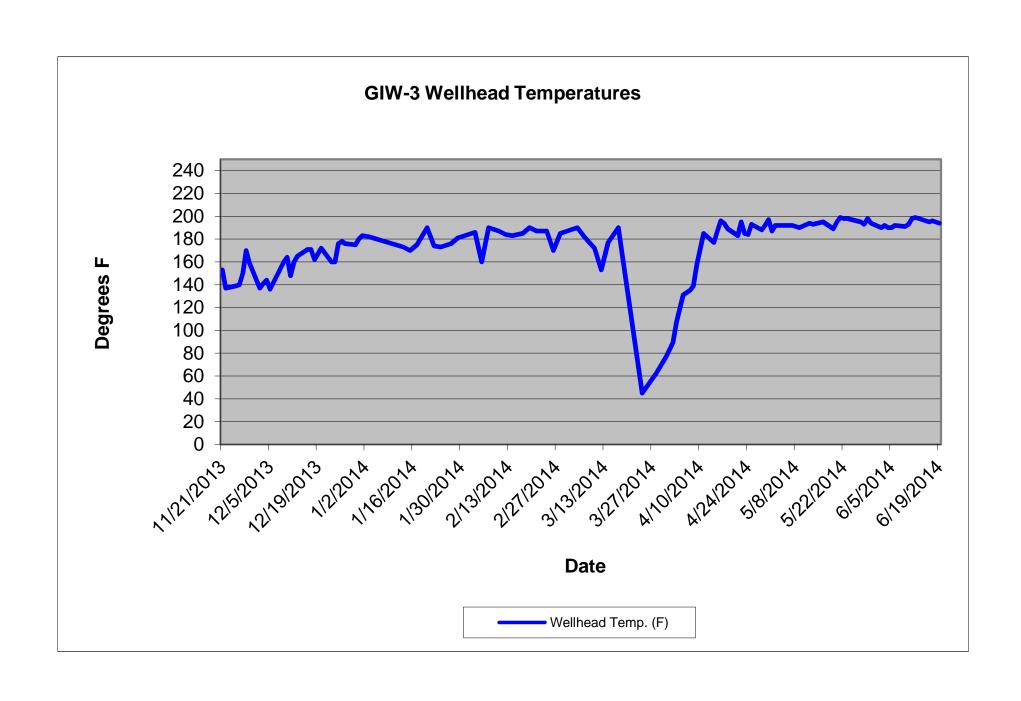
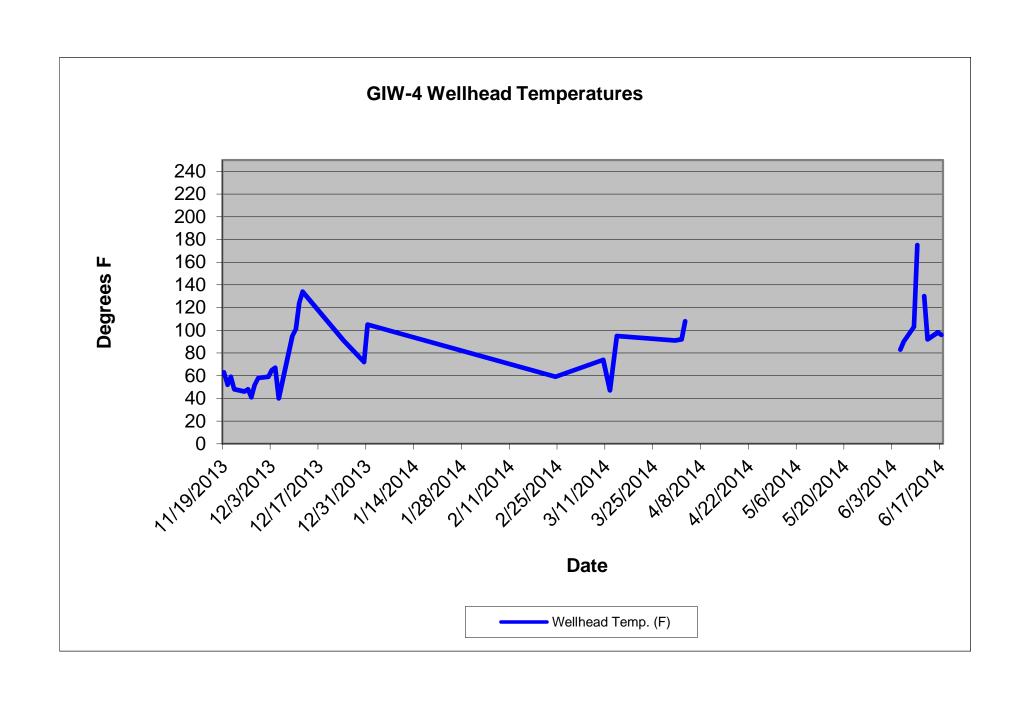
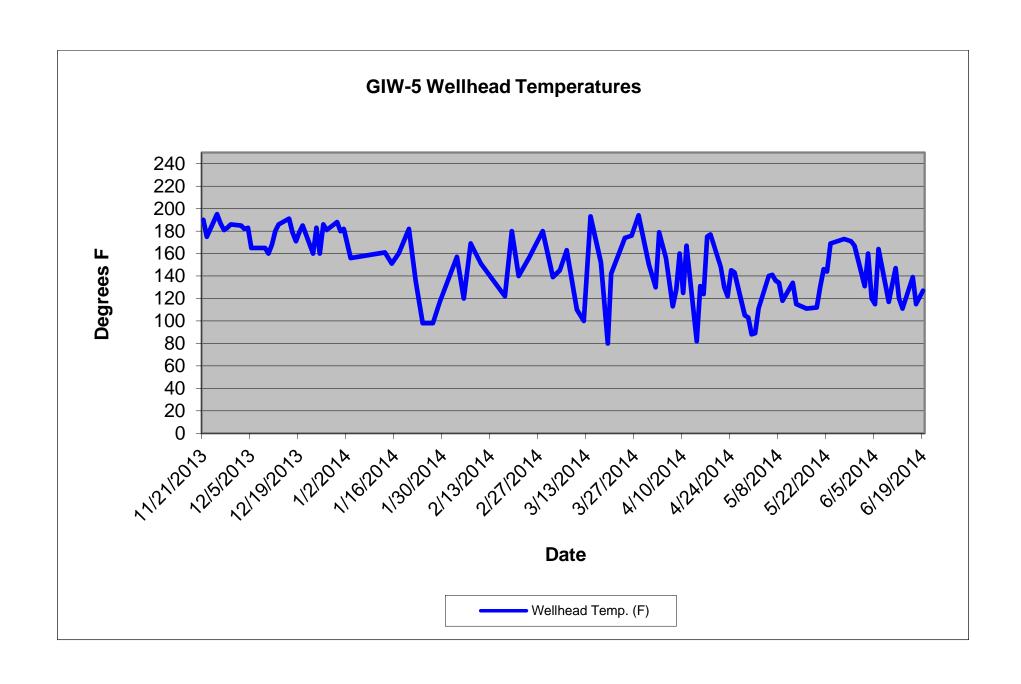
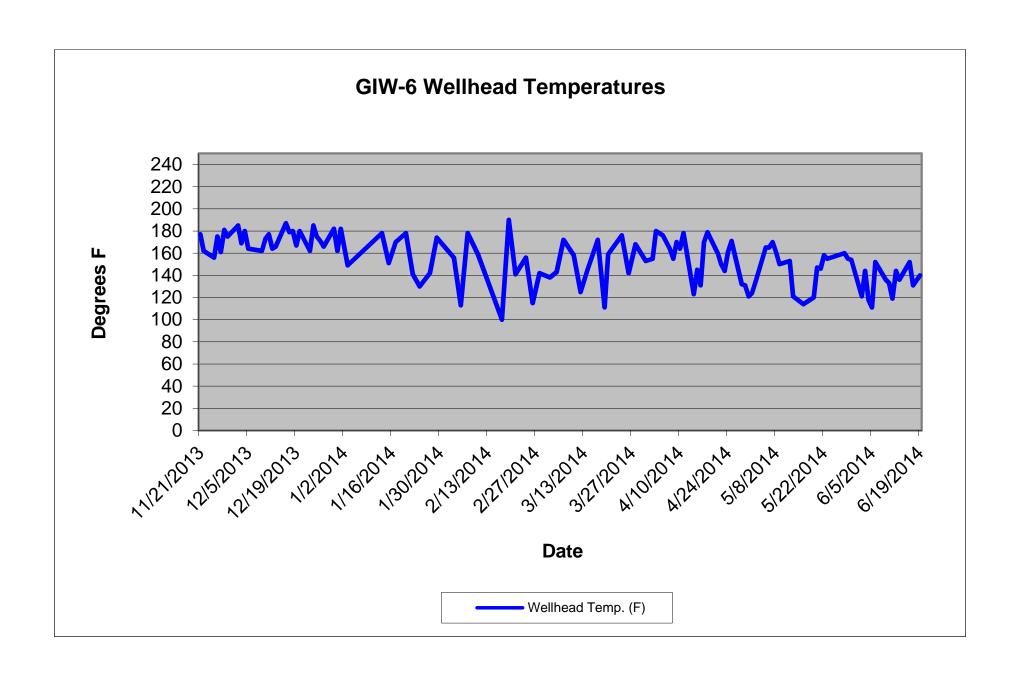
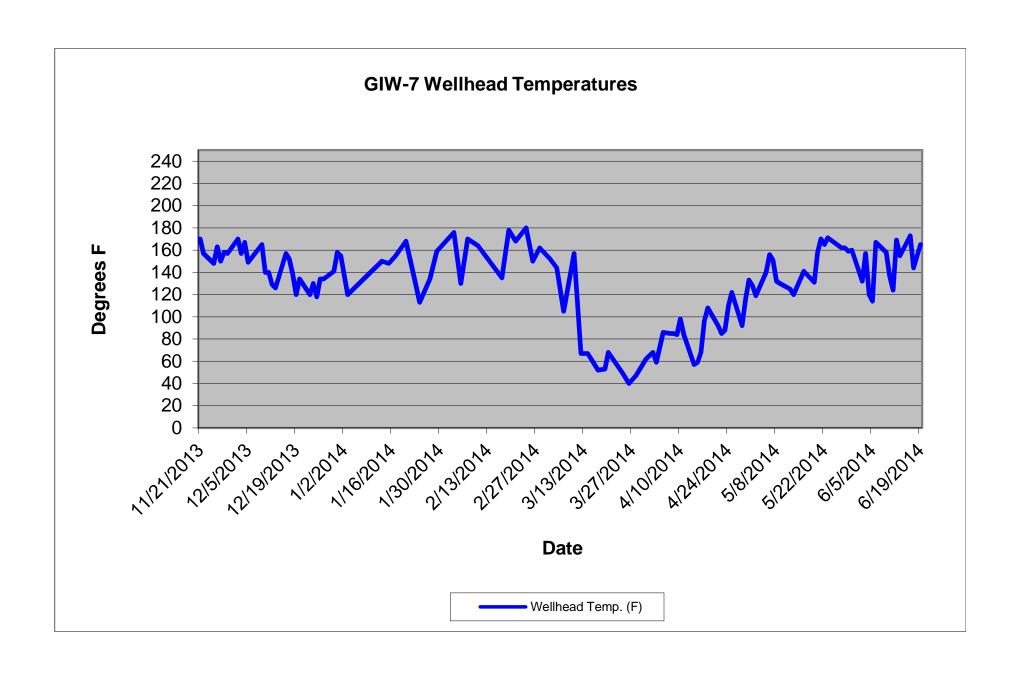
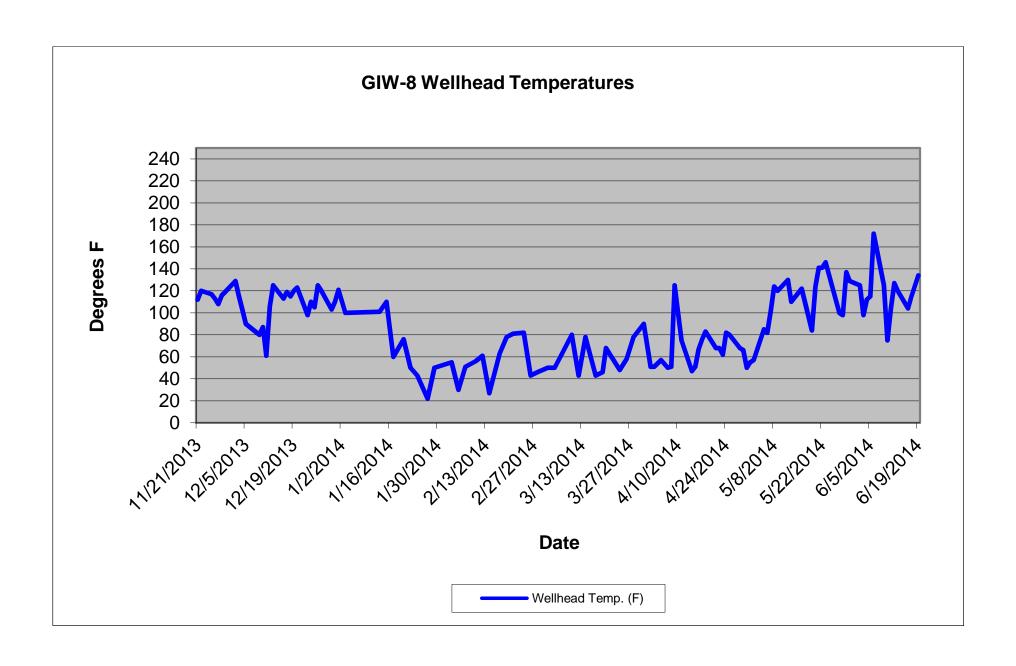
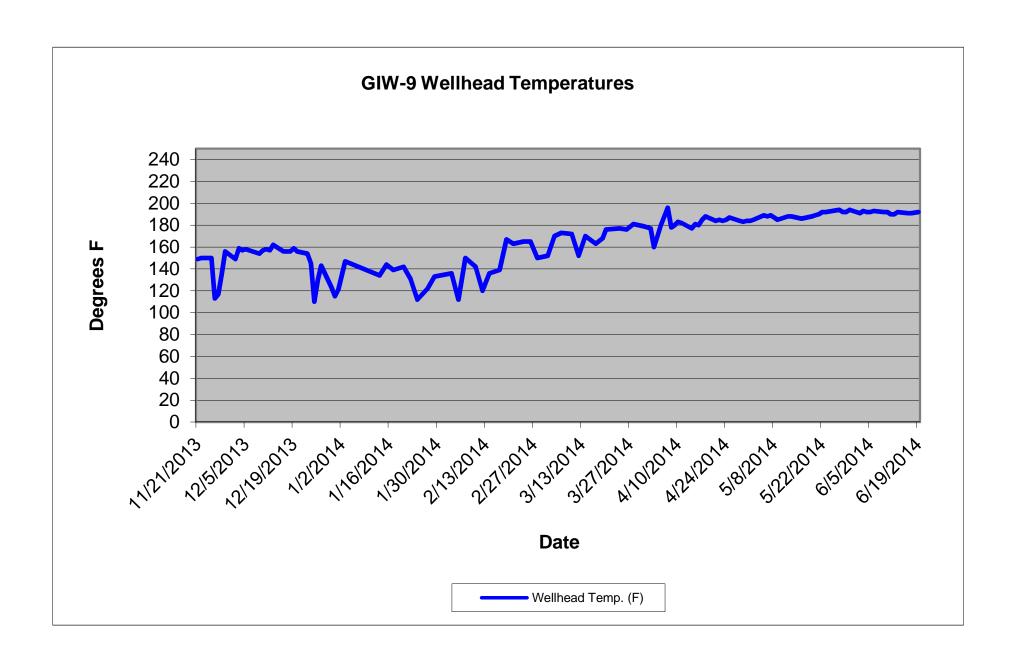
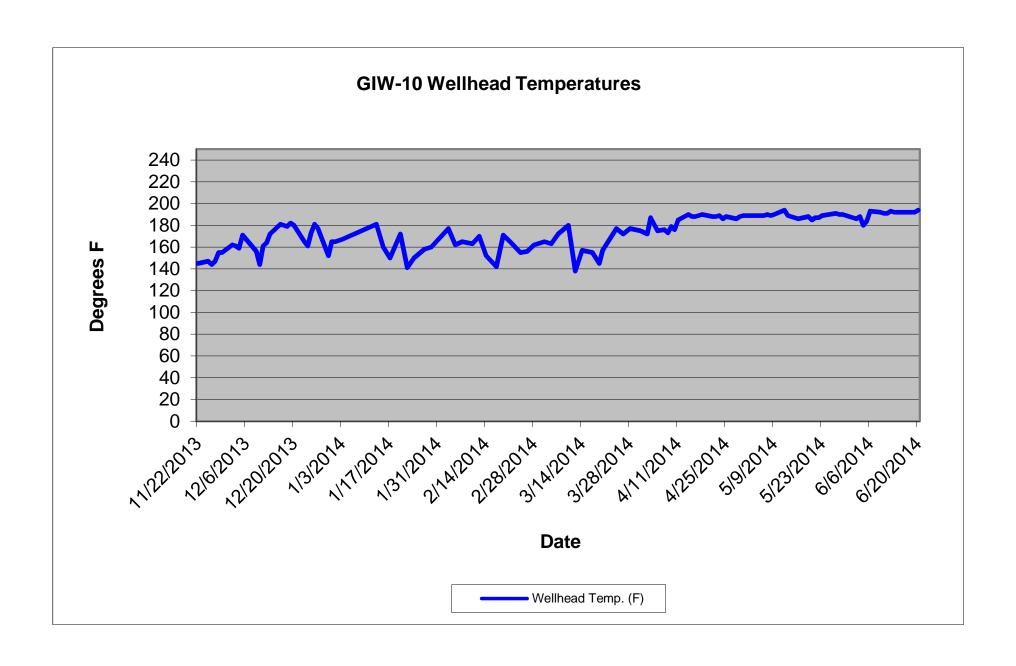
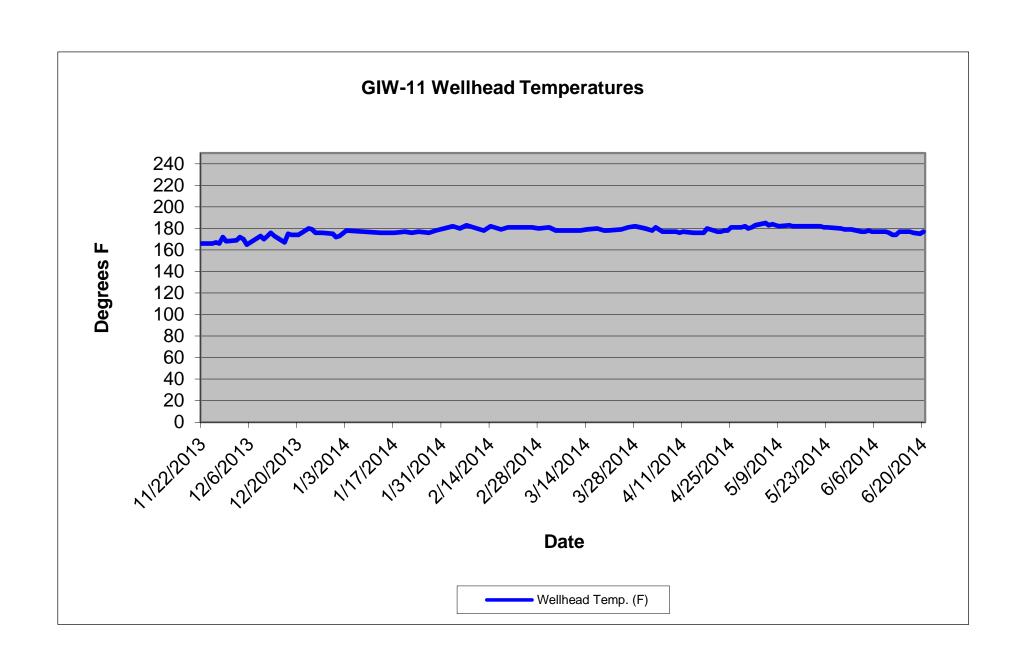
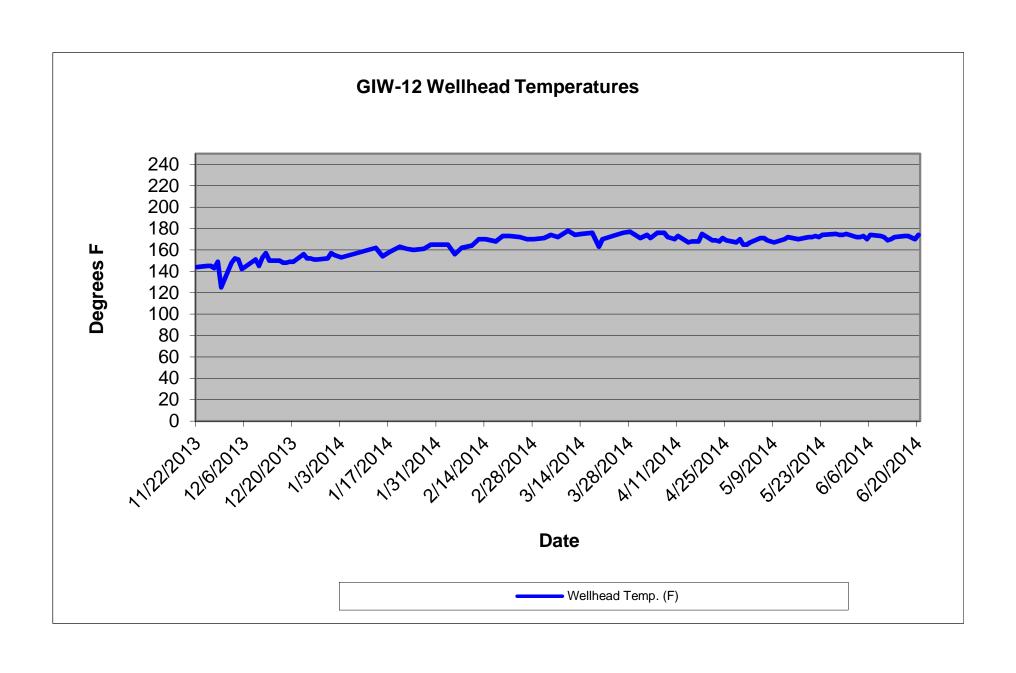
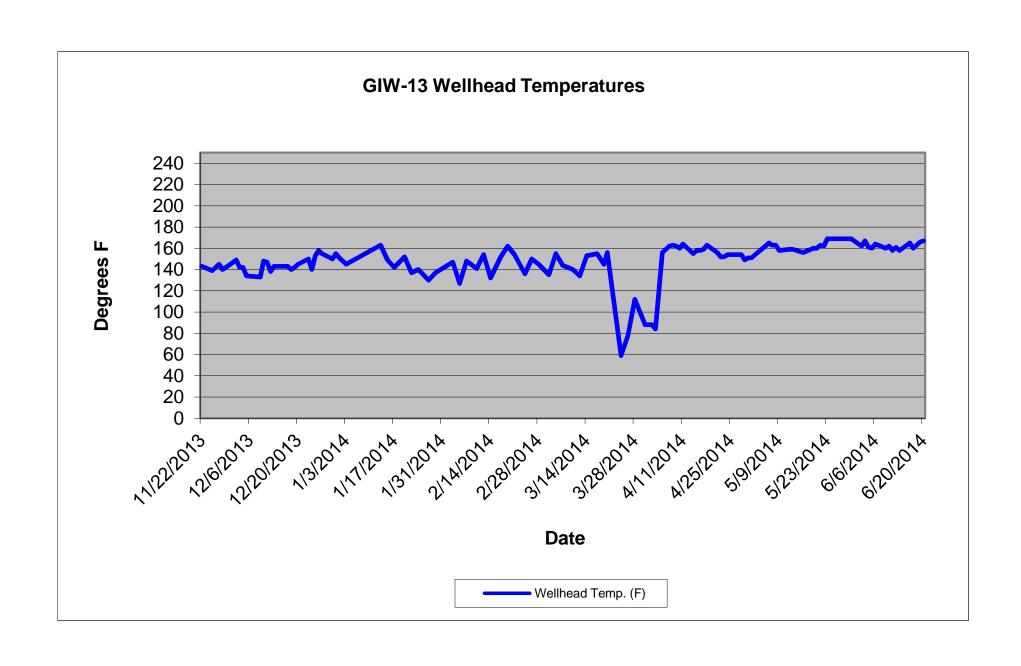
TEMPERATURE VS TIME BRIDGETON LANDFILL

The fluctuation in wellhead gas temperatures can be attributed to variation in available vacuum, gas flow and ambient temperatures at the respective well.

The water circulation cooling loop is currently installed in GIW-4. With the exception of June 11, 2014, the cooling loop was operational during the reporting period. Repairs were recently made to allow resumption of temperature monitoring at the GIW-4 wellhead.
