Bridgeton Landfill, LLC

Weekly Data Submittals

Week of November 22 - November 29, 2014

**Required by Section 52.F of Agreed Order, Case No. 13SL-CC01088
Effective May 13, 2013**

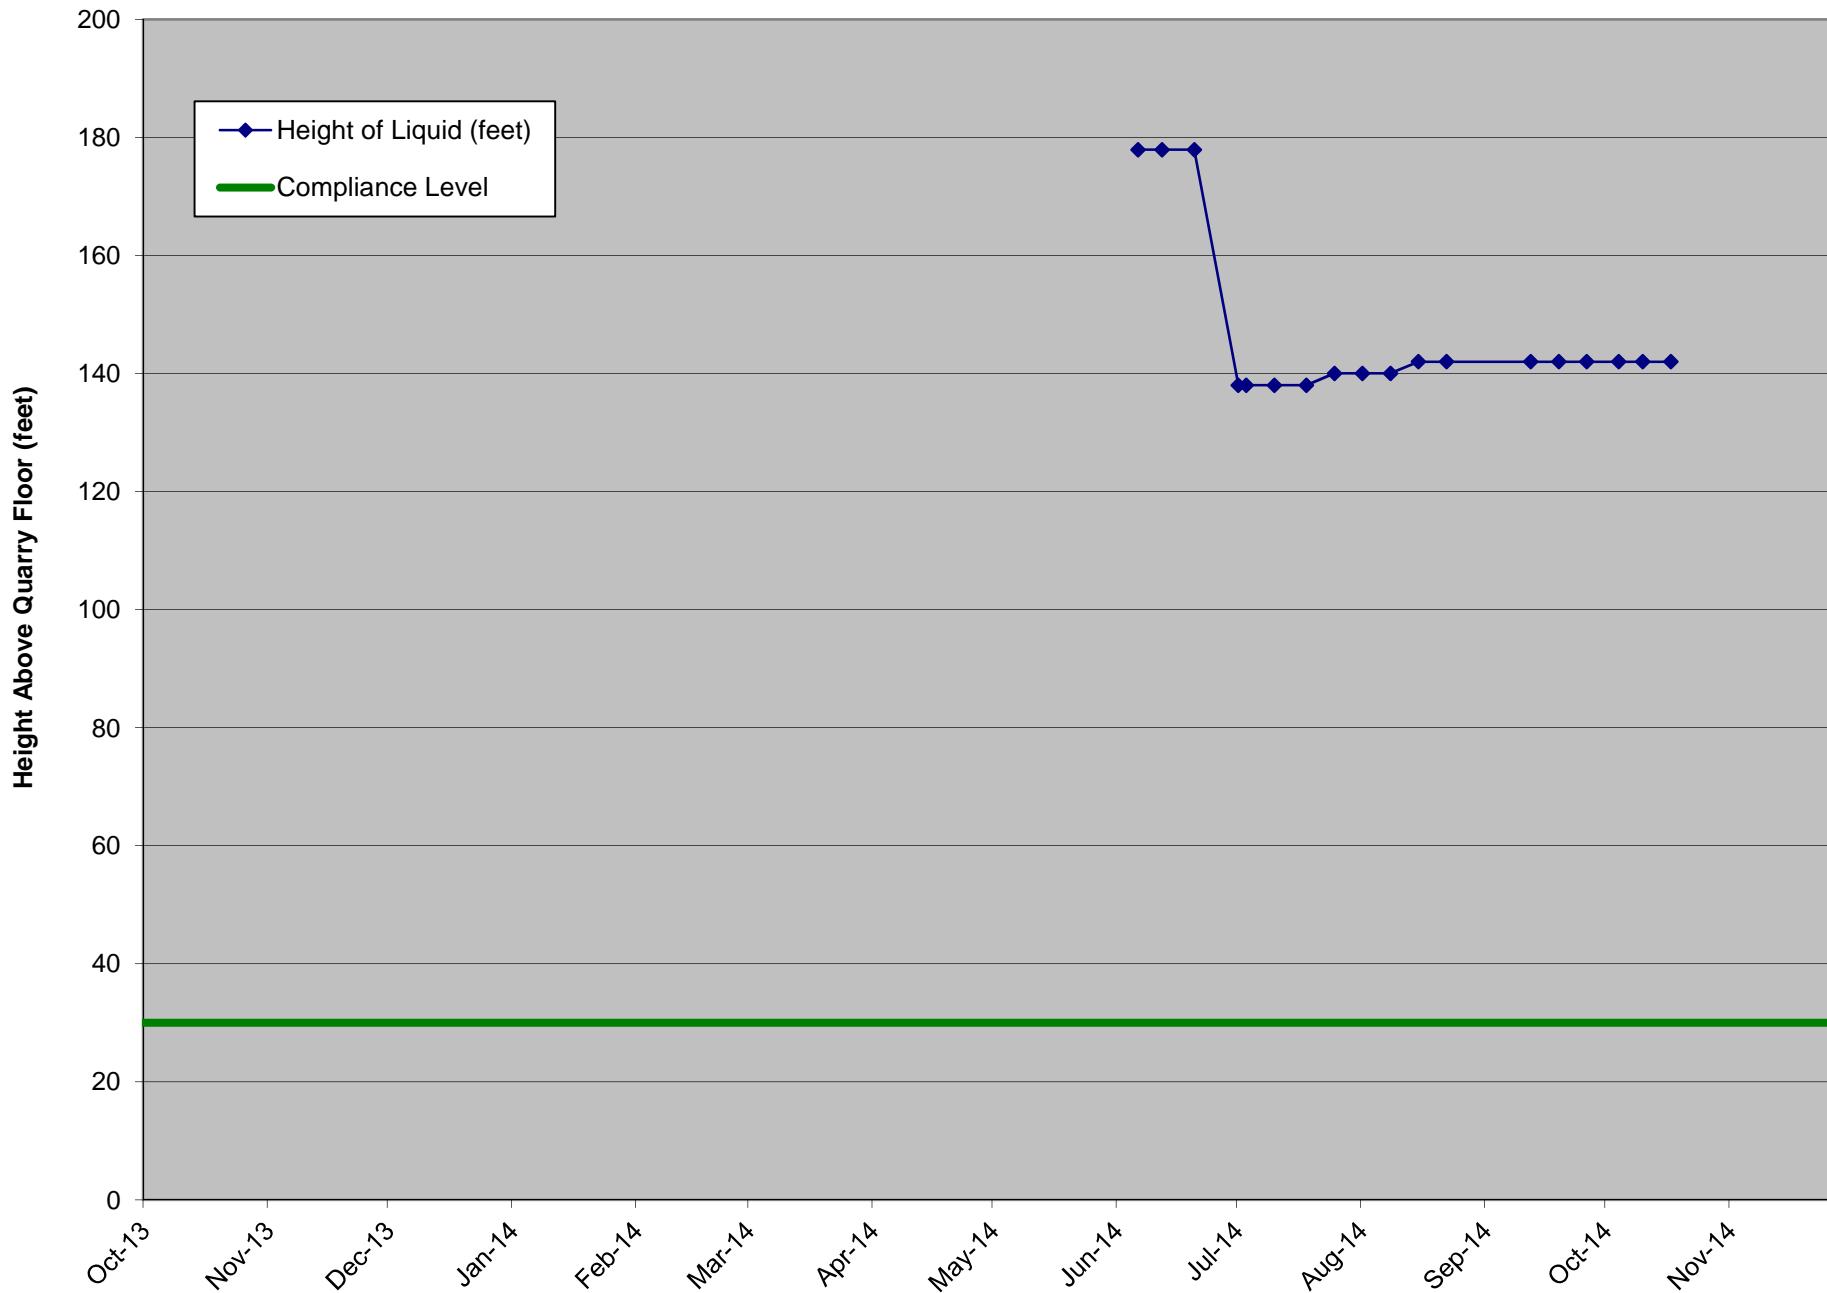
LCS-1D Liquid Level Above Quarry Floor

Leachate Collection Sump (LCS)-1D, -5A, and -6B were partially or fully operational during the weekly reporting period. LCS-1D, while operational at the time of inspection, has a broken transducer.

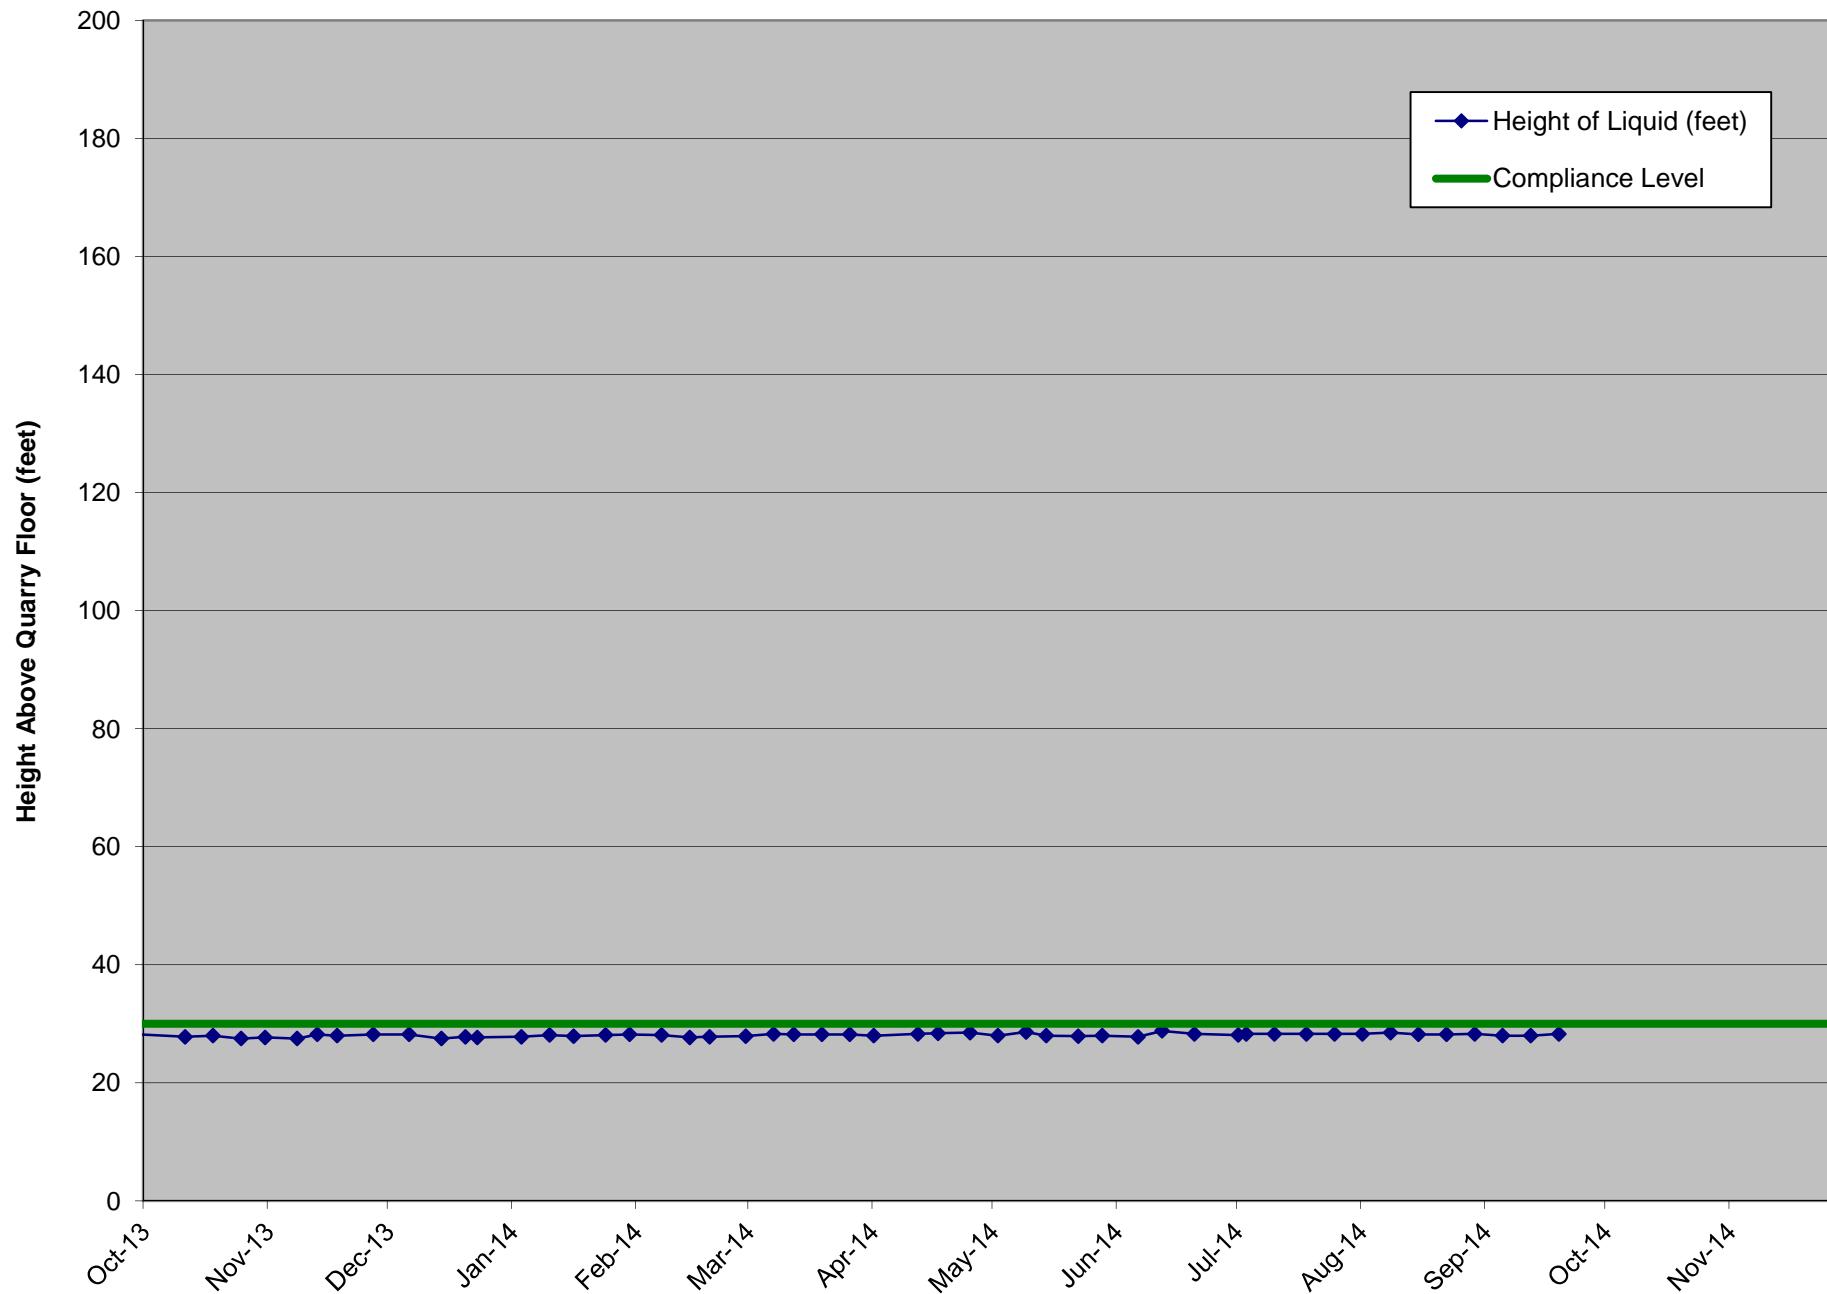
LCS-2D Liquid Level Above Quarry Floor

The pump in LCS-2D was off during the weekly monitoring event due to an “over current” error.

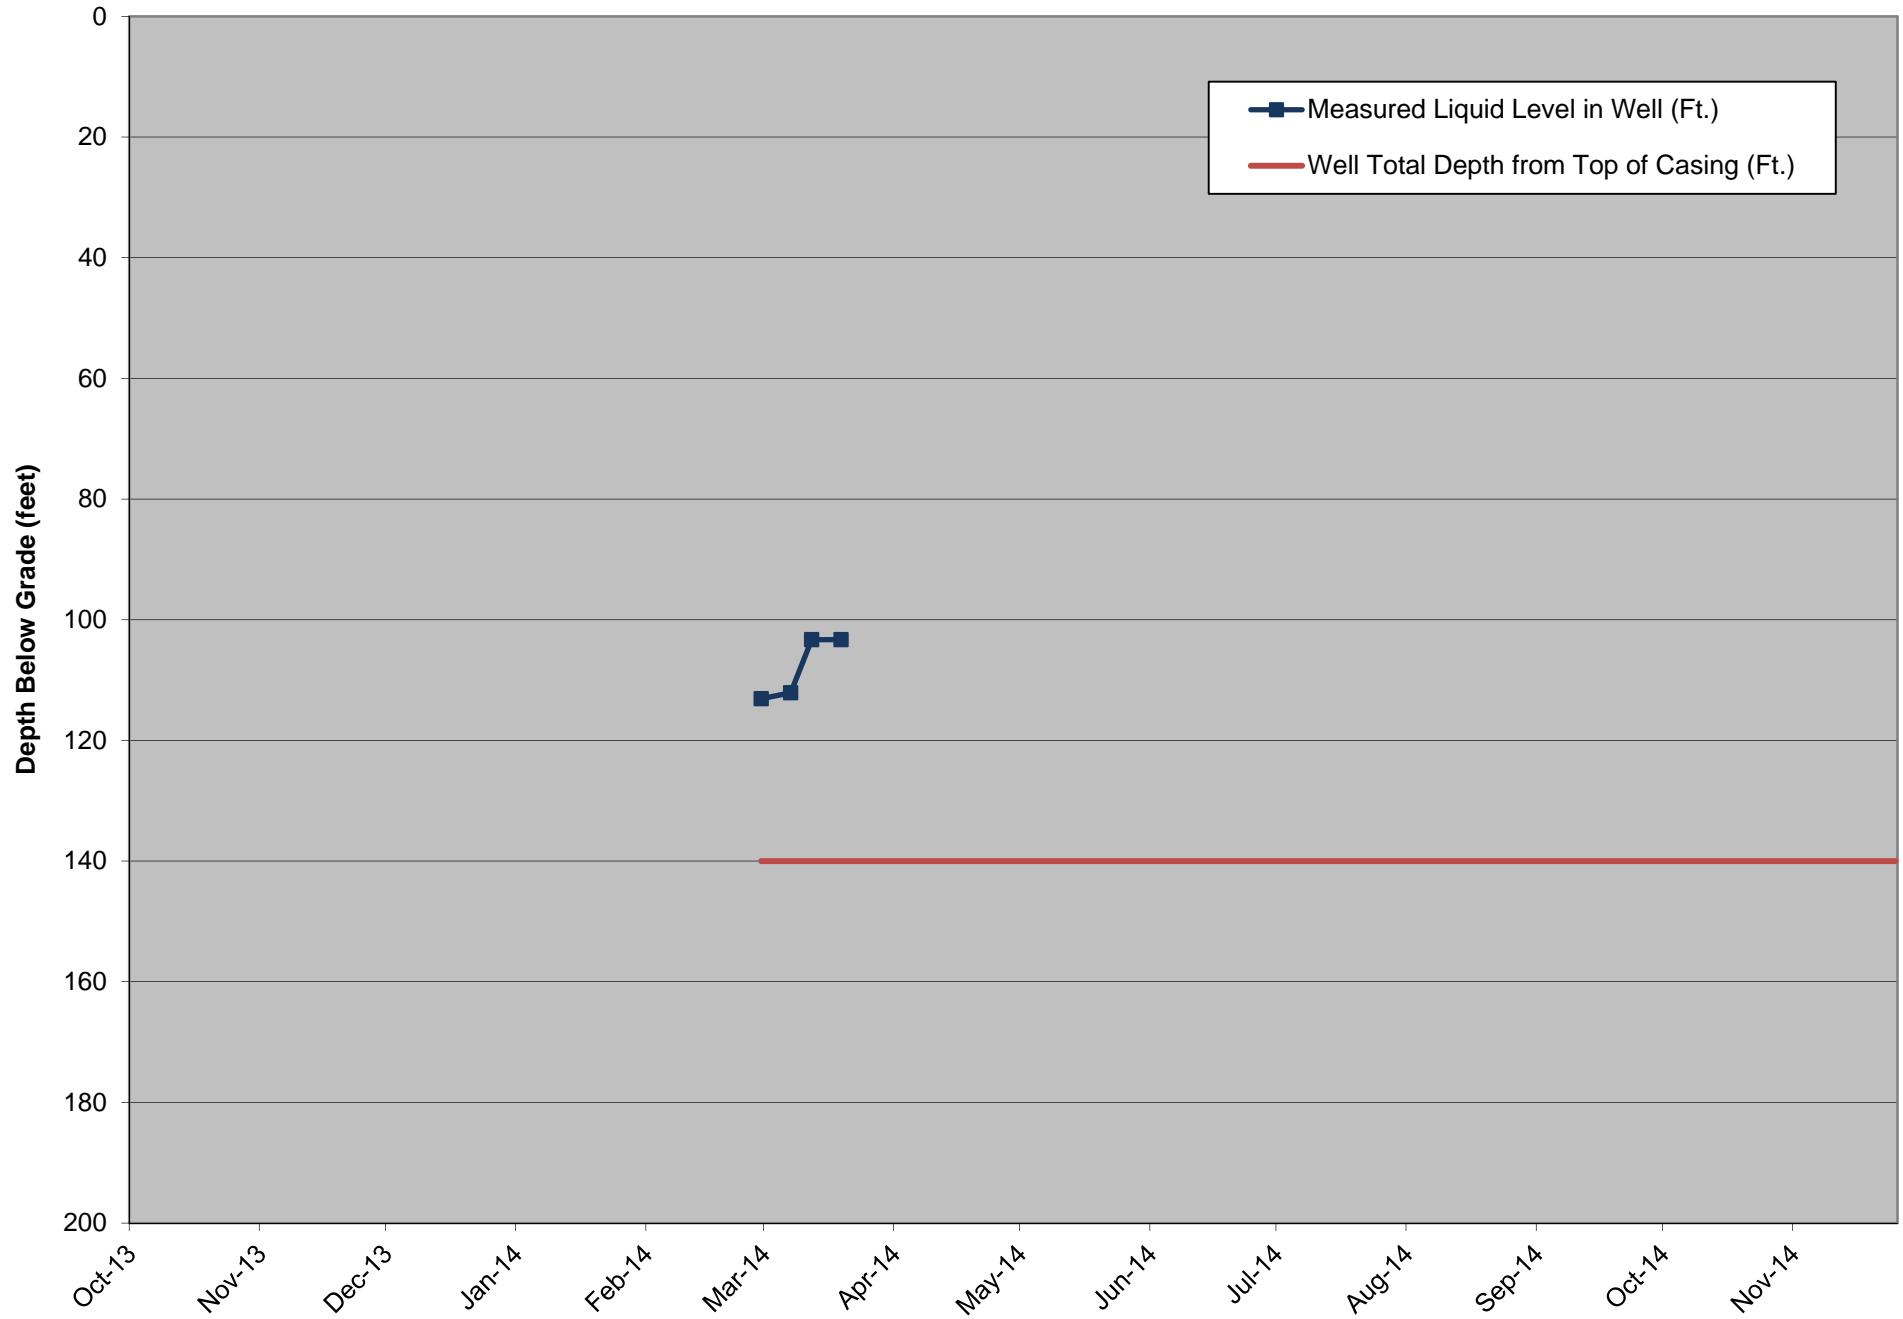
LCS-3D Liquid Level Below Ground Surface

The transducer melted in LCS-3D in March 2014 and is currently non-operational.

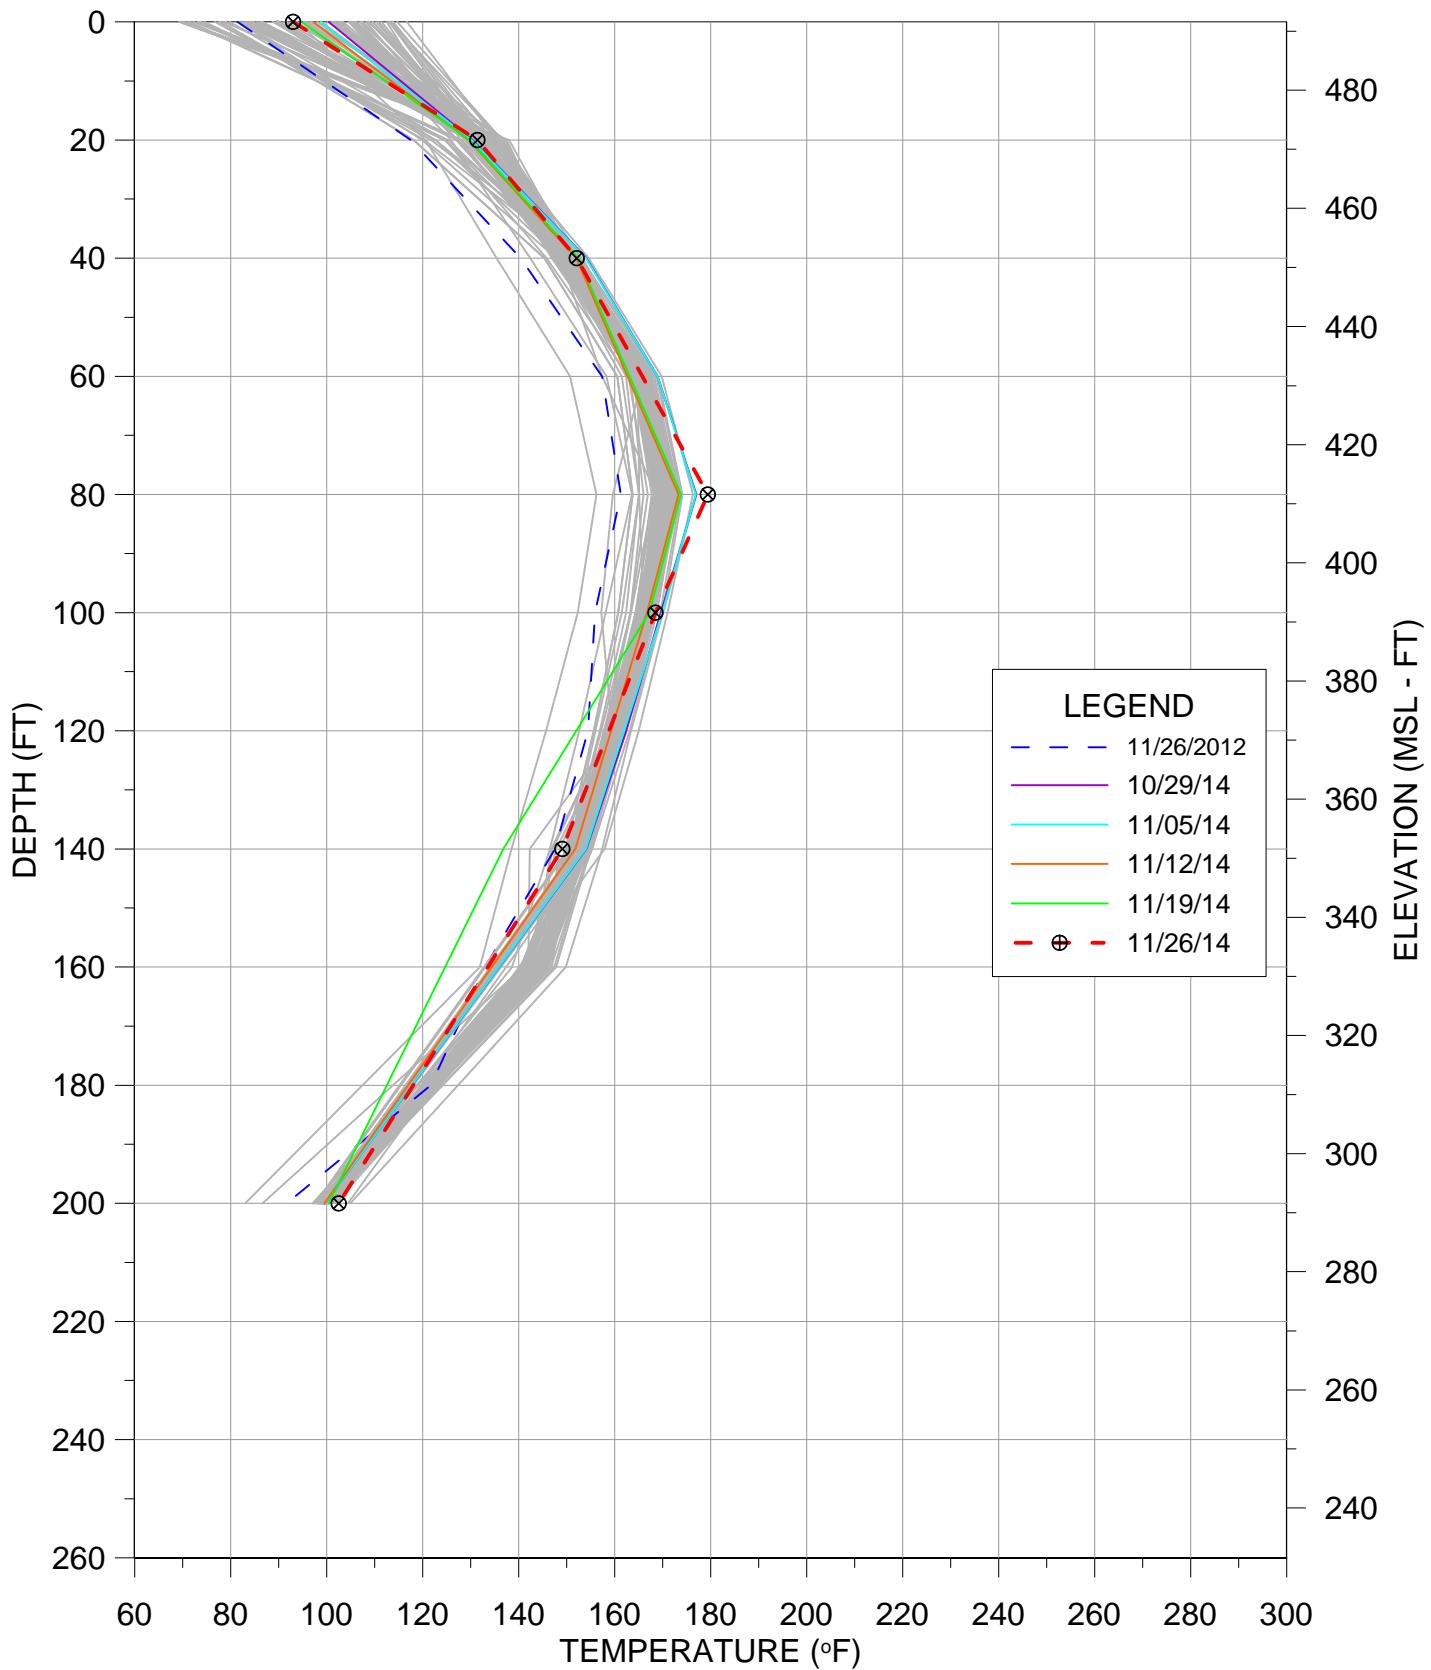
TMP-2

The following TMPs indicated generally consistent profiles to previous observations: TMP-1, -2, -3, -4, -6, -8, -10, -11, -14, -16, -17, and -18. However, it should be noted that the 80-foot interval in TMP-2, the 25-, 45, and 65-foot intervals in TMP-3, the 25-foot interval in TMP-4, and the 25-, 85-, 200-, and 220-foot intervals in TMP-11 each increased slightly in the latest reading, compared to the previous week.

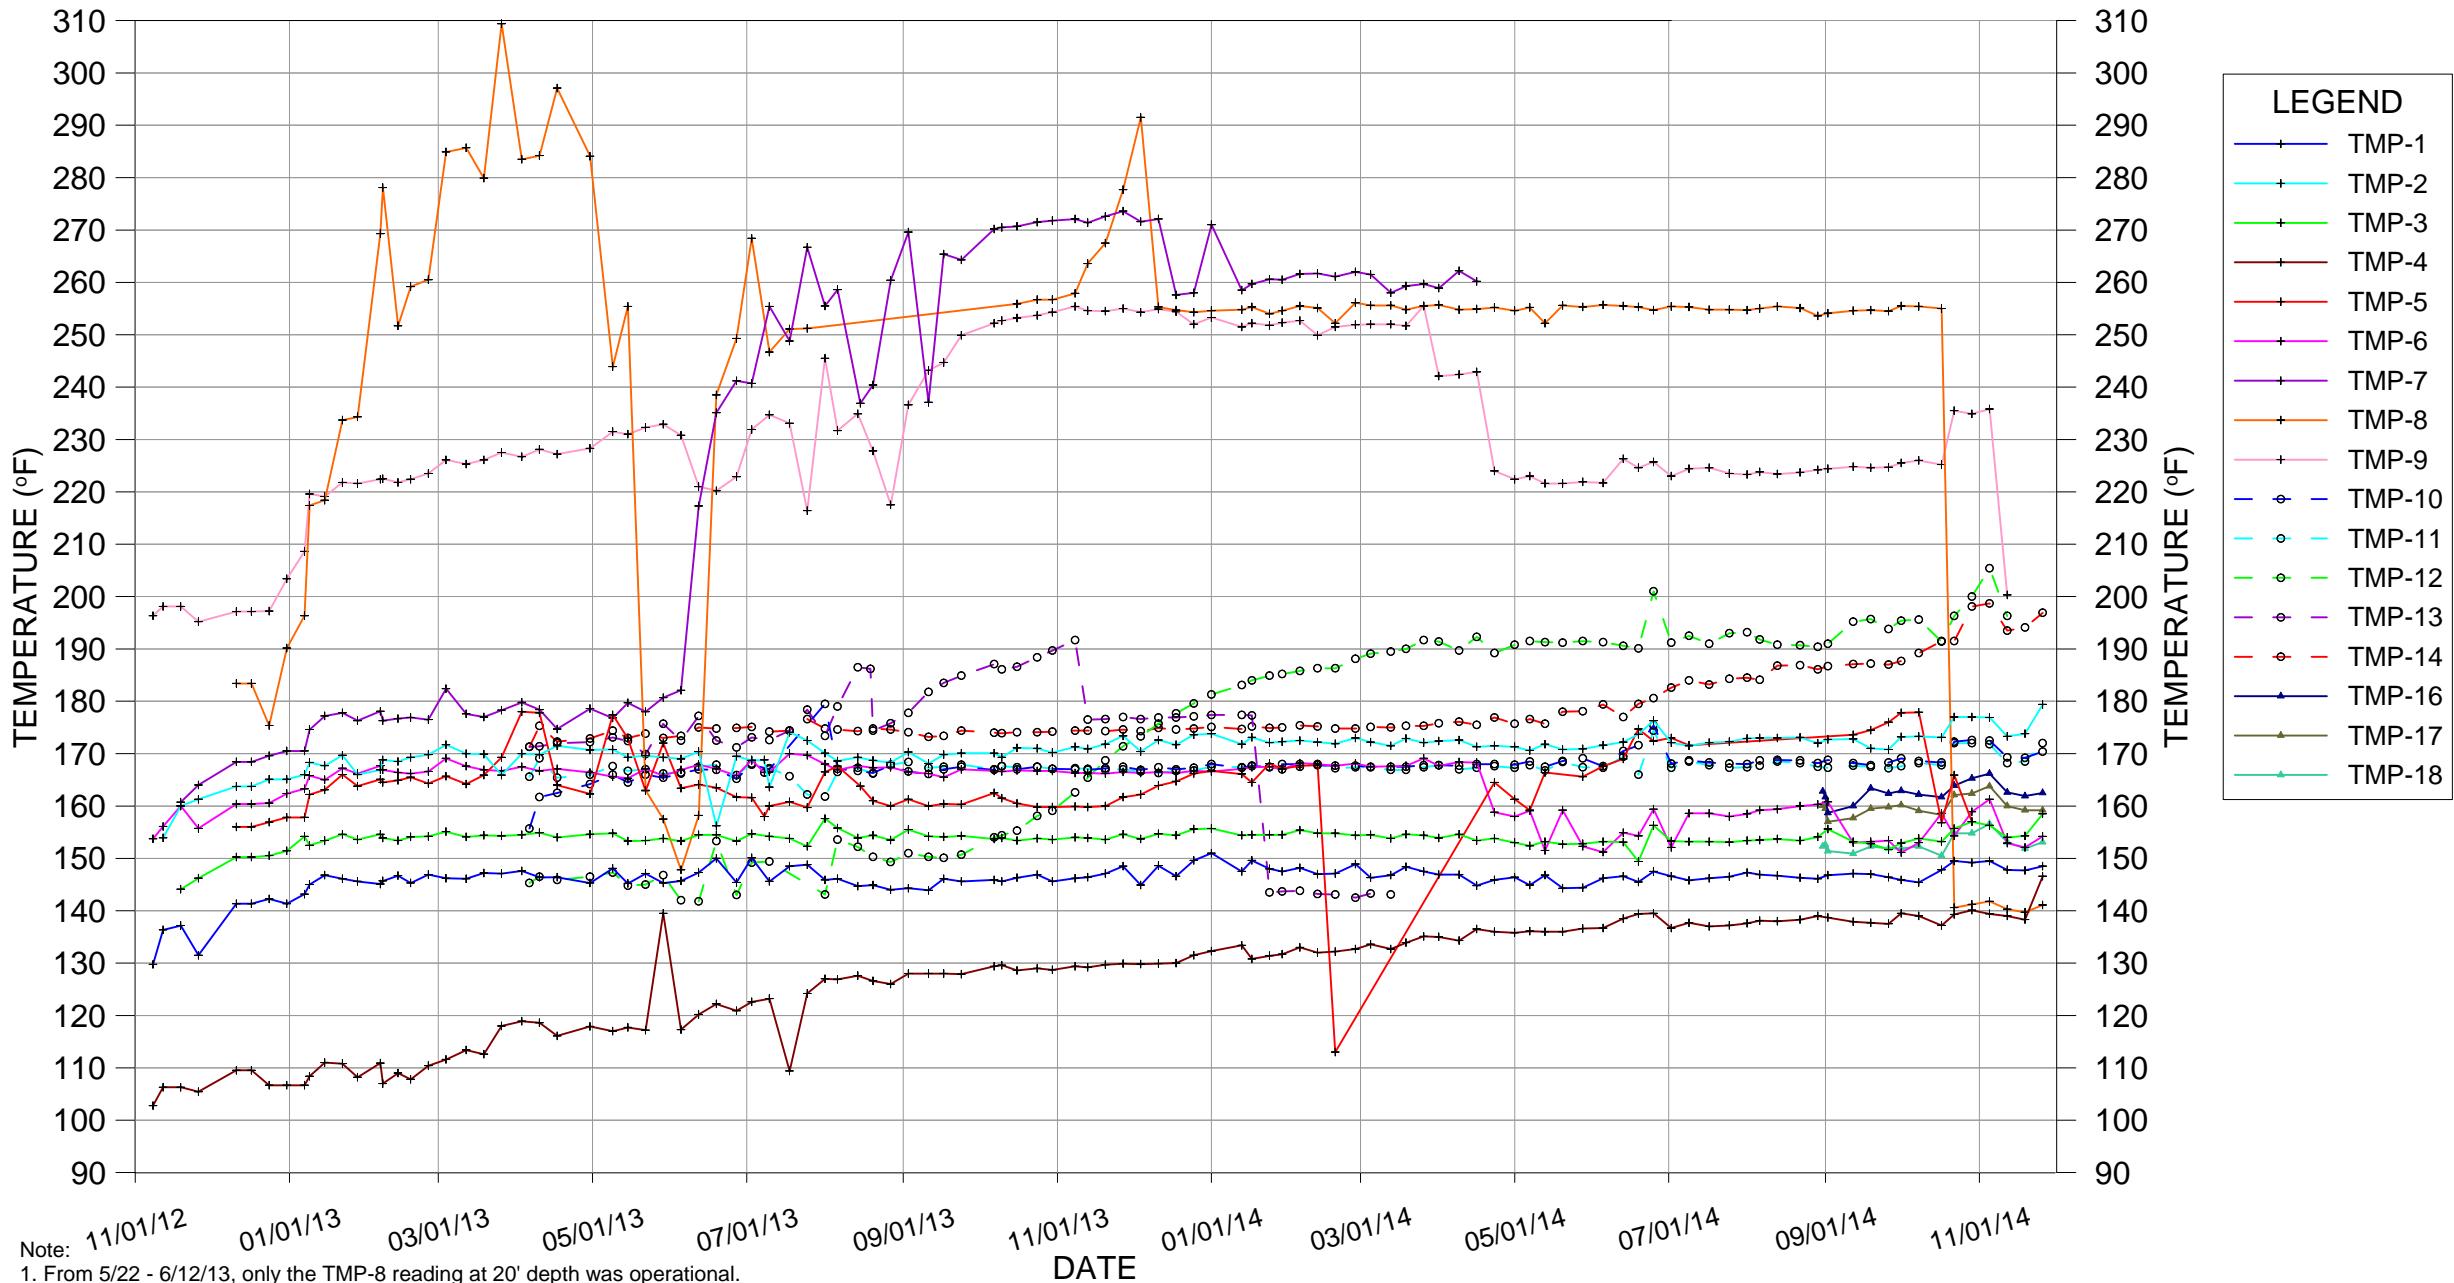
MAXIMUM TEMPERATURES

1. From 5/22 - 6/12/13, only the TMP-8 reading at 20' depth was operational.
 No valid readings were obtained for TMP-8 from 8/1 to 10/10/2013. Valid readings from 20' to 40' resumed on 10/16/2013.
 2. A new OMEGA dial was installed at TMP-7R on 6/12/2013 enabling more valid readings.
 3. No valid readings were obtained for TMP-10 and TMP-12 on 7/18/2013 or 7/25/2013.
 4. End terminals were replaced just prior to the 8/6/2013 readings with type T Omega connectors
 (part # SMPW-CC-T-M) on all TMPs except for TMP-8.

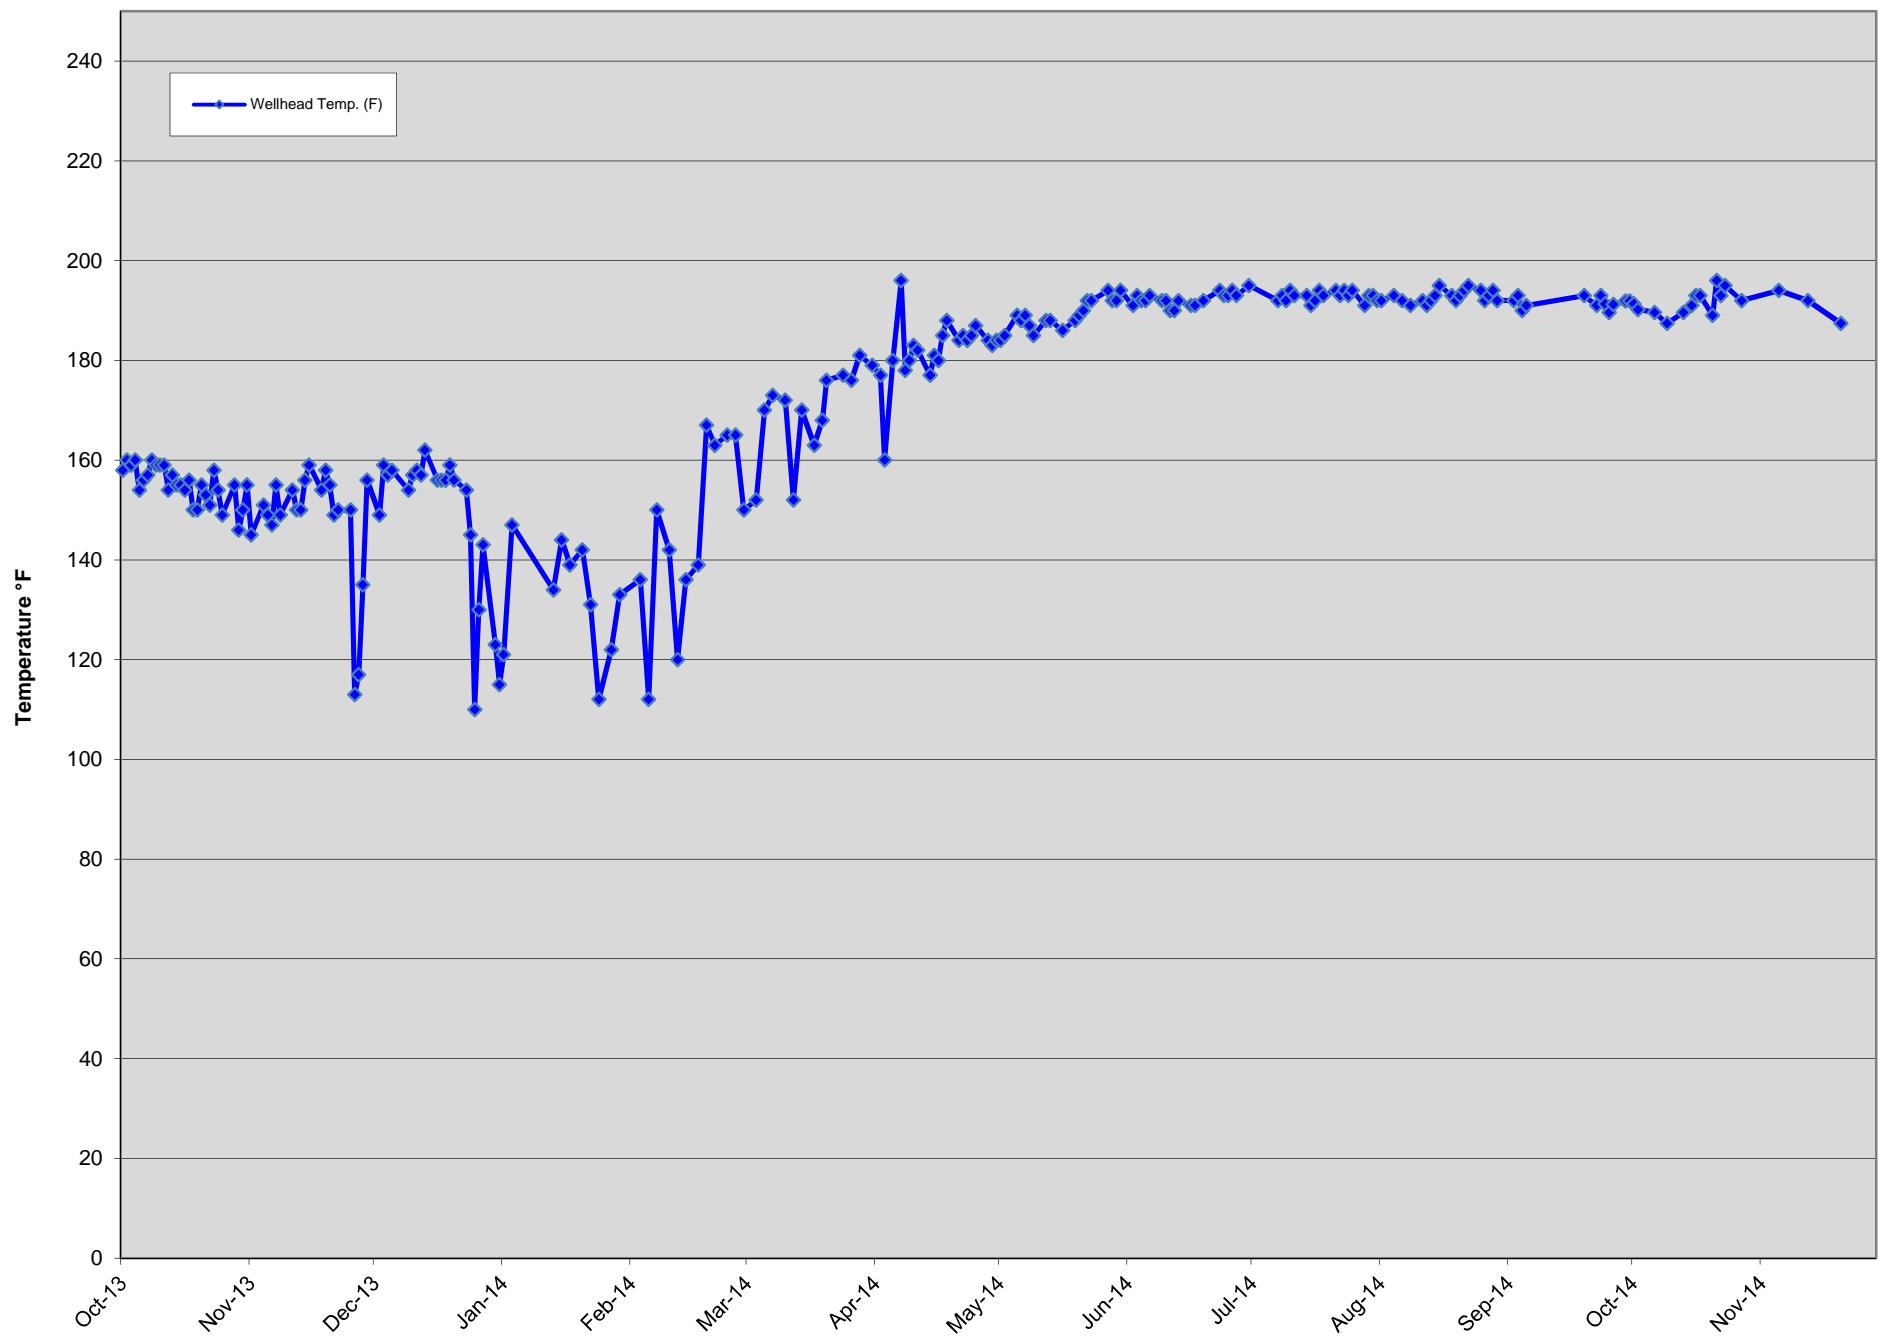
GIW-9 Wellhead Temperatures

For the remaining six wells without a cooling system installed (GIW-1, -8, -9, -11, -12, and -13), with the exception of GIW-11, gas temperatures were generally consistent over the past week as well as compared to prior weeks. GIW-11 has been experiencing 20-30 degree fluctuations in gas temperature, which is likely due to its proximity to GIW series wells with cooling loops installed. Note that GIW-9 was not monitored over the past week due to operational issues with the well.

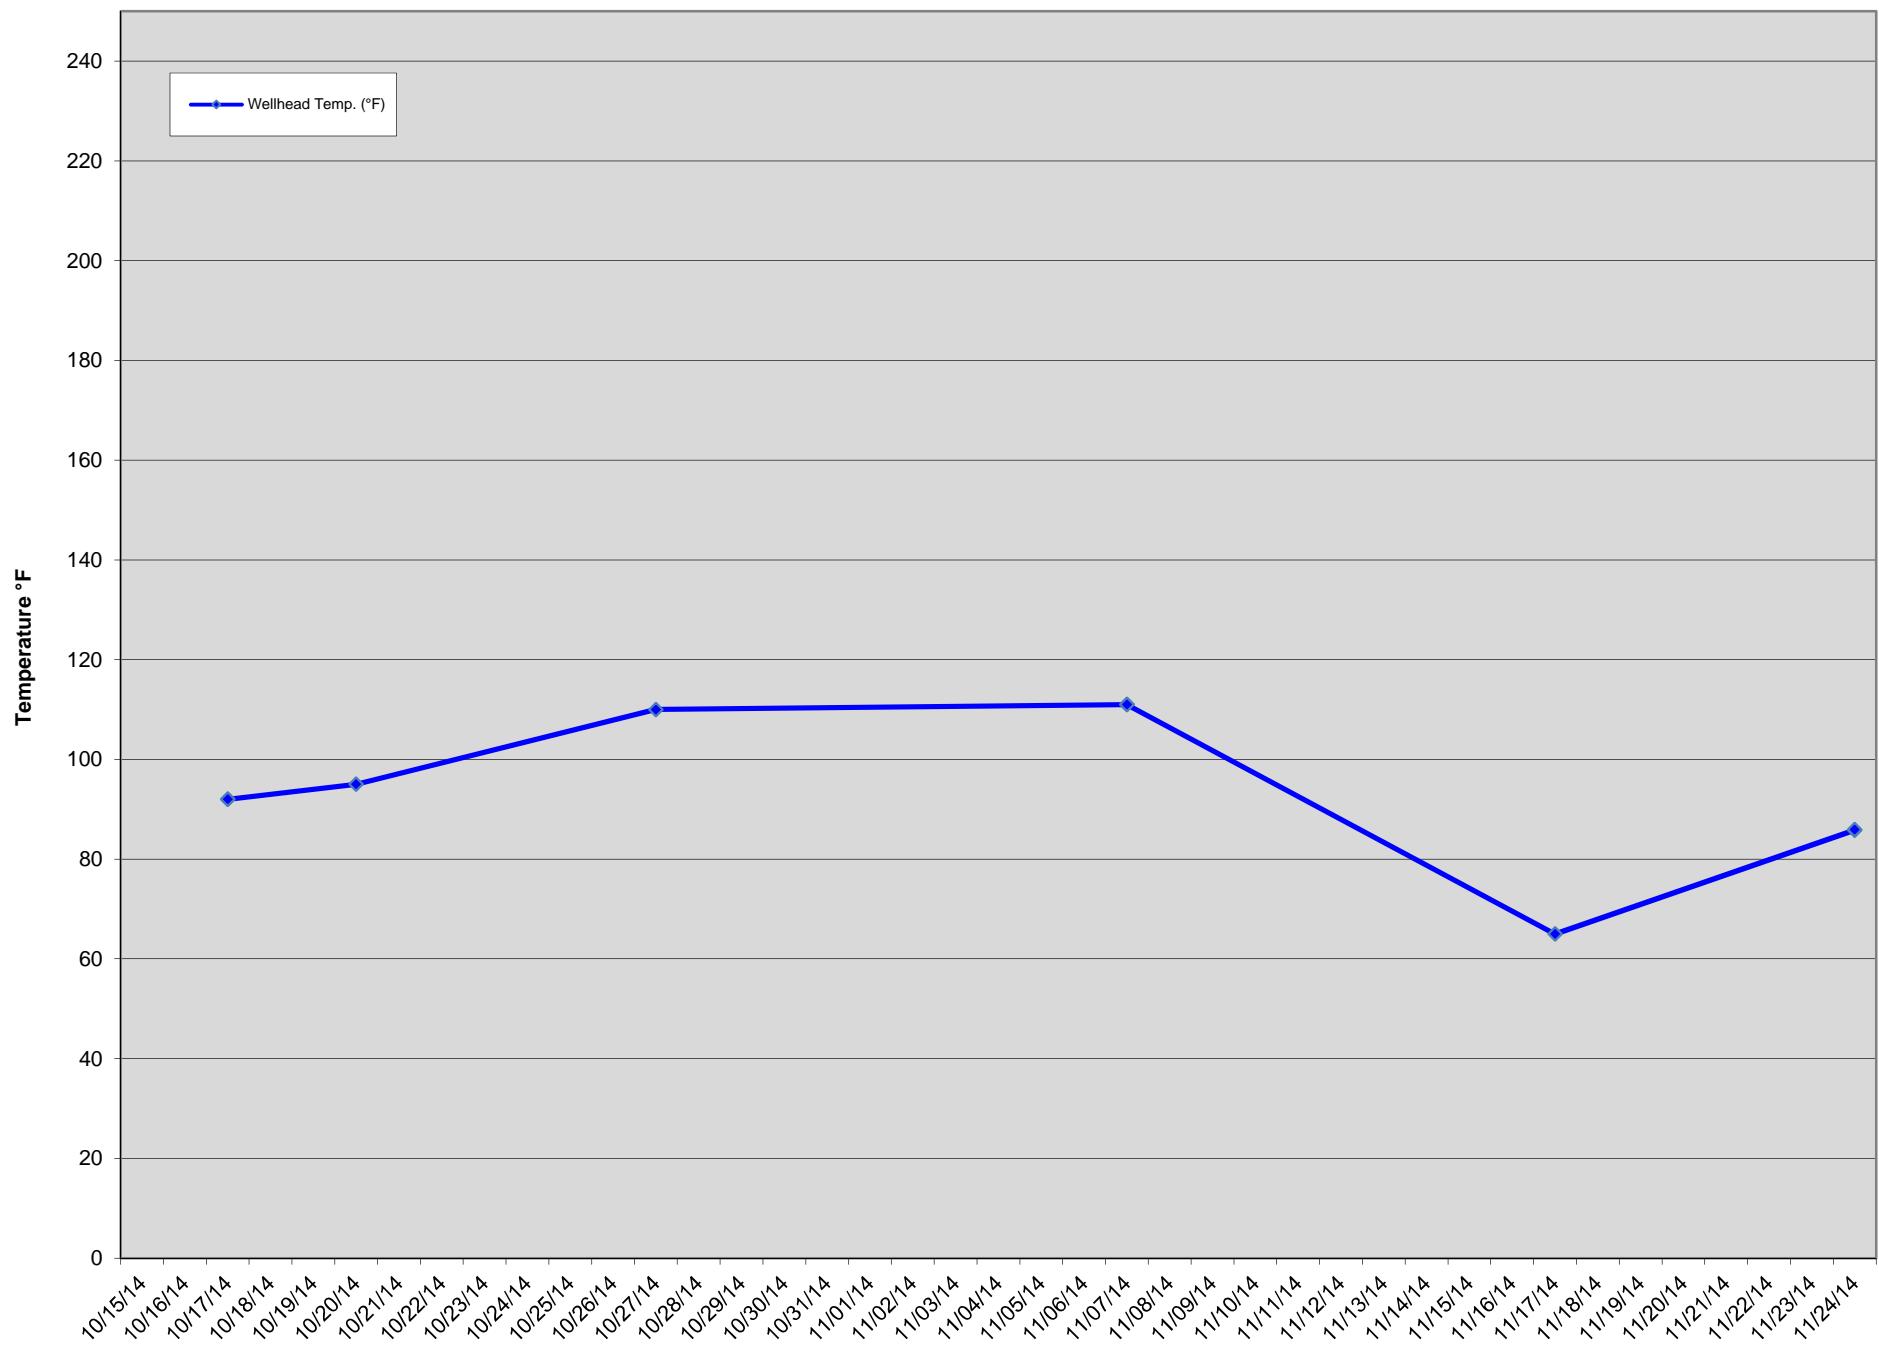
GEW-109 Wellhead Temperatures

Weekly gas temperature data is being collected for select gas extraction wells (GEWs) located in the neck area of the landfill. These wells include GEW-08, -09, -10, -38, -39, -40, -41R, -43R, -53, -54, -55, -56R, -109, and -110. Over the past week all 14 wells were monitored. With the exception of GEW-109 and -110 the well temperatures are generally consistent in comparison to prior weeks. GEW-109 and -110 increased by 20 degrees and 16 degrees, respectively, when compared to the temperatures from the previous week. This is likely due to low flow within each well and low ambient temperatures.
