Bridgeton Landfill, LLC

Weekly Data Submittal

Week of August 26, 2018 – September 1, 2018

**Required by Section IX.33.g of Final Consent Judgment, Case No. 13SL-
CC01088-01
Effective June 29, 2018**

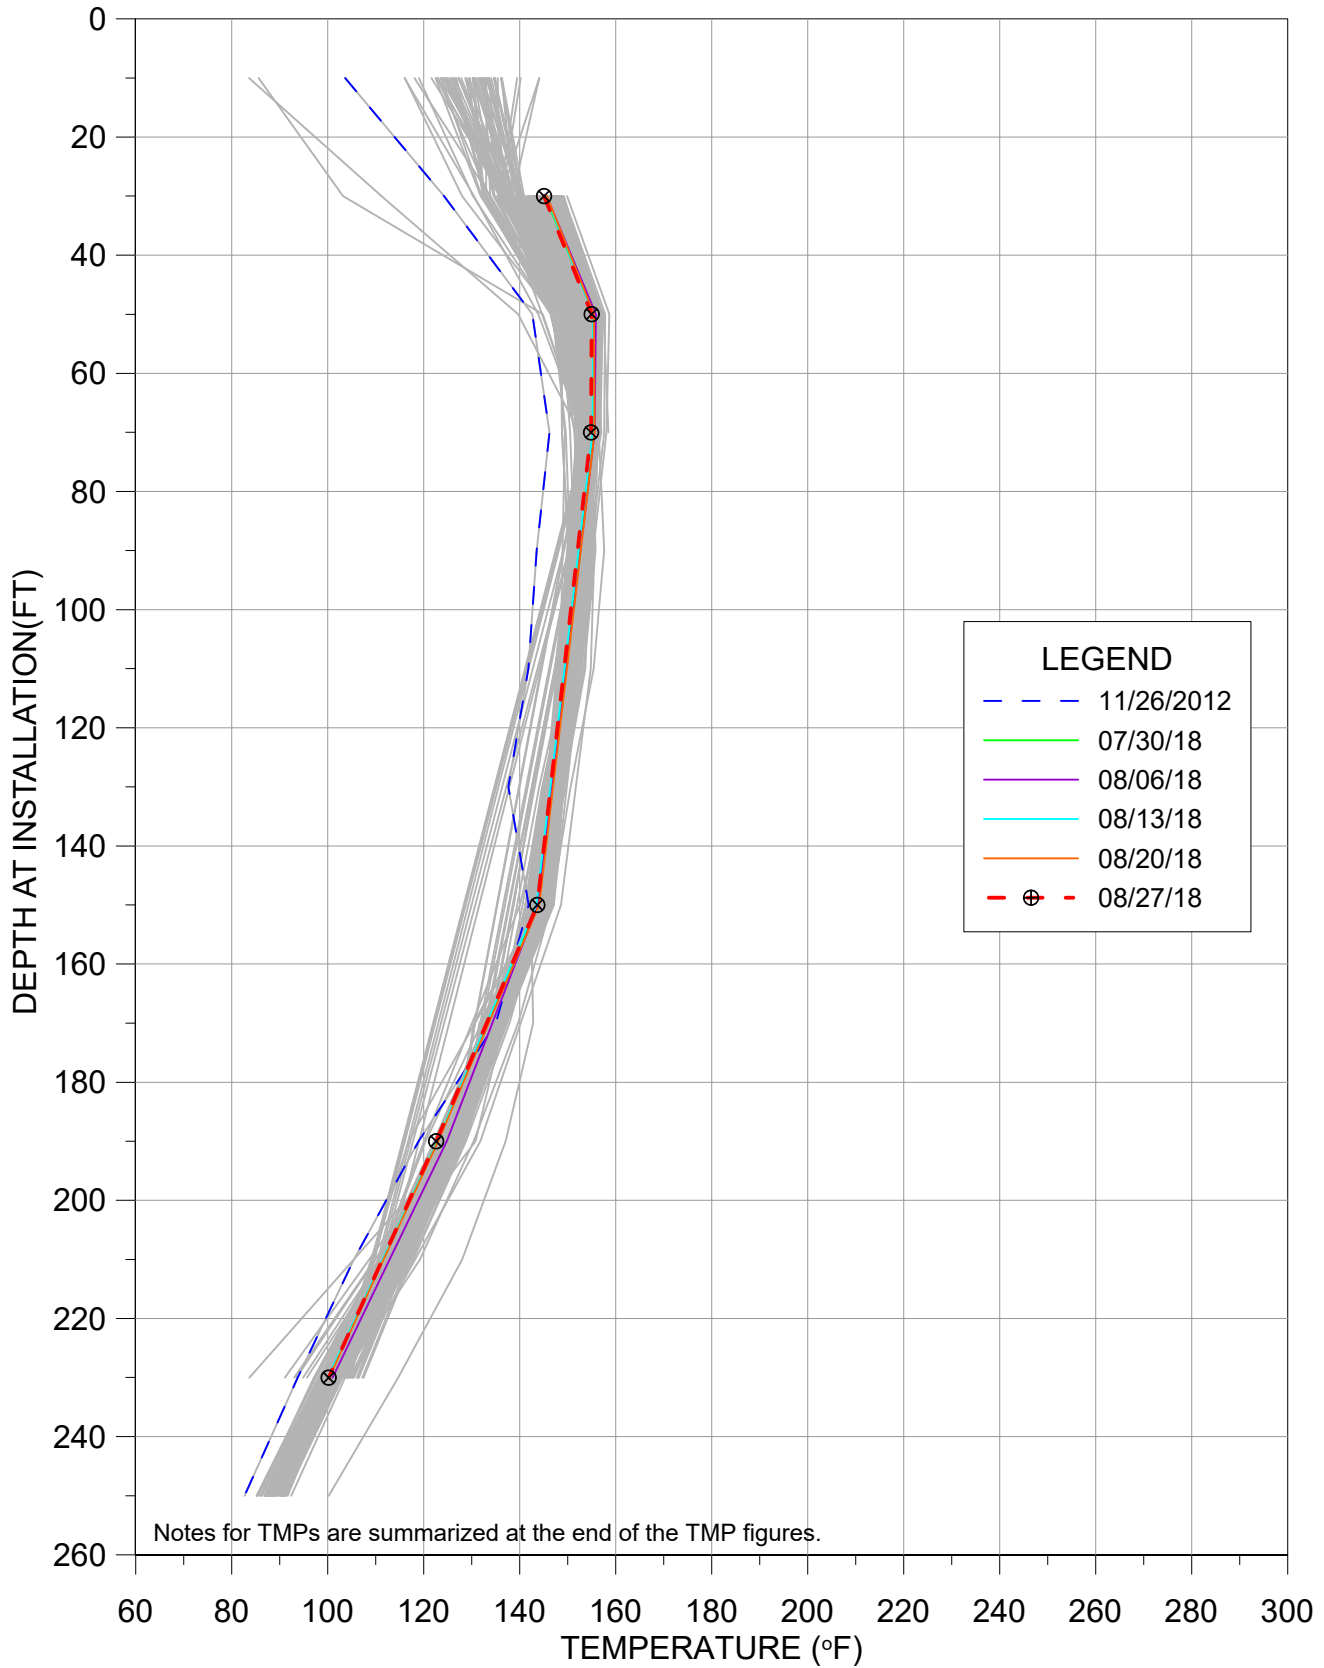
TMP-3

1. No reliable temperature readings have been obtained at 170 ft depth since 1/29/2014, except on 3/13/2014.
2. The connectivity tests on 4/11/2014 conducted by CEC showed that units at 10, 90, 130, 210 and 250 ft depths are no longer reliable.
3. The connectivity tests on 10/28/2014 conducted by Feezor Engineering showed that units at 10, 90, 110, 130, 210 and 250 ft depths are not reliable.

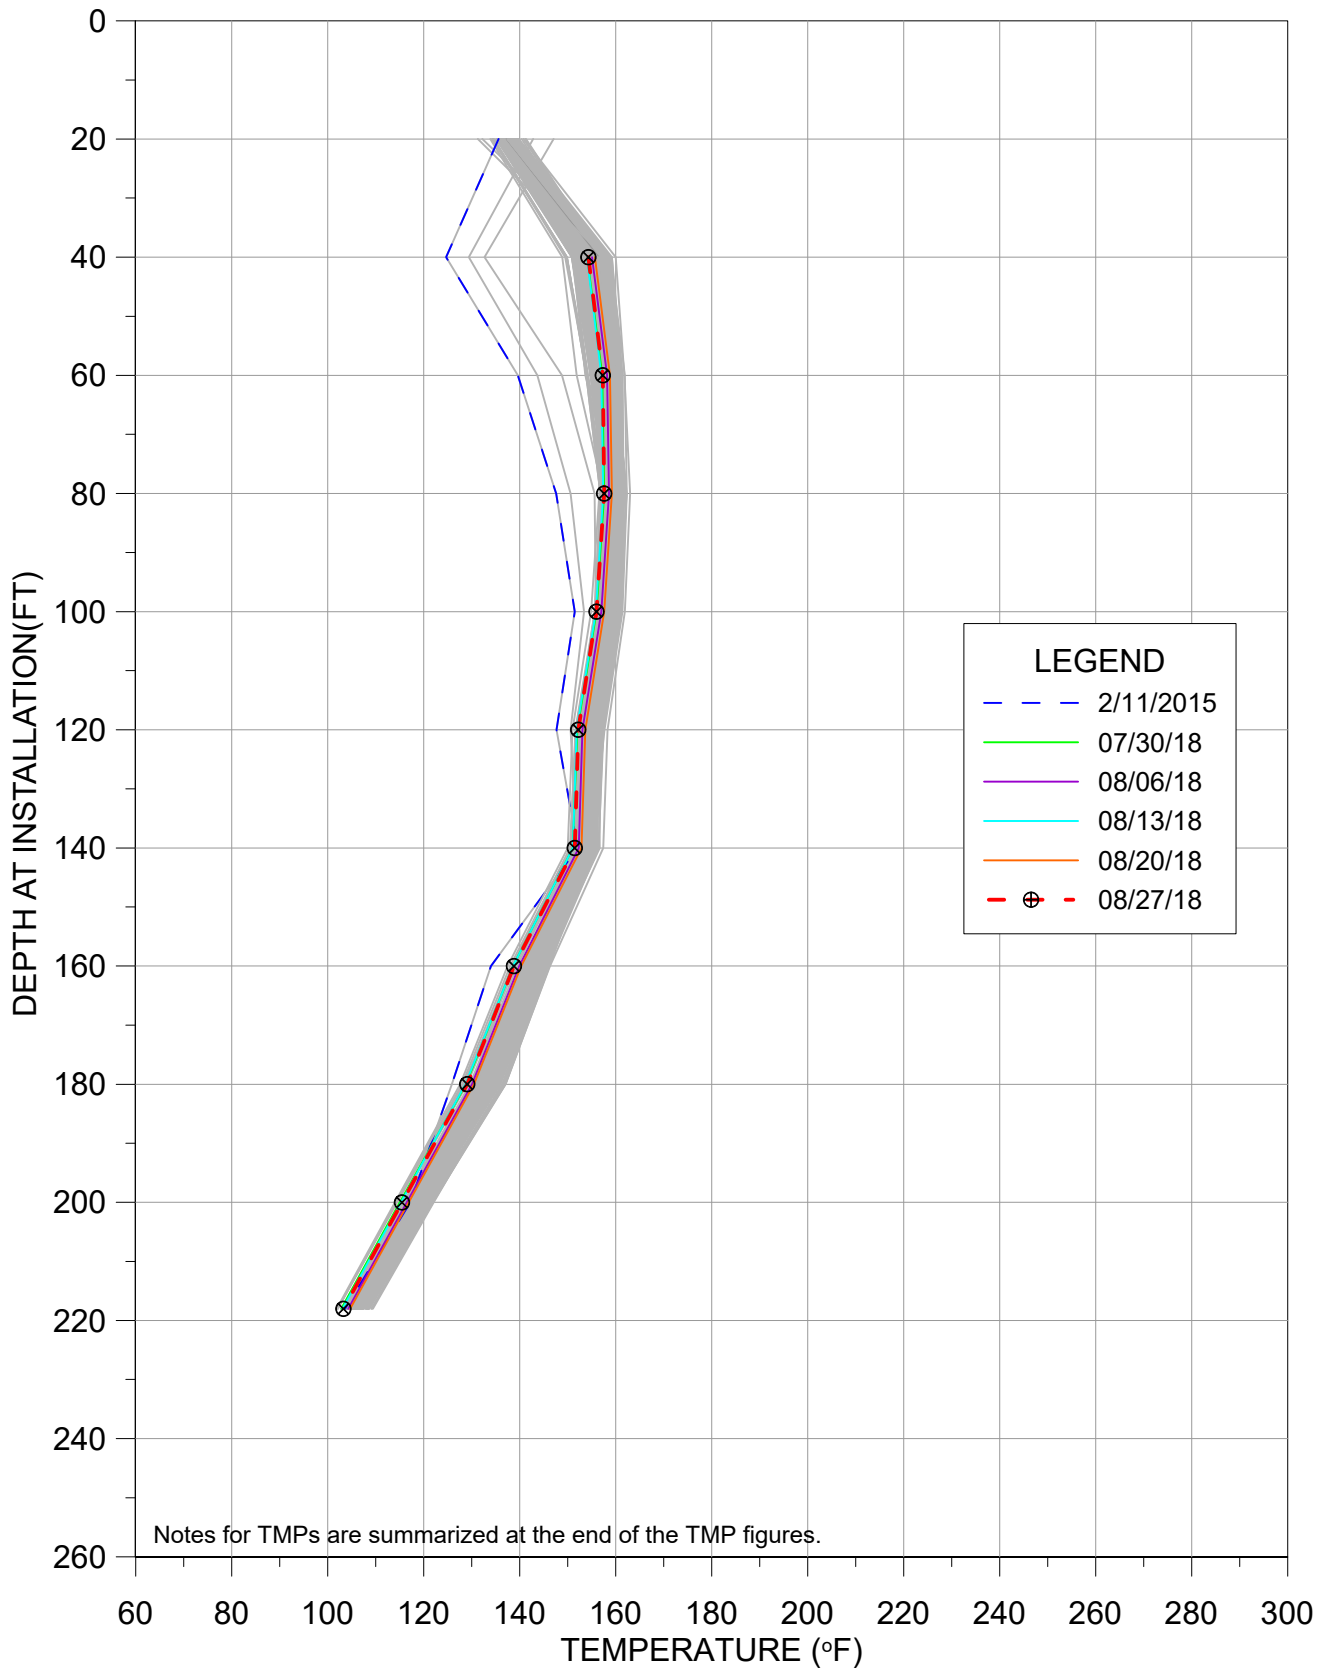
TMP-3R

1. The unit at 20 ft depth had a fluctuating resistance since 9/25/2017. Therefore the temperature is determined to be unreliable.

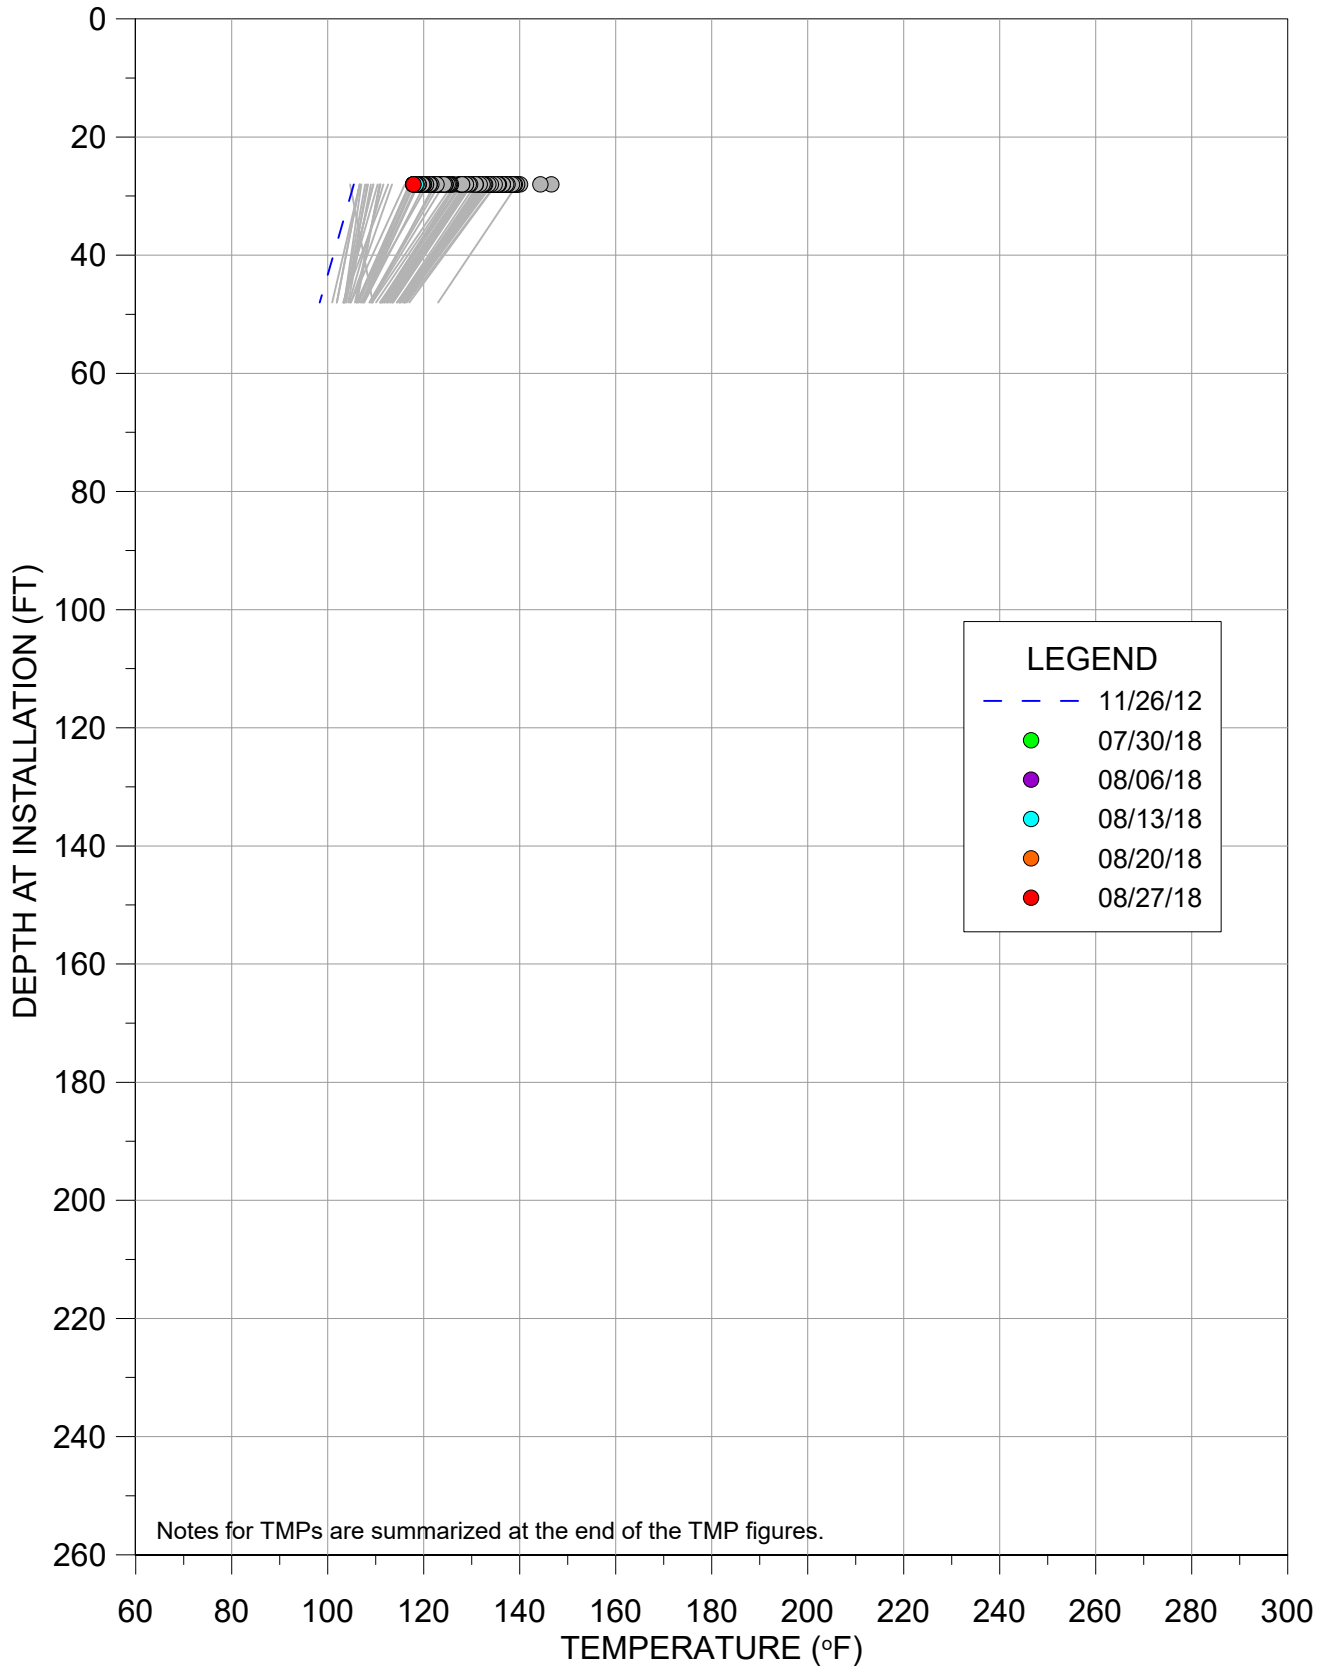
TMP-4

1. The connectivity tests on 4/11/2014 conducted by CEC showed that the unit at 48 ft depth is no longer reliable.

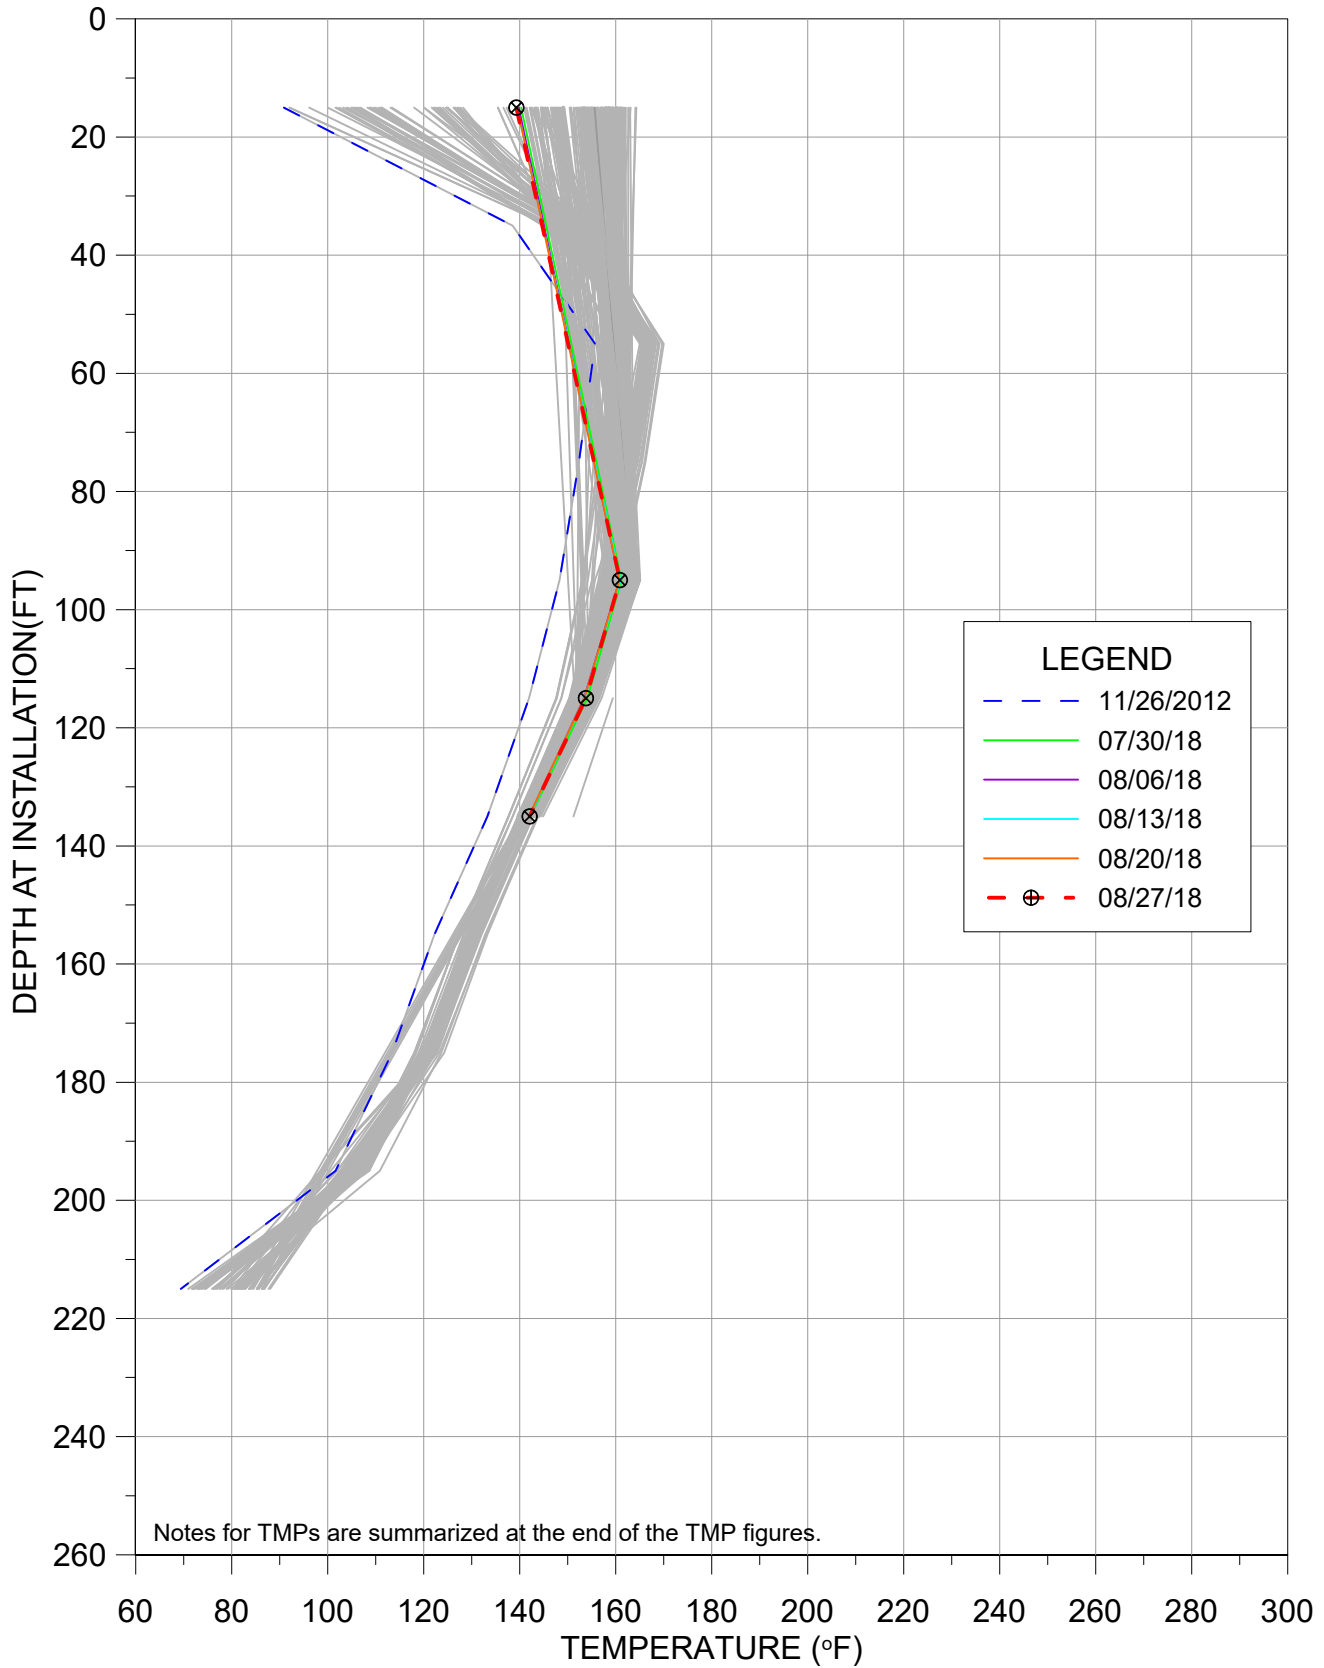
TMP-6

1. The connectivity tests on 4/11/2014 conducted by CEC showed that units at 35, 55, 75, 155, 175, and 195 ft depths are no longer reliable.
2. No reliable temperature readings have been obtained at the unit at 215 ft depth since 6/13/2014.

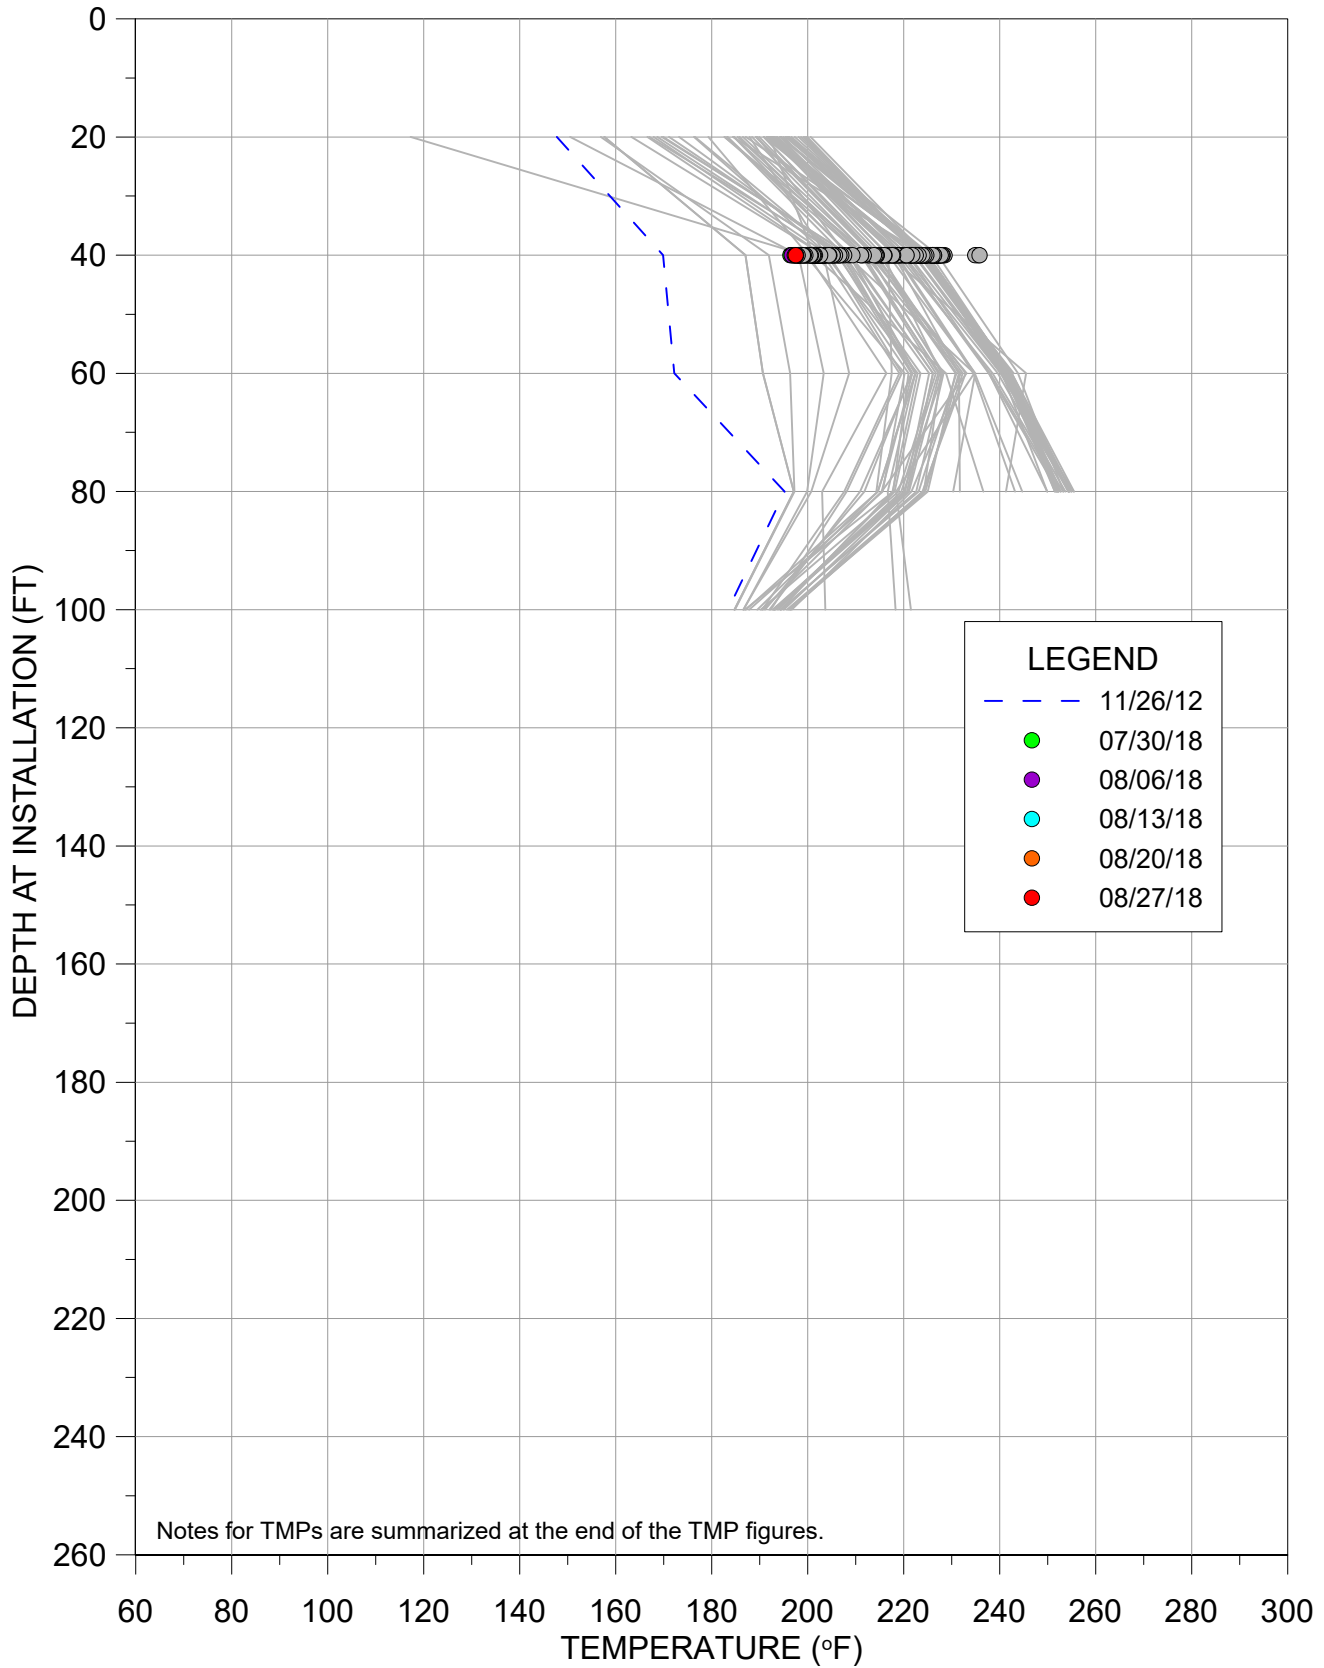
TMP-9

1. Unit at 100 ft depth had an inaccurate temperature reading on 8/1/2013 and no reading since 8/6/2013.
2. The connectivity tests on 4/11/2014 conducted by CEC showed that units at 20, 60, 80, and 100 ft depths are no longer reliable.

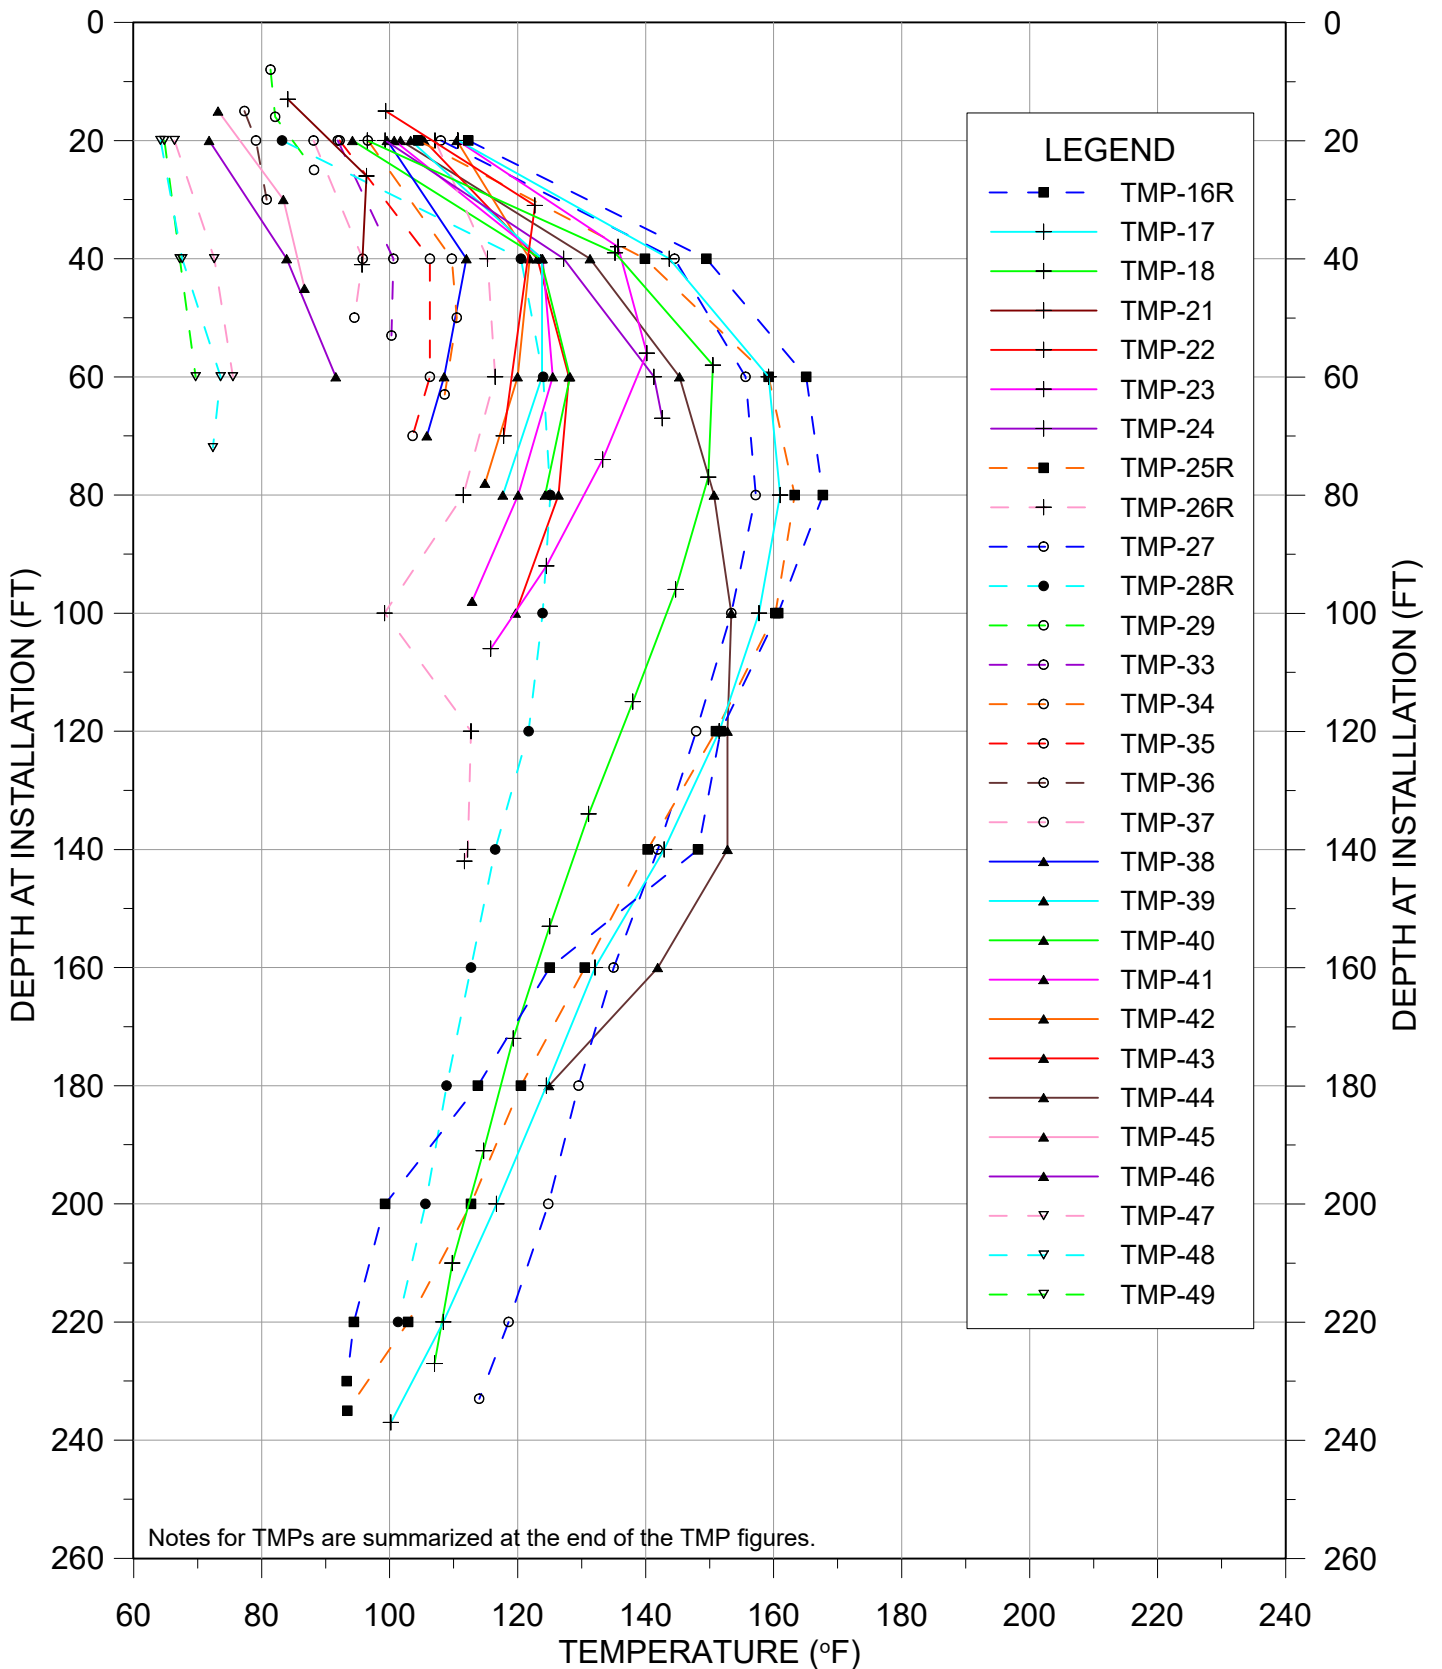
8/27/2018 - NORTH QUARRY

The TMPs listed above (and associated replacement TMP's) except TMP -6, -9, -11R, and -14R constitute the North Quarry TMPs as defined in August 2017 *North Quarry Subsurface Temperature Monitoring Probes Work Plan*. No temperature within the individual thermocouple of the North Quarry TMPs exceeds the temperature threshold set forth within this workplan.

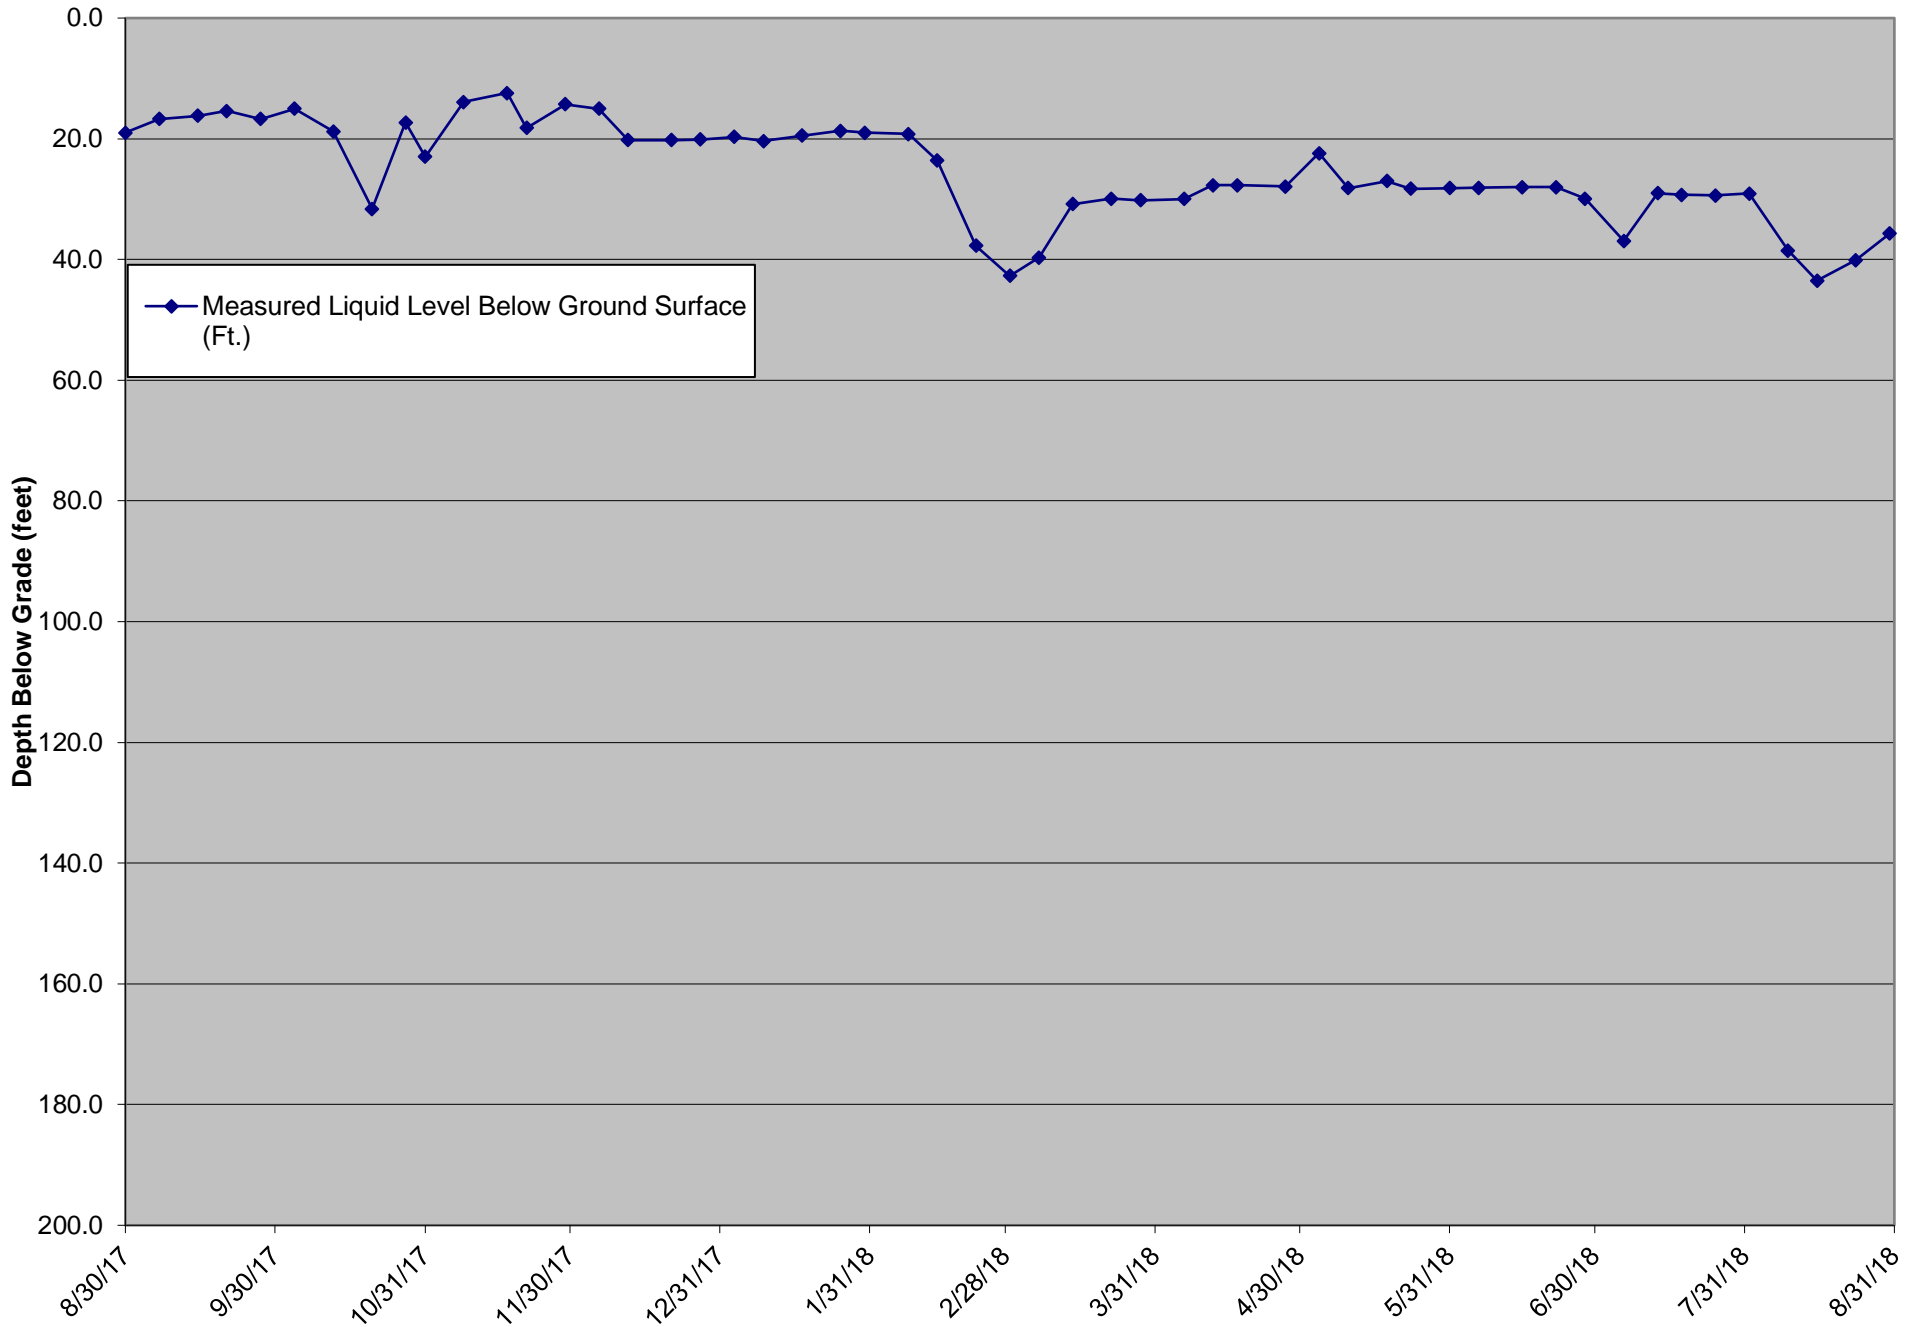
LCS-3D Liquid Level Below Ground Surface

The QED AP-4 in LCS-3D was fully operational during the weekly reporting period. Liquid level was measured manually.

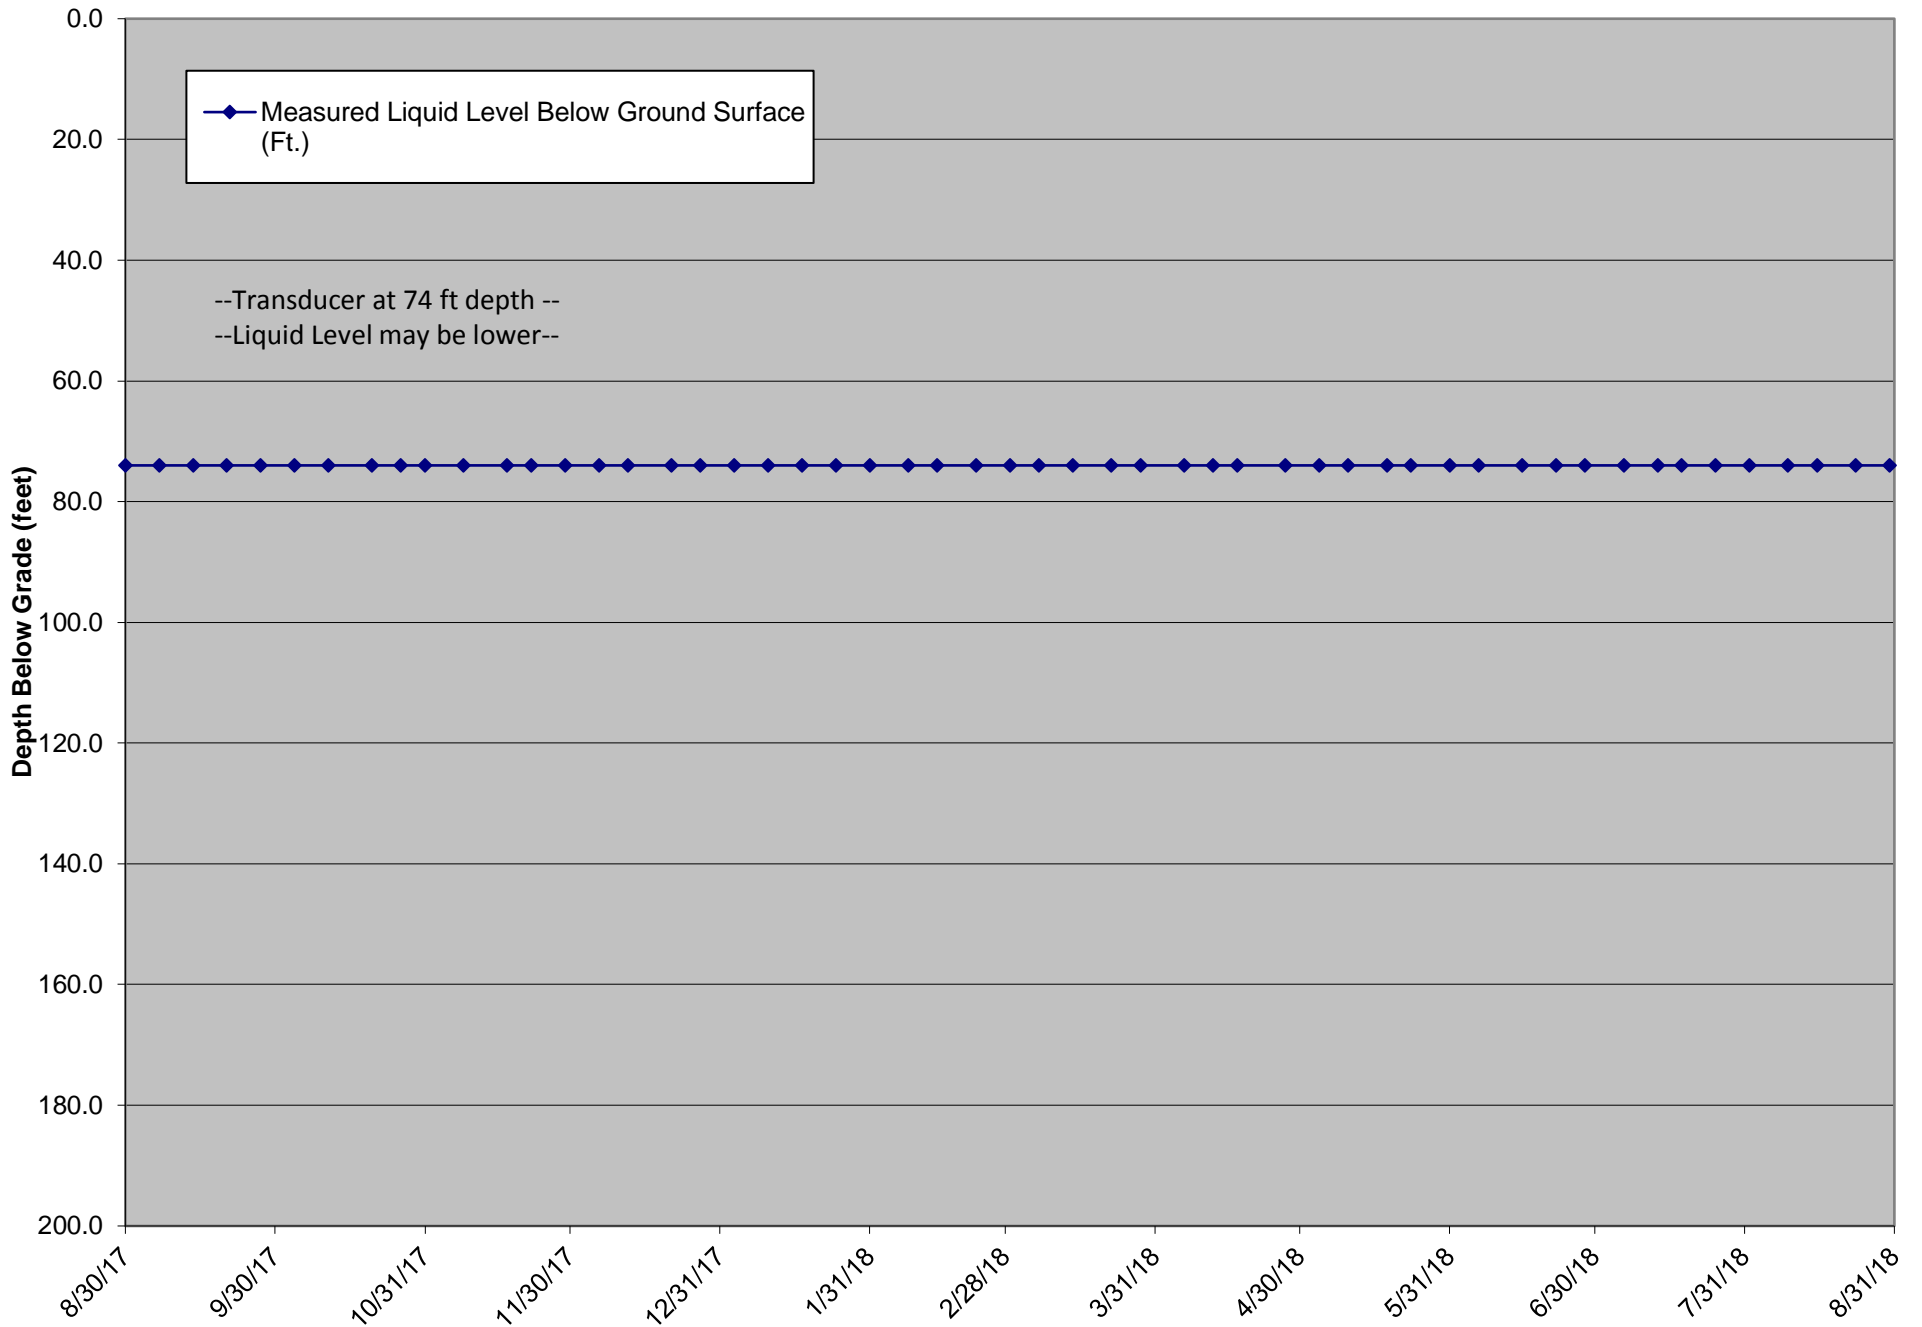
LCS-4B Liquid Level Below Ground Surface

The level sensor in LCS-4B is currently operational and responsive. Liquid level was not recorded by the level sensor during the weekly reporting period. LCS-4B is equipped with a flow meter that displayed no flow during the weekly reporting period. Therefore, it can be concluded that the liquid level was below the bottom of the pump and level sensor in LCS-4B.

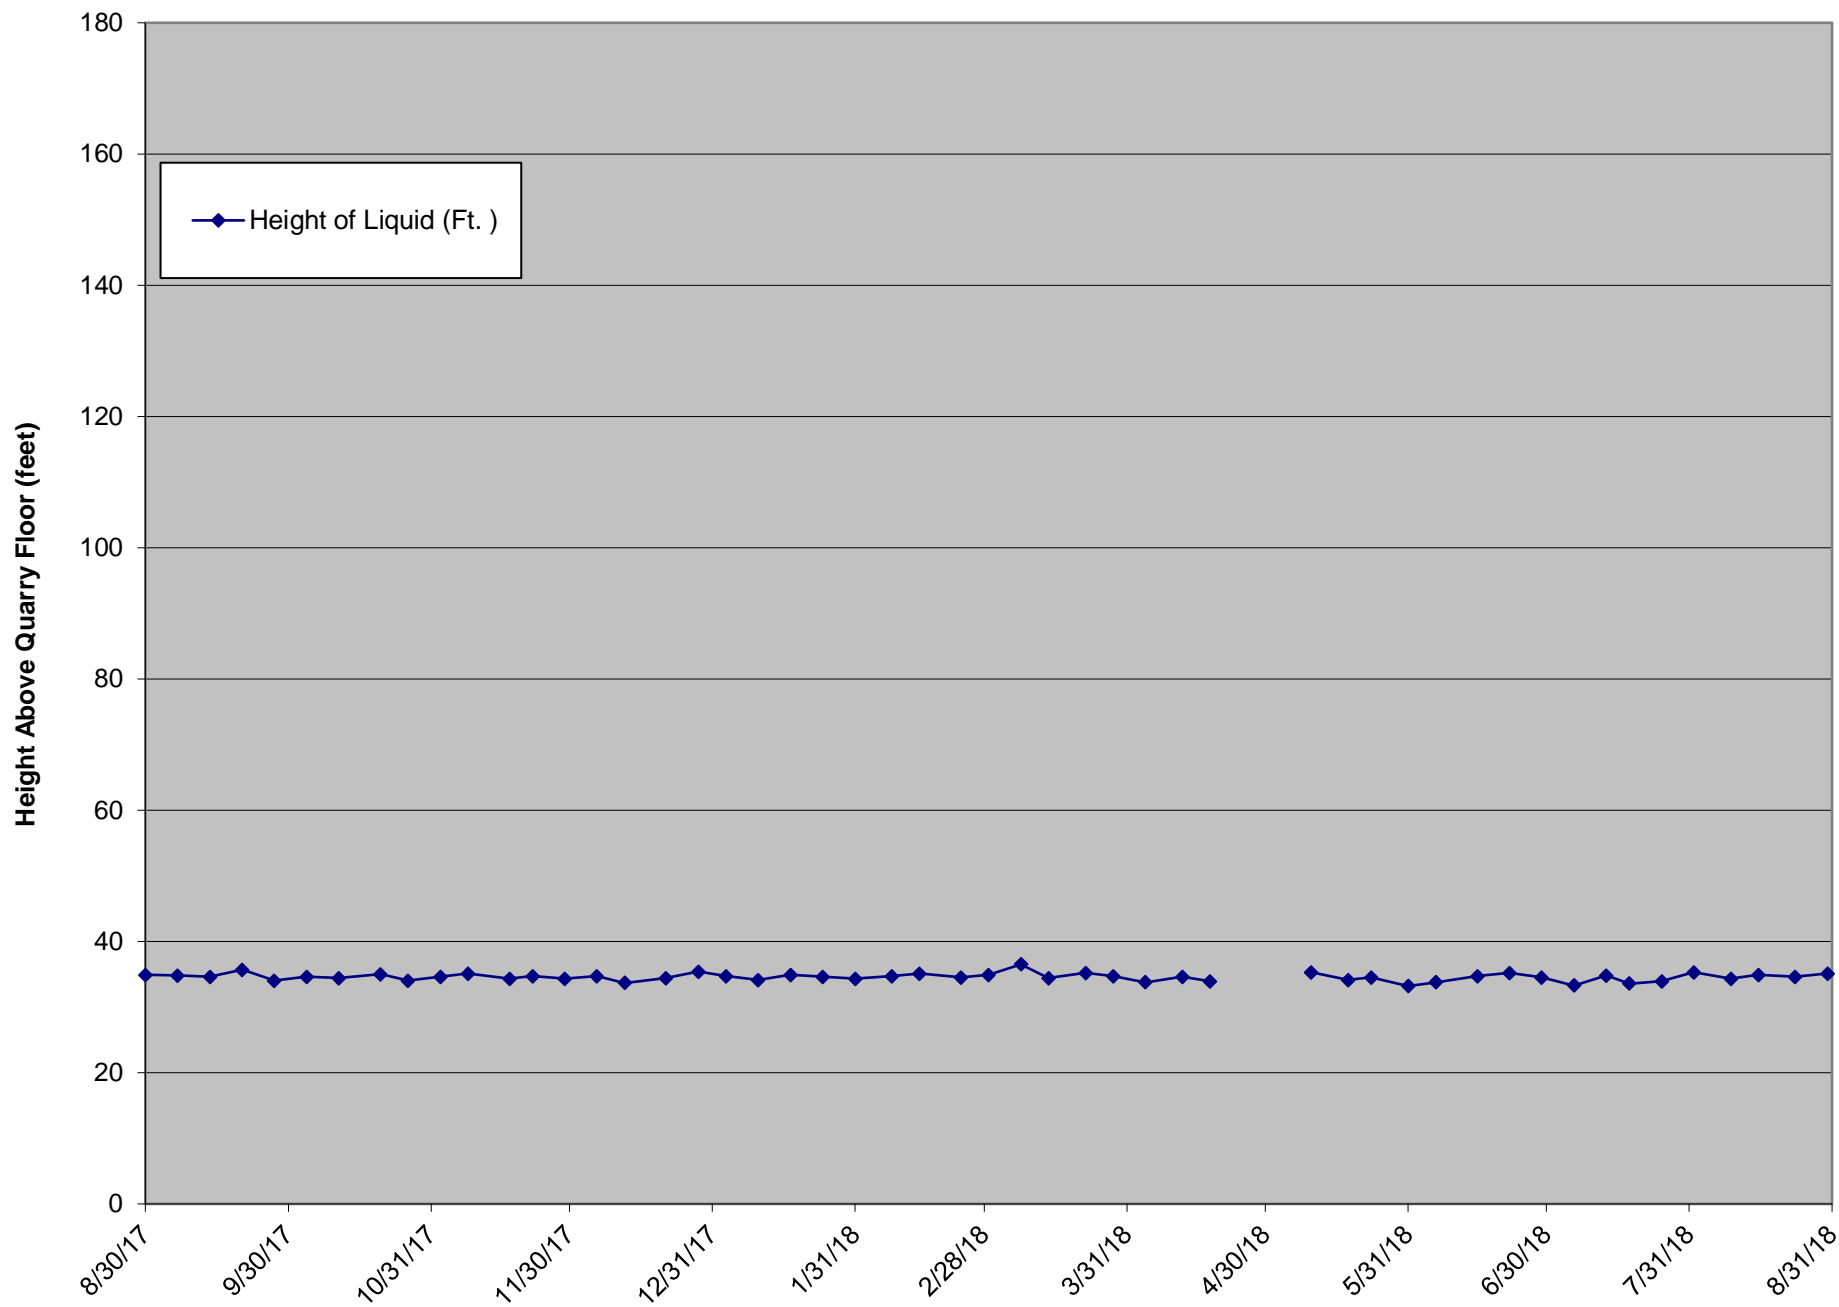
LCS-5B Liquid Level Above Quarry Floor

LCS-5B and LCS-6B were fully operational during the weekly reporting period.
